BONDURANT
ARCHITECTURE

ARDISSONE CONDOMINIUM ASSOCIATION, INC

Report Date:
July 13, 2023

1.0 INTRODUCTION

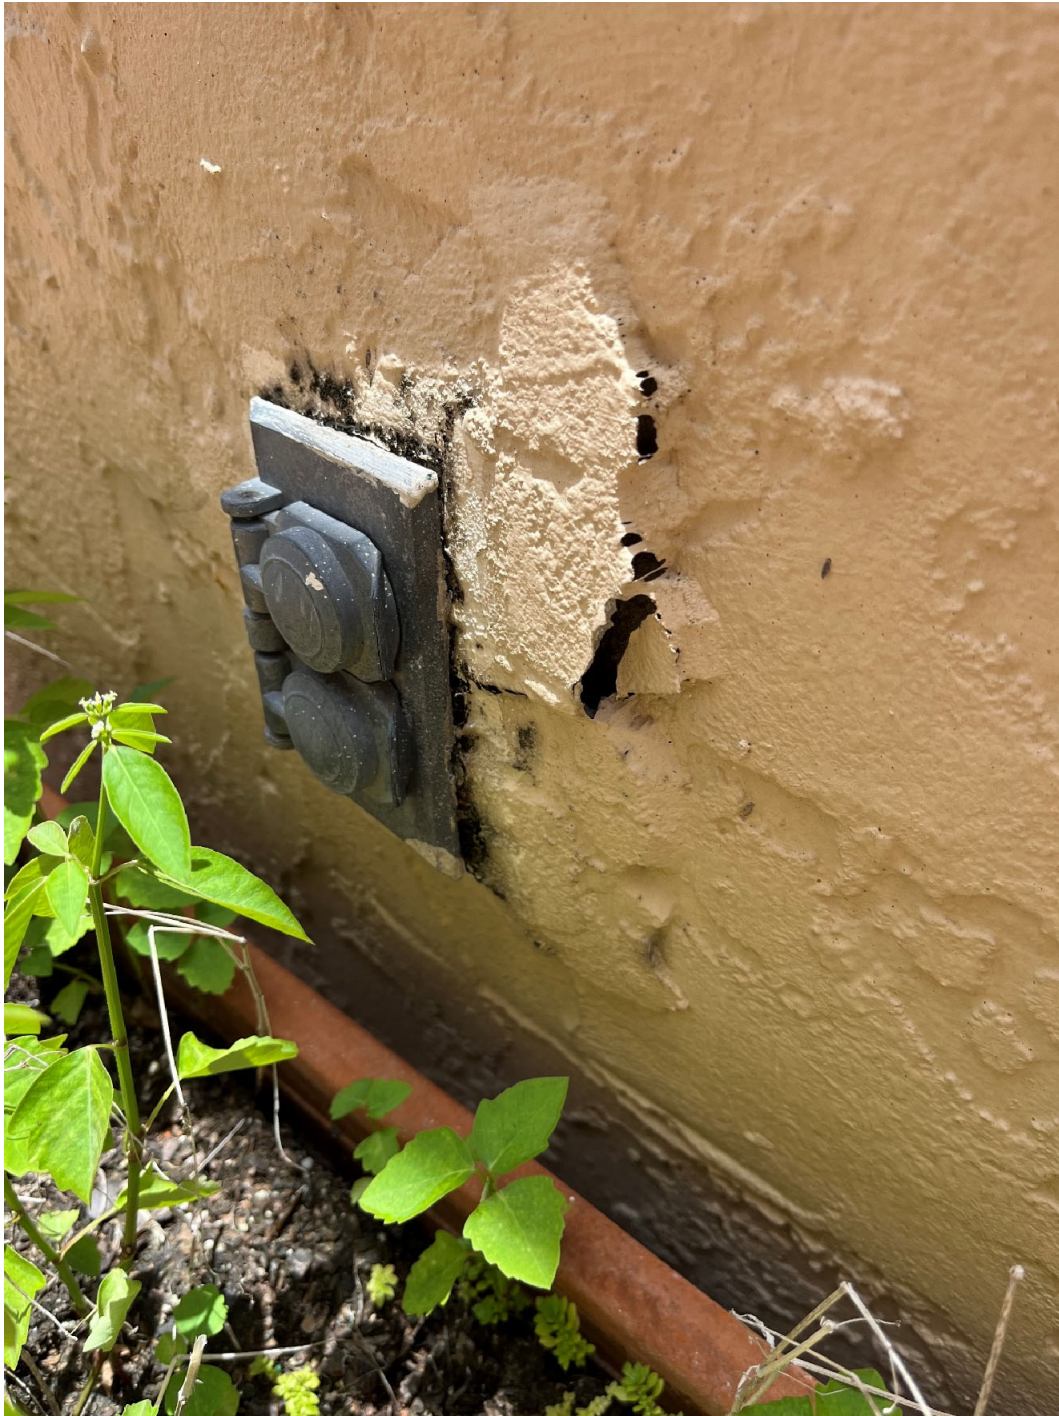
Unit 101

There was a significant crack at the electrical outlet on the patio. This is a double concern because of its proximity to electrical components. Water and electricity are not a good mix so this should be repaired as soon as possible.

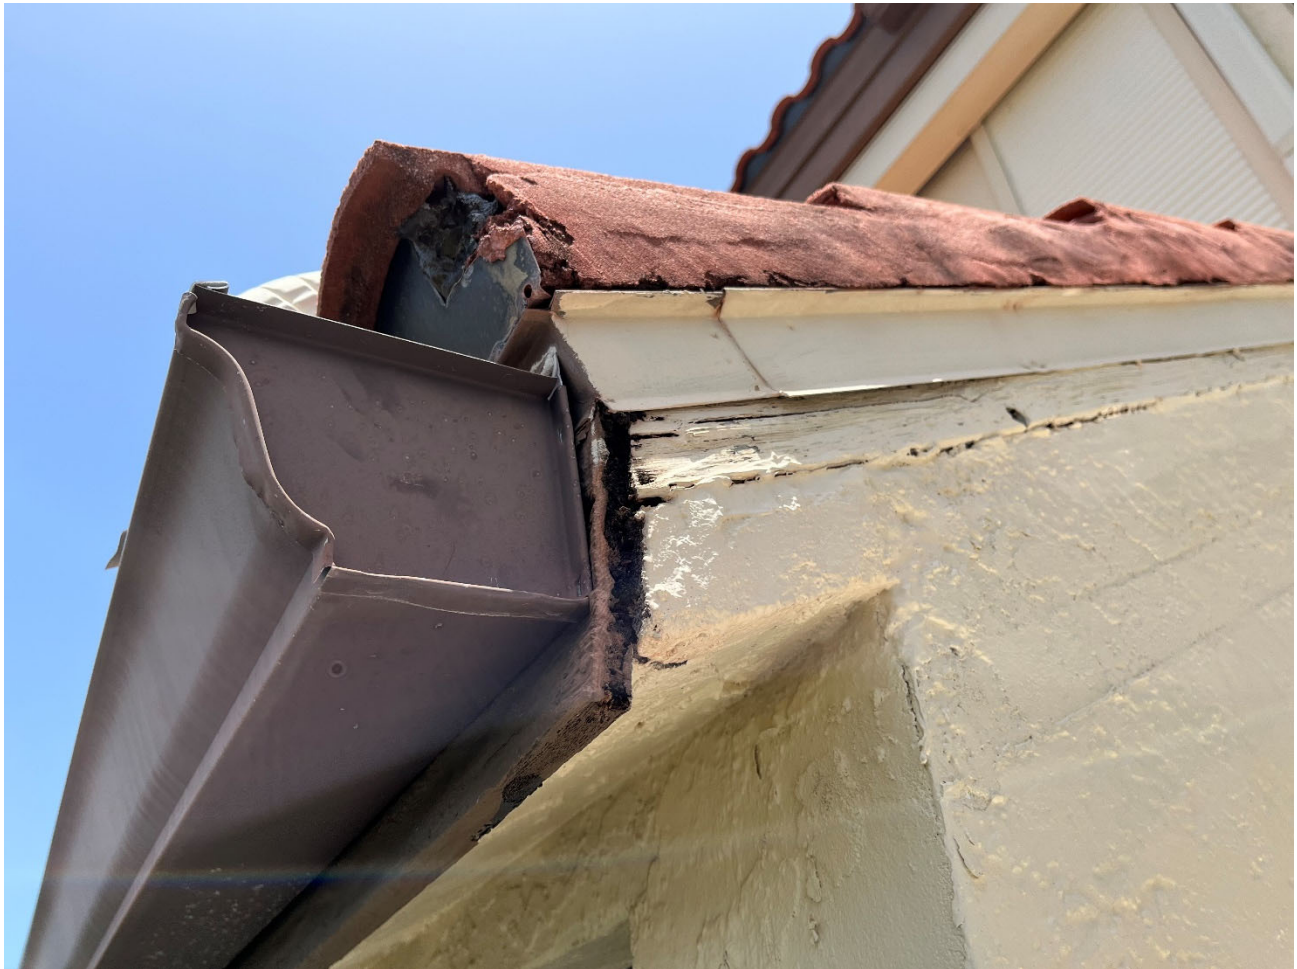
Unit 103

This photo is taken of the end of the gutter and fascia next to the exterior balcony. It shows deterioration of the wood fascia and wood rake trim. At the very least, these components need better weather protection to include caulking and painting. Replacement of these water damaged components is highly advisable.

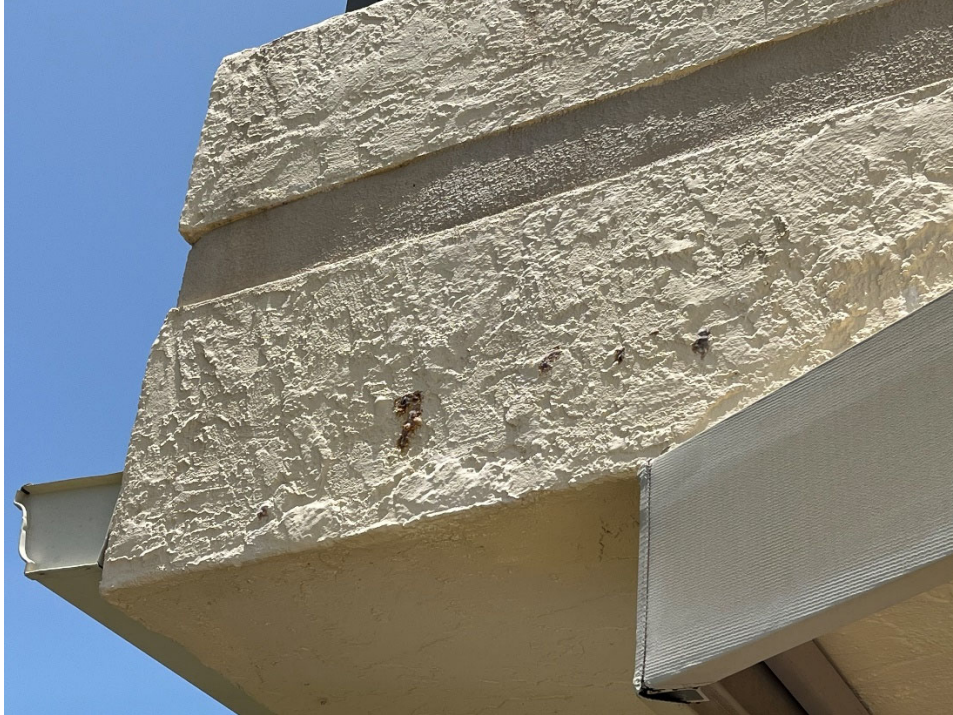
Unit 104

Above the balcony, there are rust stains on the face of the stucco. Manager advised that this is most likely caused by the planters on the patio above, but this indicates water penetration into the reinforcing steel inside the concrete. The source of this water intrusion must be located and addressed to prevent any deterioration of the reinforcing steel.

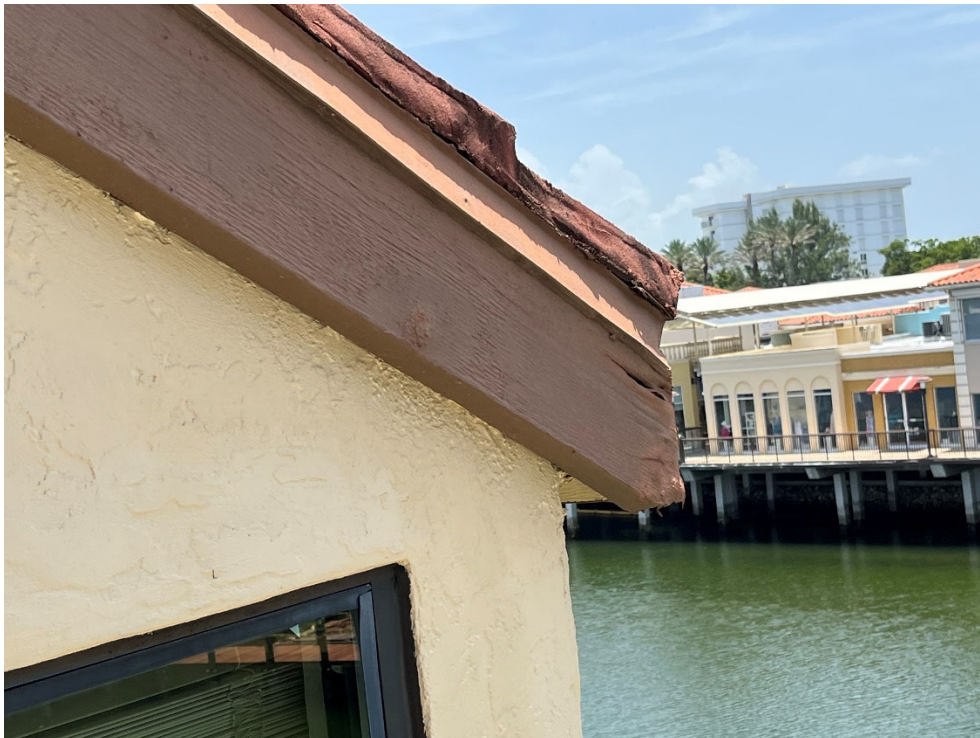
Common water damaged wood components adjacent the balcony patio.

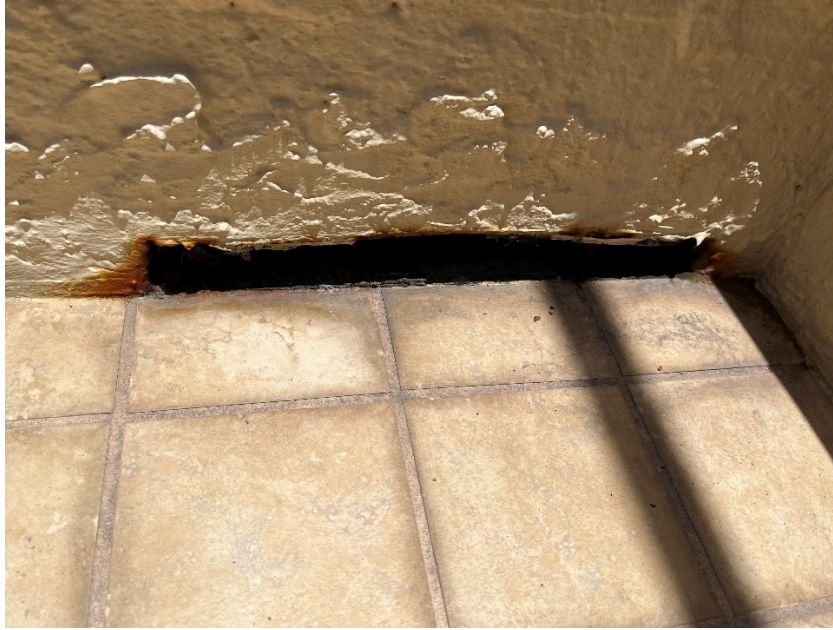
Unit 105 Penthouse

This unit had a rusting scupper on the balcony patio. This could be contributing to the rusting observed on the face of the stucco observed from Unit 104. Manager advised that all scuppers on patios will be redone soon so this issue will be resolved at that time.

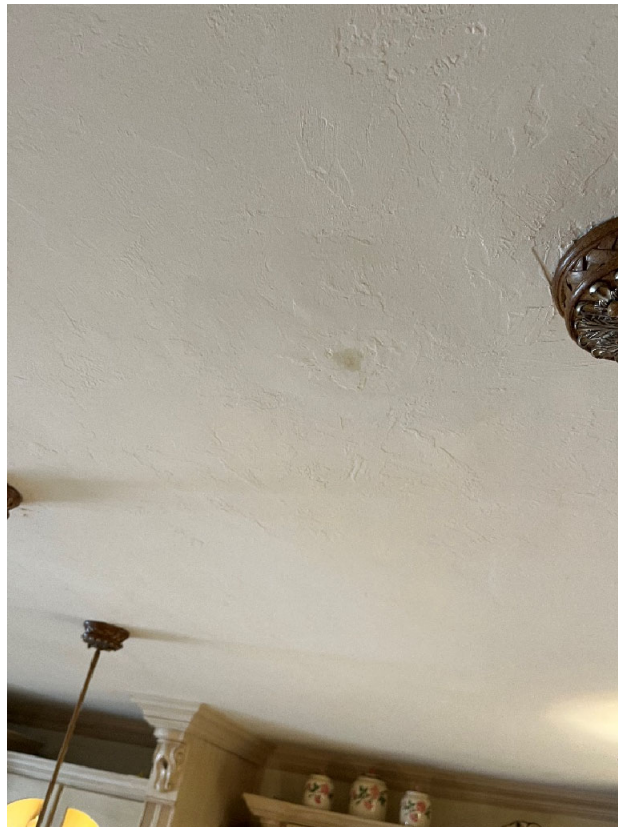
Unit 105 had a small water stain on the ceiling above the Kitchen. Resident said it had been there for quite a while. Suggest having this stain repaired to see if it re-emerges. Could have resulted from a roof leak that has now been corrected.

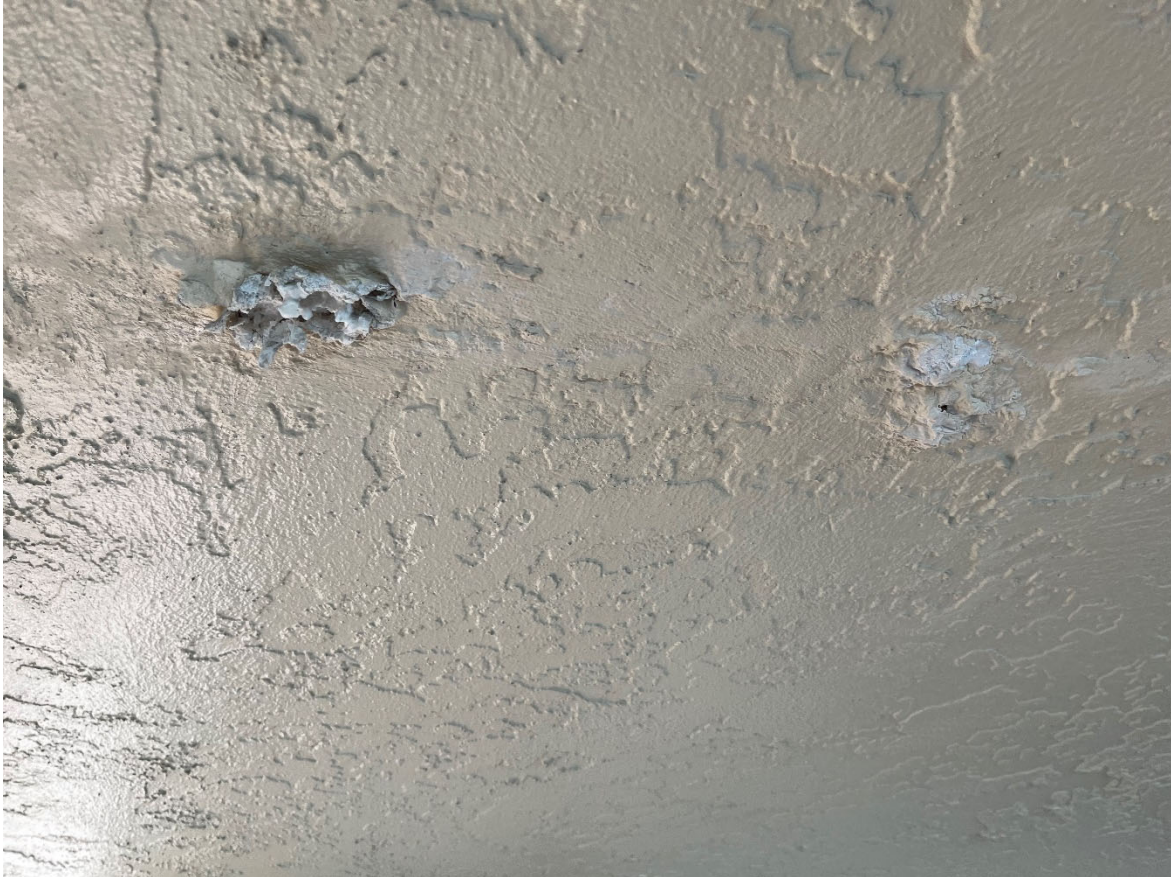
Unit 202 had some soft areas in the ceiling over the exterior balcony patio. Most likely the result of water penetration from the former planters on the balcony above. Suggest repairing the stucco after the planters above are removed and the area sealed from water penetration. Monitor this area after repair to see if evidence of water penetration re-emerges.

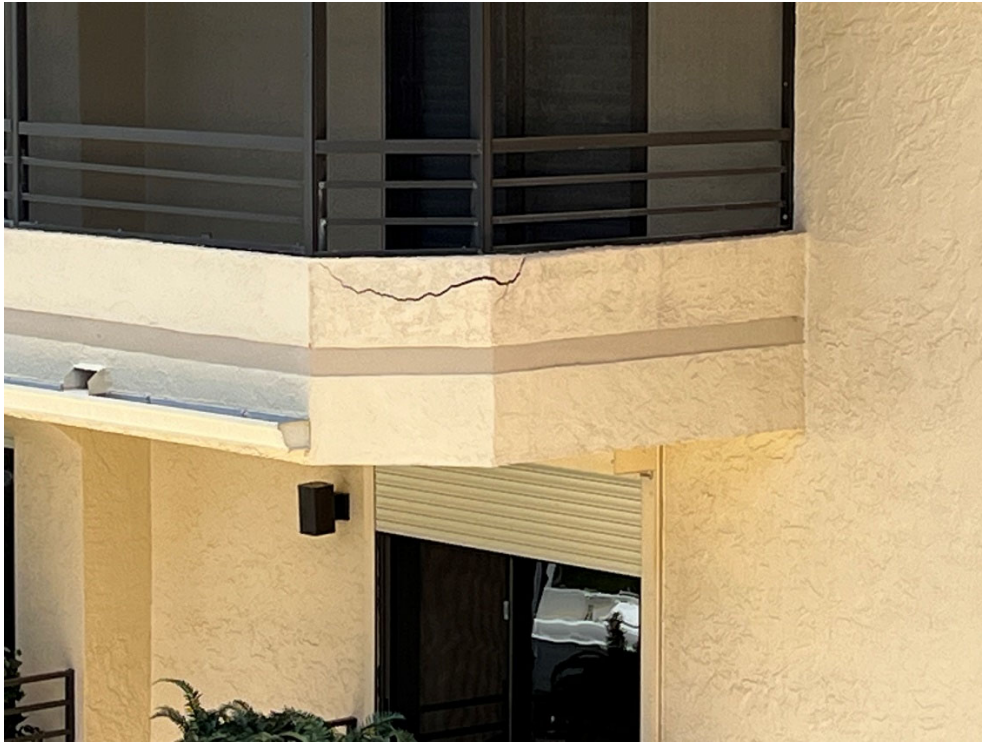
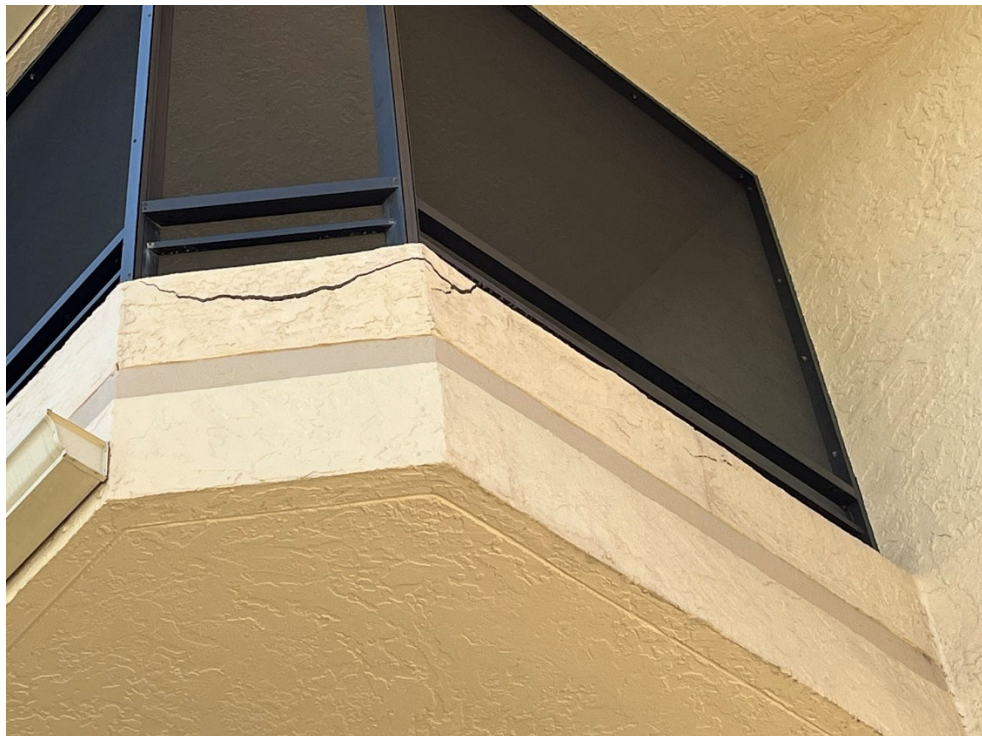
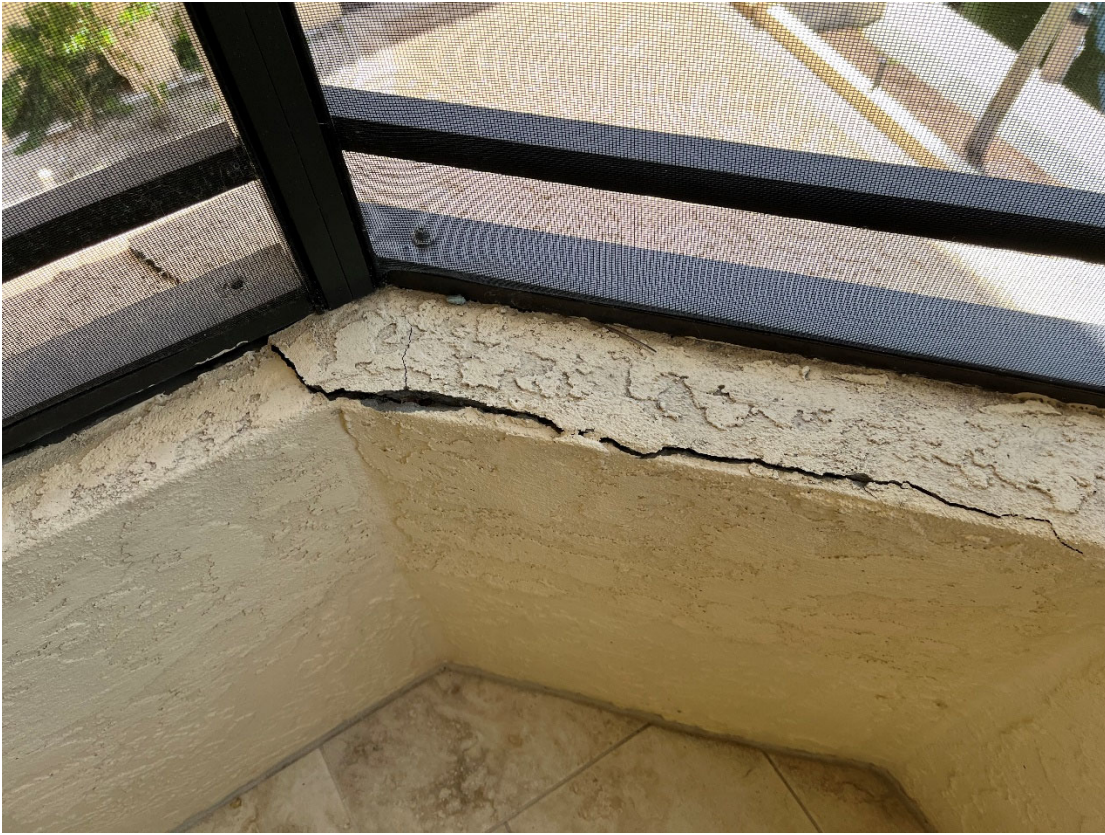
Unit 204 had one of the worst cracks observed on any of the buildings. It is located on the southwest corner of the building in the concrete base below the handrail. This condition will eventually lead to a failure of the balcony railing and could result in a catastrophic fall if not corrected soon. Inspector strongly suggests having the concrete in this area removed and new concrete formed to replace the damaged area.

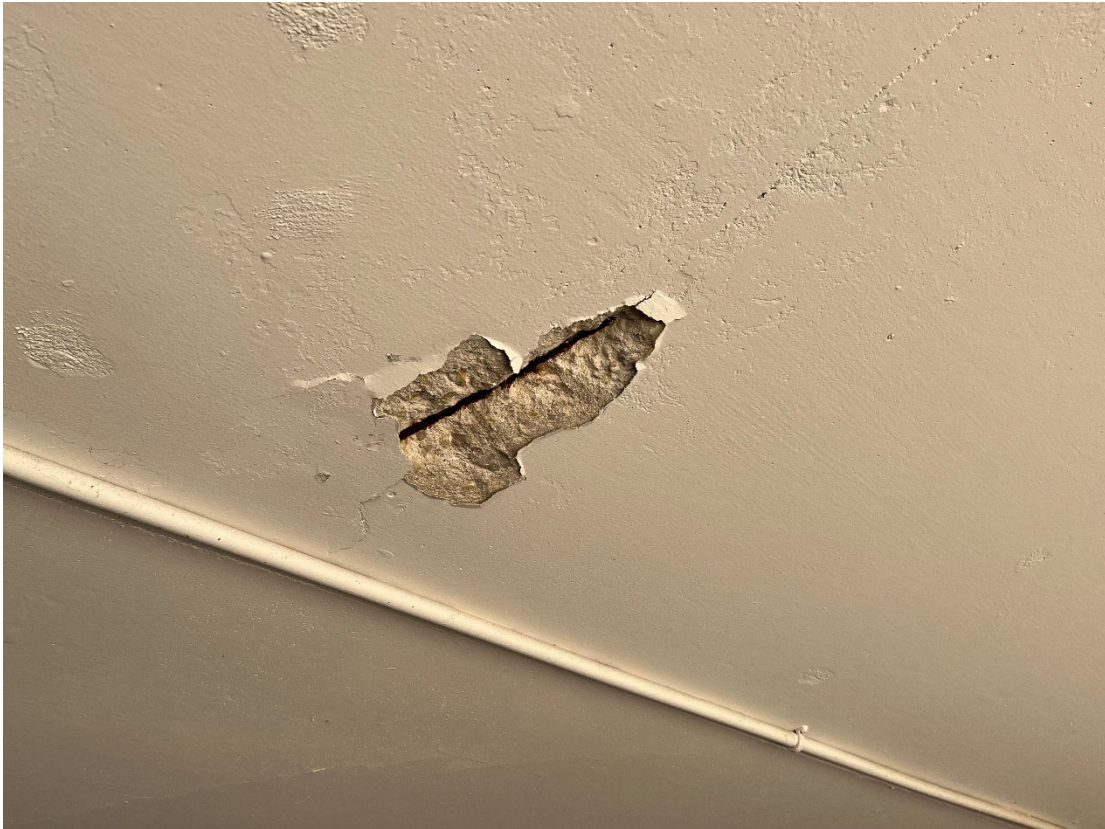
Parking Garage Ceiling

Repair this condition that has left steel rebar rusting and exposed.

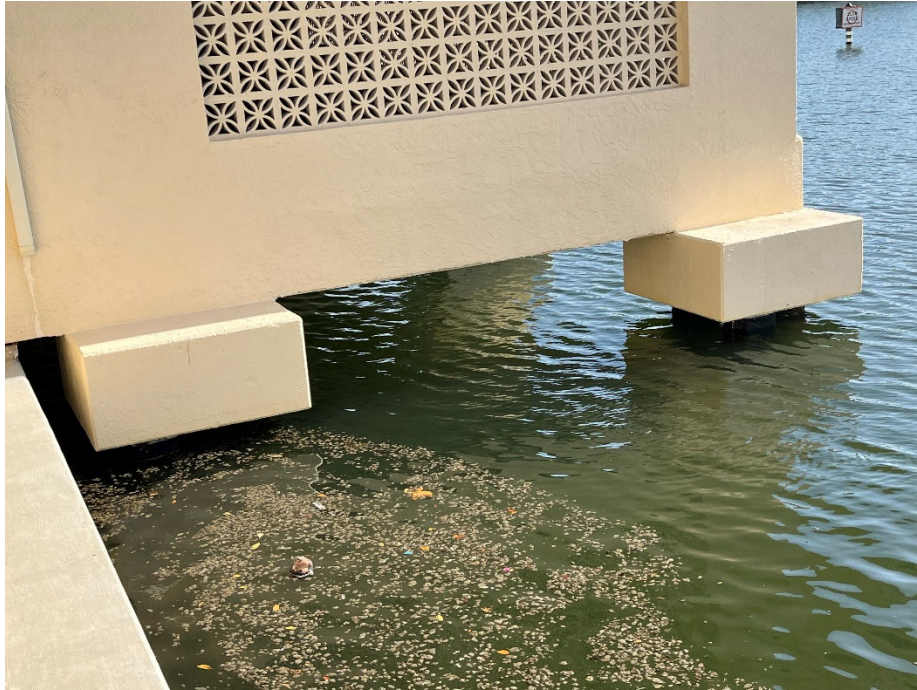
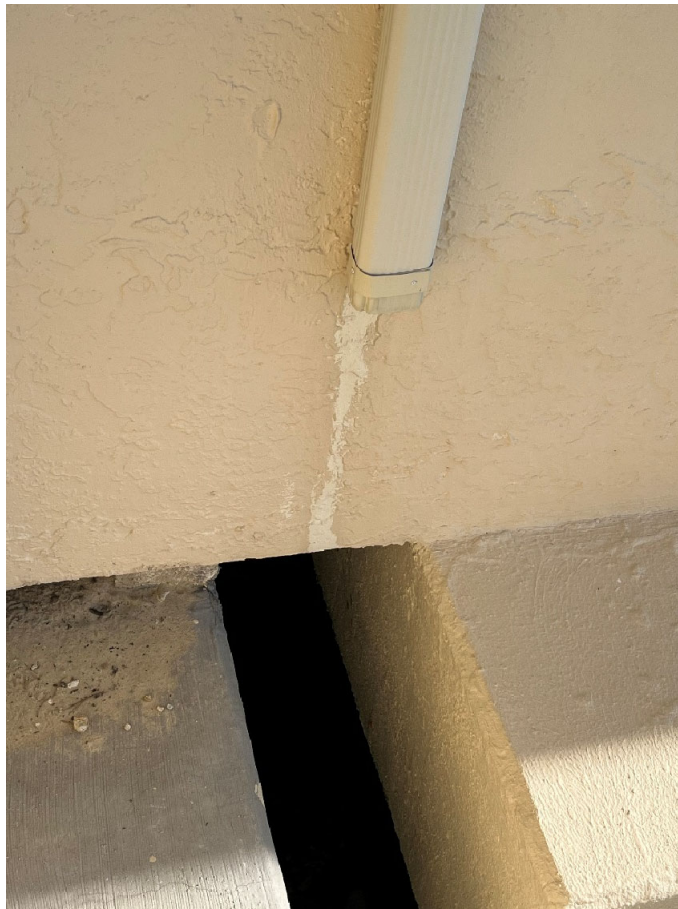
Downspout on south end of building is missing the elbow required to kick the water away from the face of the building. As a result, water run-off has marred the paint and eroded the stucco. Suggest installation of extension so elbow can be located below the bottom edge of the wall.

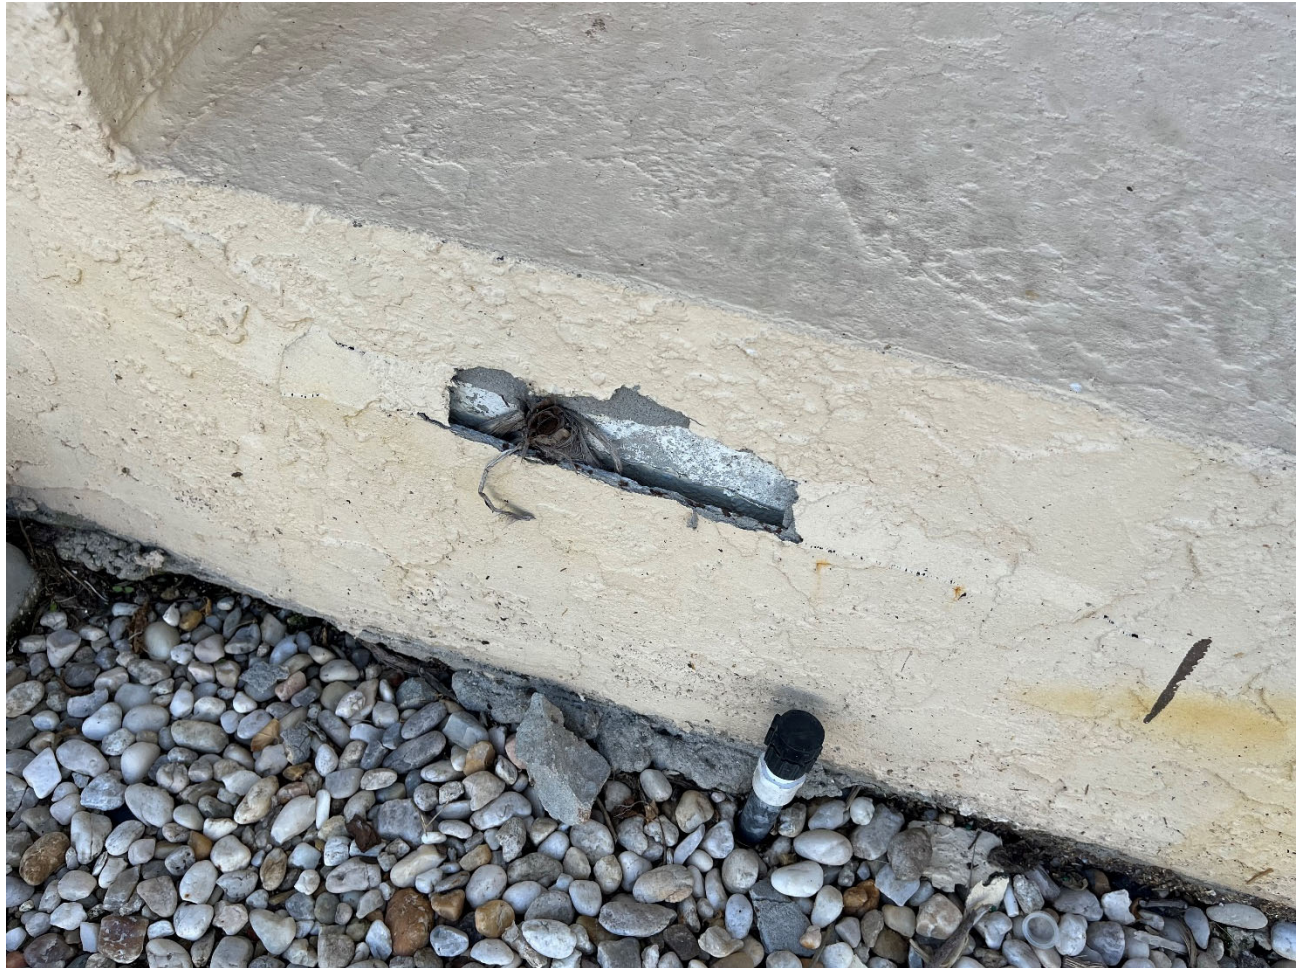
Building Two also had some stucco damage on the front face of the building near the northwest corner. Biologics had grown up behind the stucco detaching it from the structure and leaving the supporting concrete of the foundation exposed. Suggest removing enough stucco to remove the plant remains from behind it, then inspect the concrete underneath for any latent damage. Repair as needed.

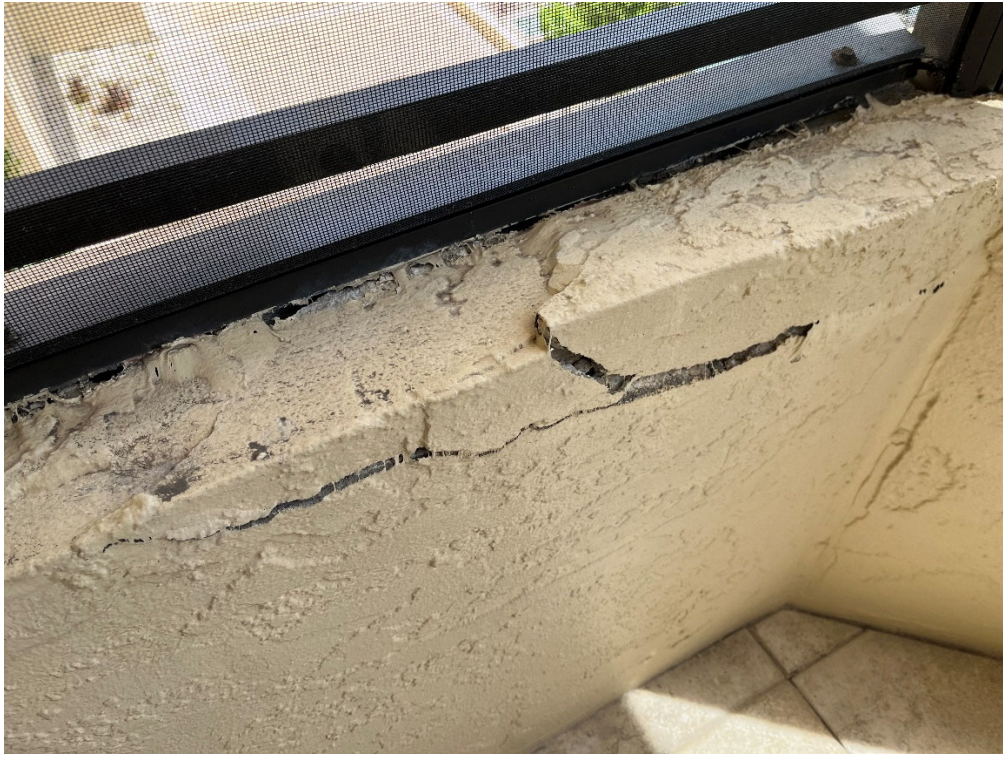
Unit 304

Similar to Building Two, Building Three also had cracks in the concrete bases below the balcony railings. These cracks can let a significant amount of water in which can erode and damage the underlying structural components, Suggest correcting these conditions as soon as possible.

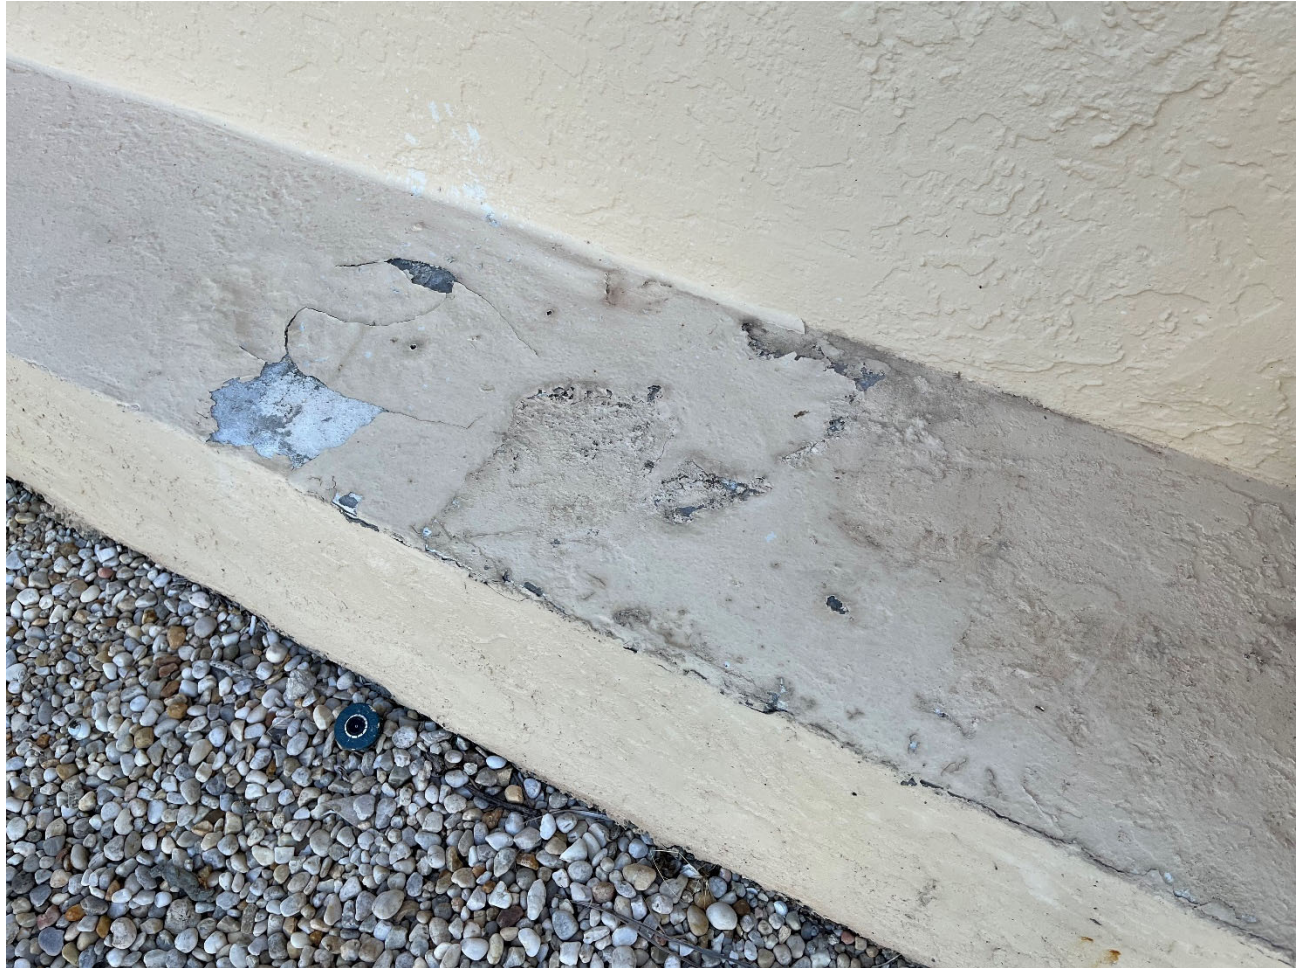
Building Three also has a driveway that runs in front of the building. Parallel to this drive is a concrete grade beam that is part of the foundation. The stucco on this beam was cracked and peeling which could lead to water penetrating into the concrete foundation. Suggest having the stucco repaired in this area to protect the concrete foundation from the weather and its possible deterioration of the substrate materials.

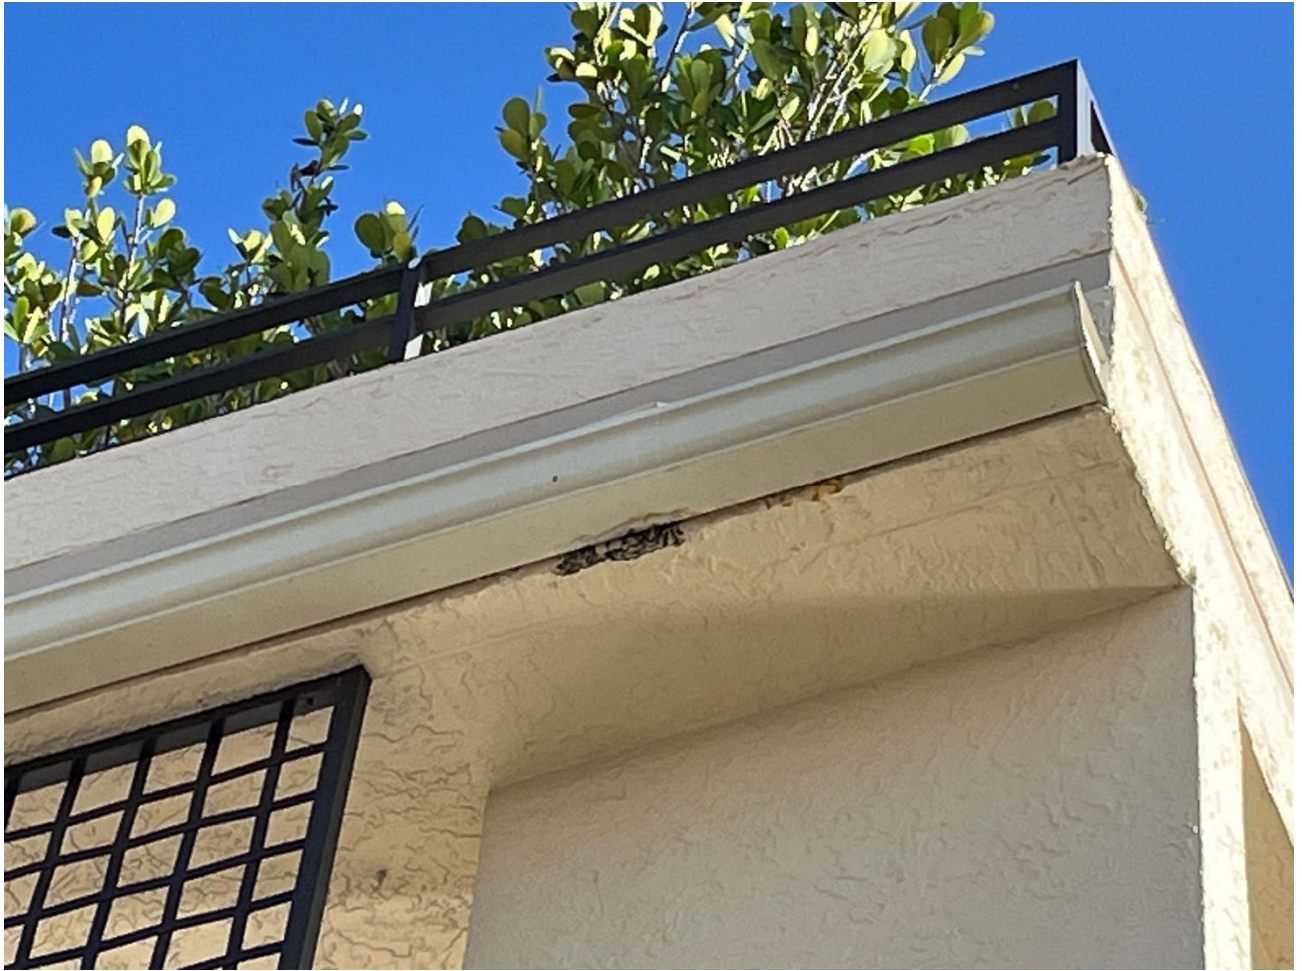
Above Unit 404

Building Four was mostly free of any significant anomalies. There was one area of minor water damage where it appeared that the planters of the balcony above Unit 404 had leaked out behind the gutter. Since the planters are slated to be removed in the near future, the cause of this condition will most likely be remedied. Suggest repairing the stucco once the planters are removed, and monitor this area to be sure the problem has been resolved.

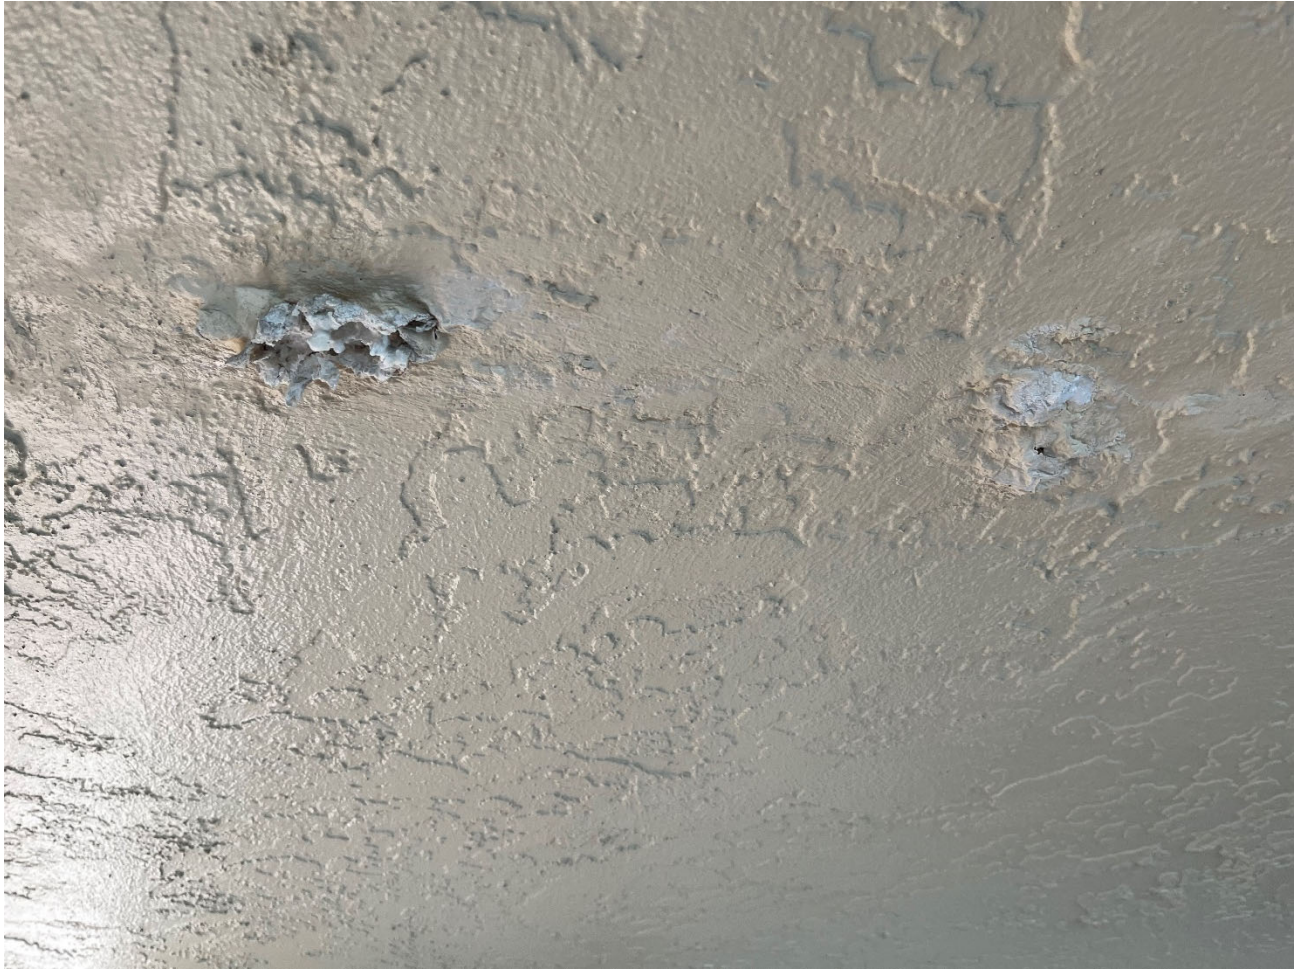
Building Five had some characteristic rusting of the stucco in the areas near the planters on the balconies. Once planters are removed, clean off rust and repaint, which should correct that issue. There was one area on the ceiling of the exterior balcony of Unit 504 where efflorescence from a water leak was particularly heavy. Most likely caused by the planter in the balcony above, but needs to be cleaned and repaired once the planter above is removed.

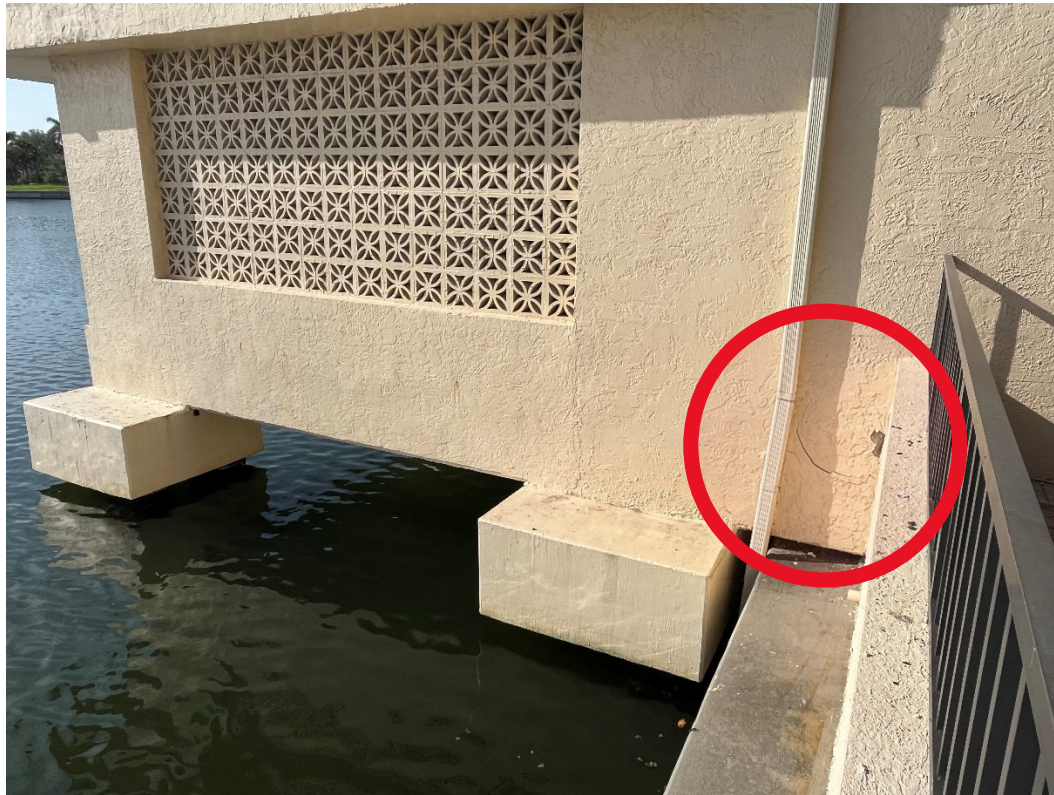
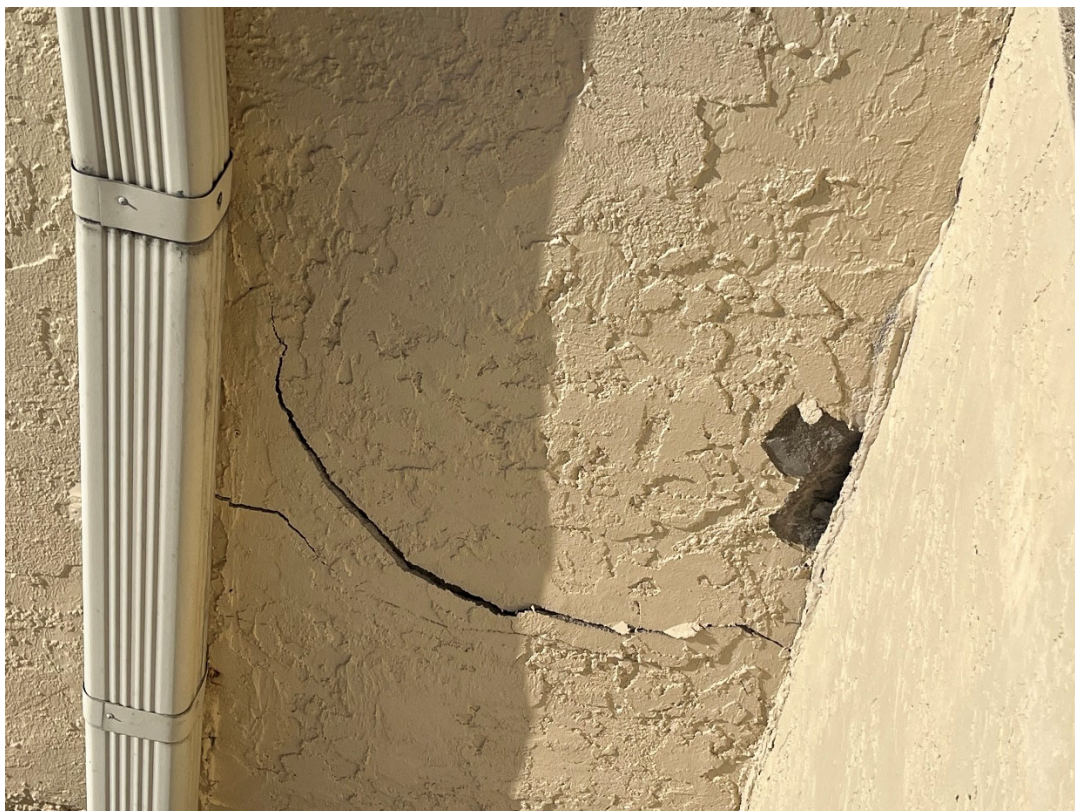
Building Five also had some significant cracks in the stucco on the northside near the water's edge. Water penetrating this area can lead to a host of issues so inspector suggests having the stucco repaired in this area to maintain water tightness of the building finish.

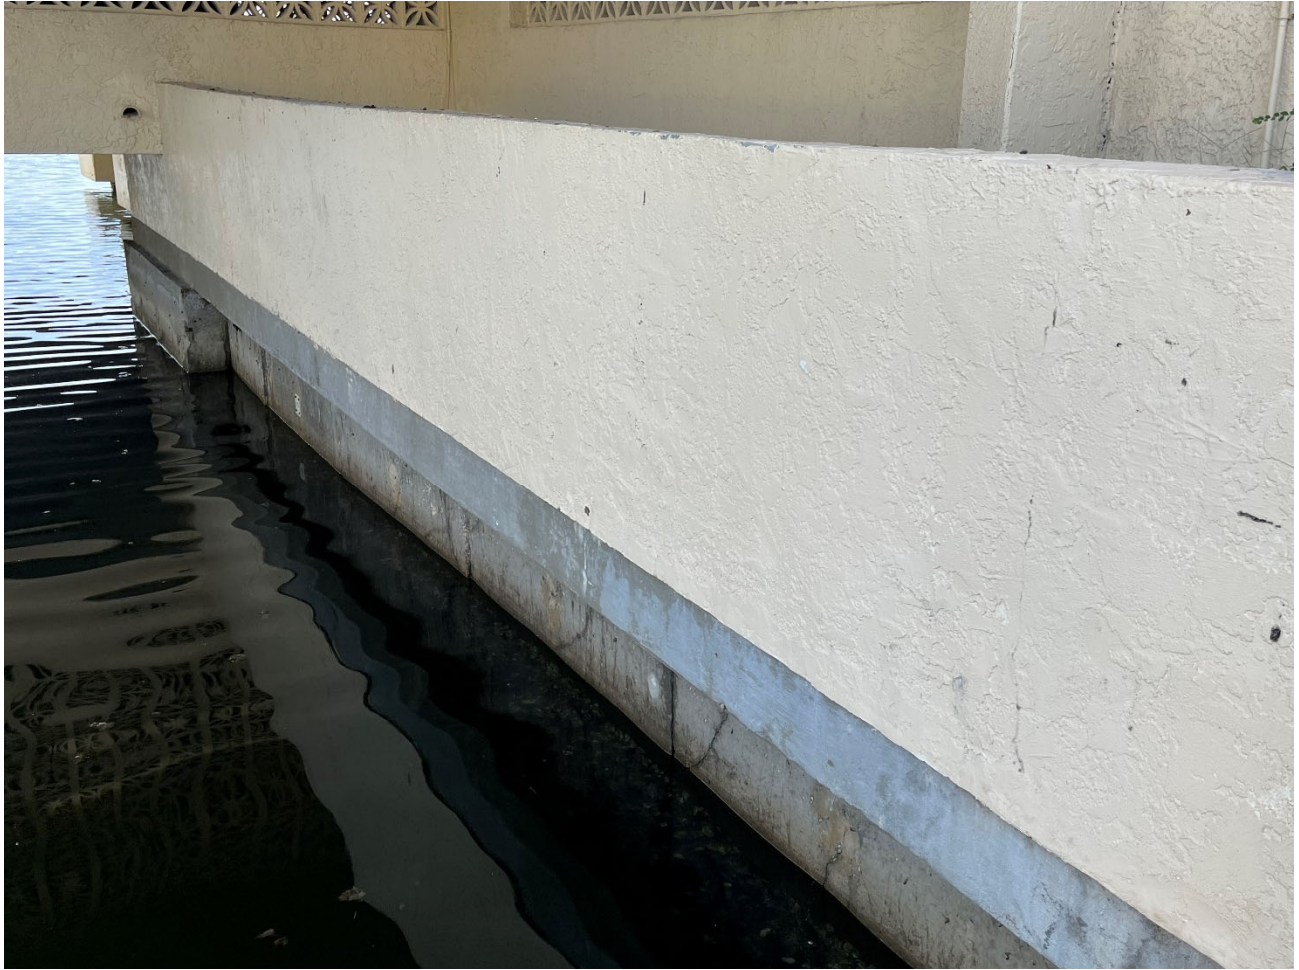
Concrete Beam at Water's Edge

Building Six is the northern most building of the complex and as such is surrounded by water on three sides. This makes maintenance of the supporting structure even more critical as the building is totally dependent on the concrete beams for support. These beams had hairline cracks in them that may allow water to penetrate into substrate materials. Though minor in nature now, they do not need to be left unattended. Inspector suggests having all such hairline cracks in all supporting beams that intersect the water well sealed to prevent any water migration into steel reinforcing inside the concrete.

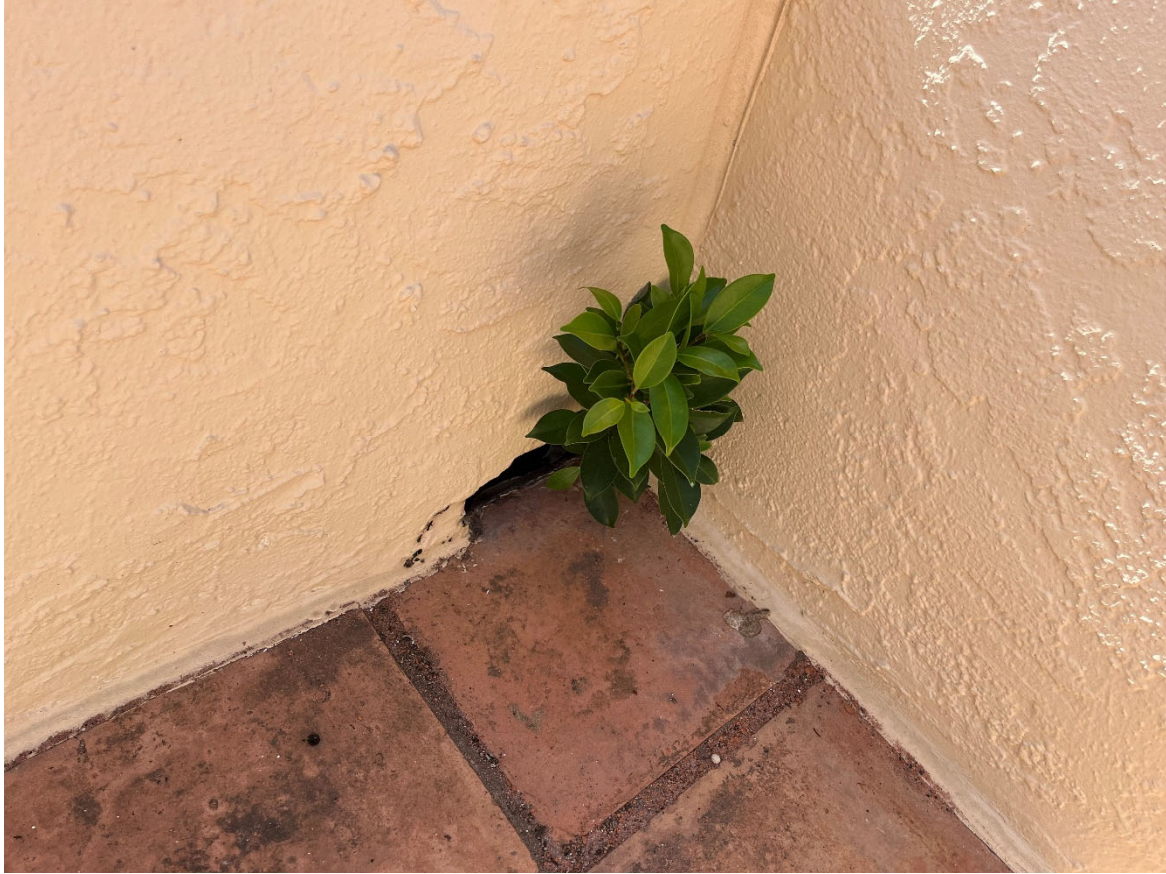
Unit 605 had a significant plant growing out of the scupper. Roots from such plants can do significant damage to substrate materials. Manager said conditions like this will be corrected when scuppers on all exterior balcony patios are to be redone soon. Suggest removing this plant as soon as possible to avoid further damage.
