BONDURANT
ARCHITECTURE

ARDISSONE CONDOMINIUM ASSOCIATION, INC

Report Date:
July 13, 2023

1.0 INTRODUCTION

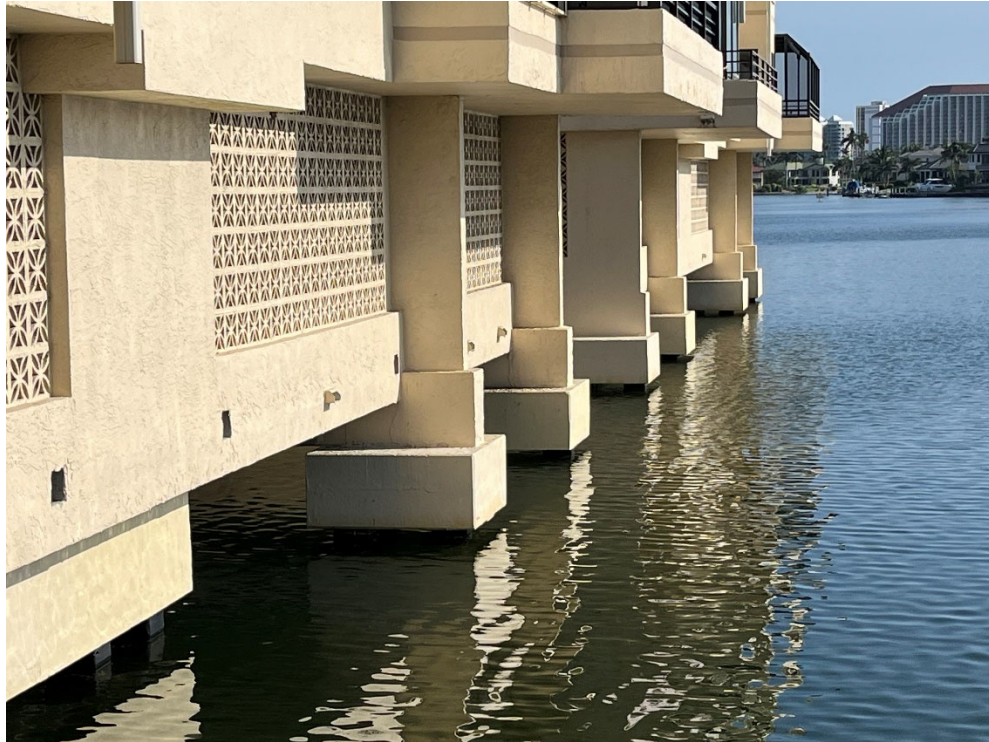
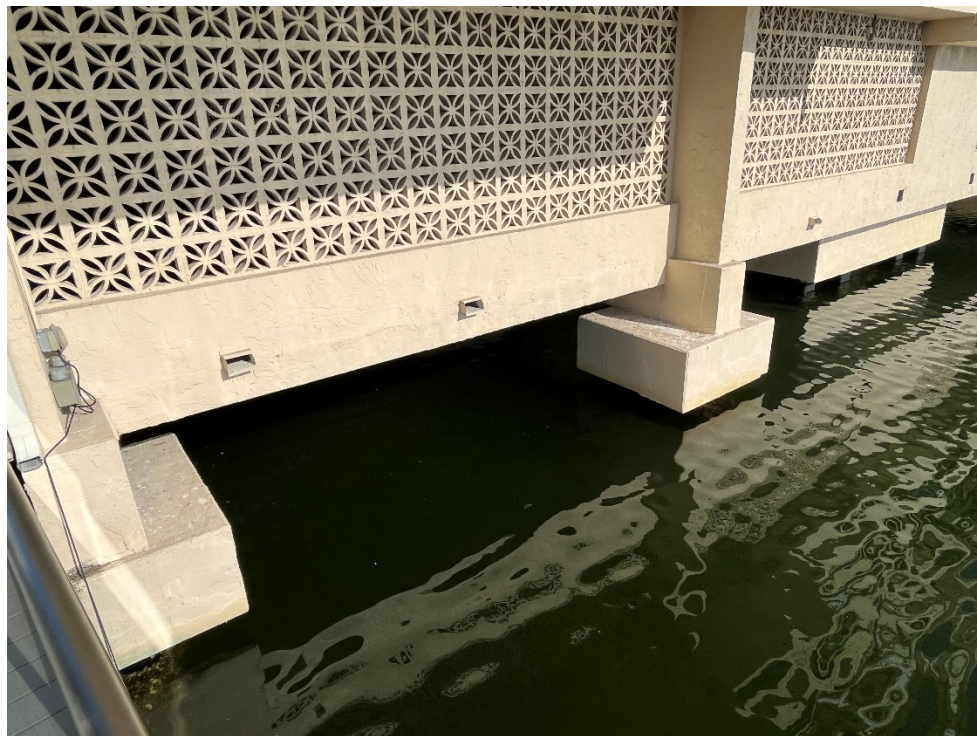
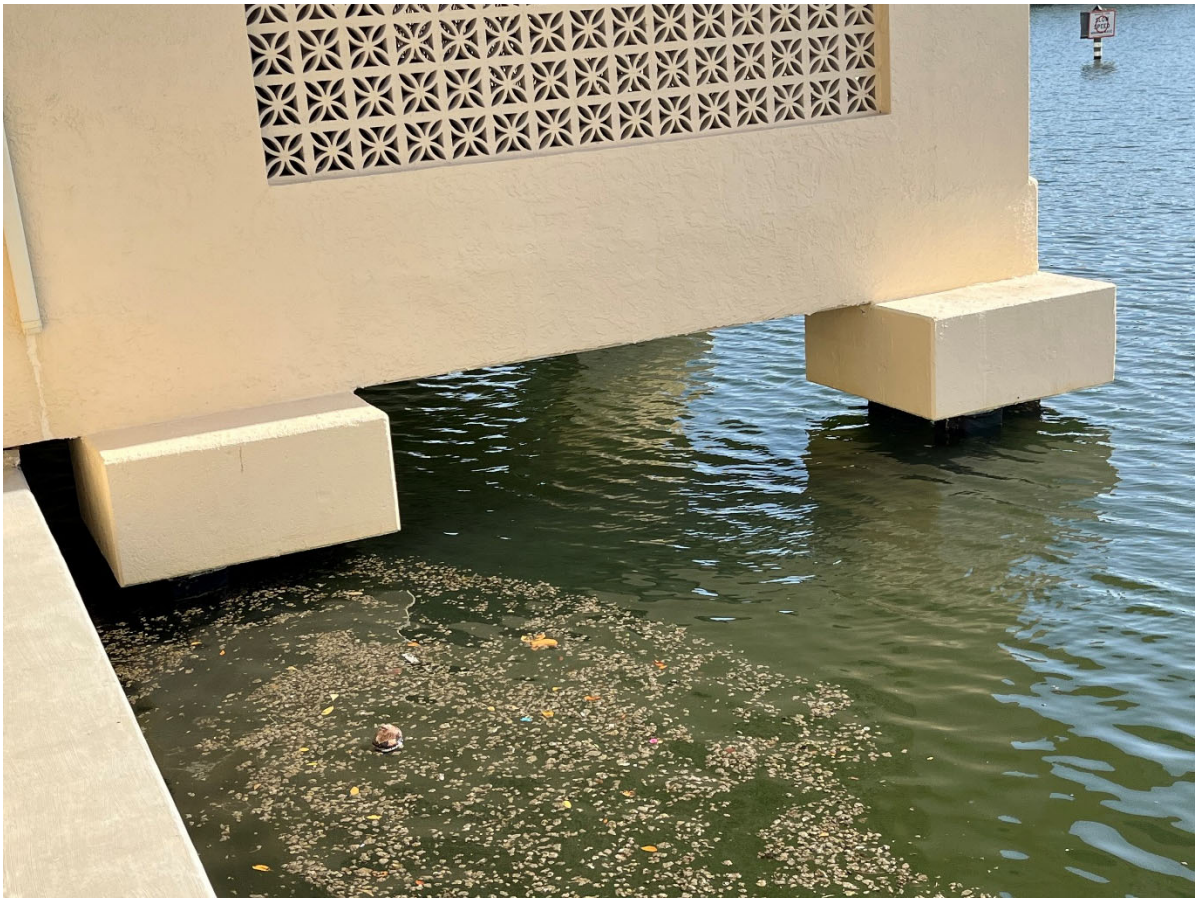
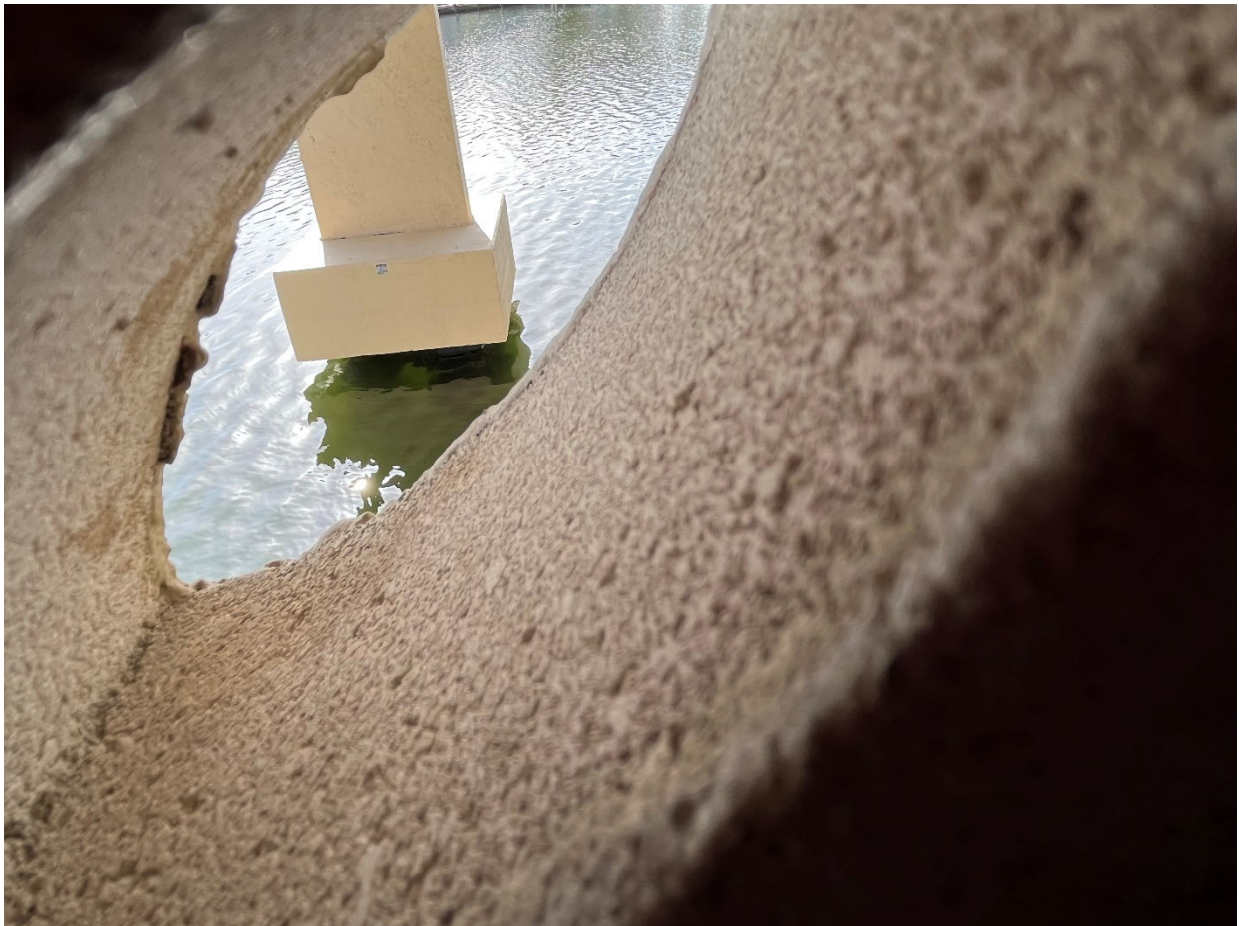
Concrete Pile Caps and Underwater Columns (Piles)

These critical components were viewed from several different vantage points. All appeared to be in good condition with no hairline cracks observed. Piles in contact with water were protected with an elastic covering to make them more abrasion resistant to the movement of the water. On-site Facilities Manager said the pile caps were inspected on a yearly basis by a structural engineering firm. This regimen should be maintained as it will assure the long term viability of these critical structural components.

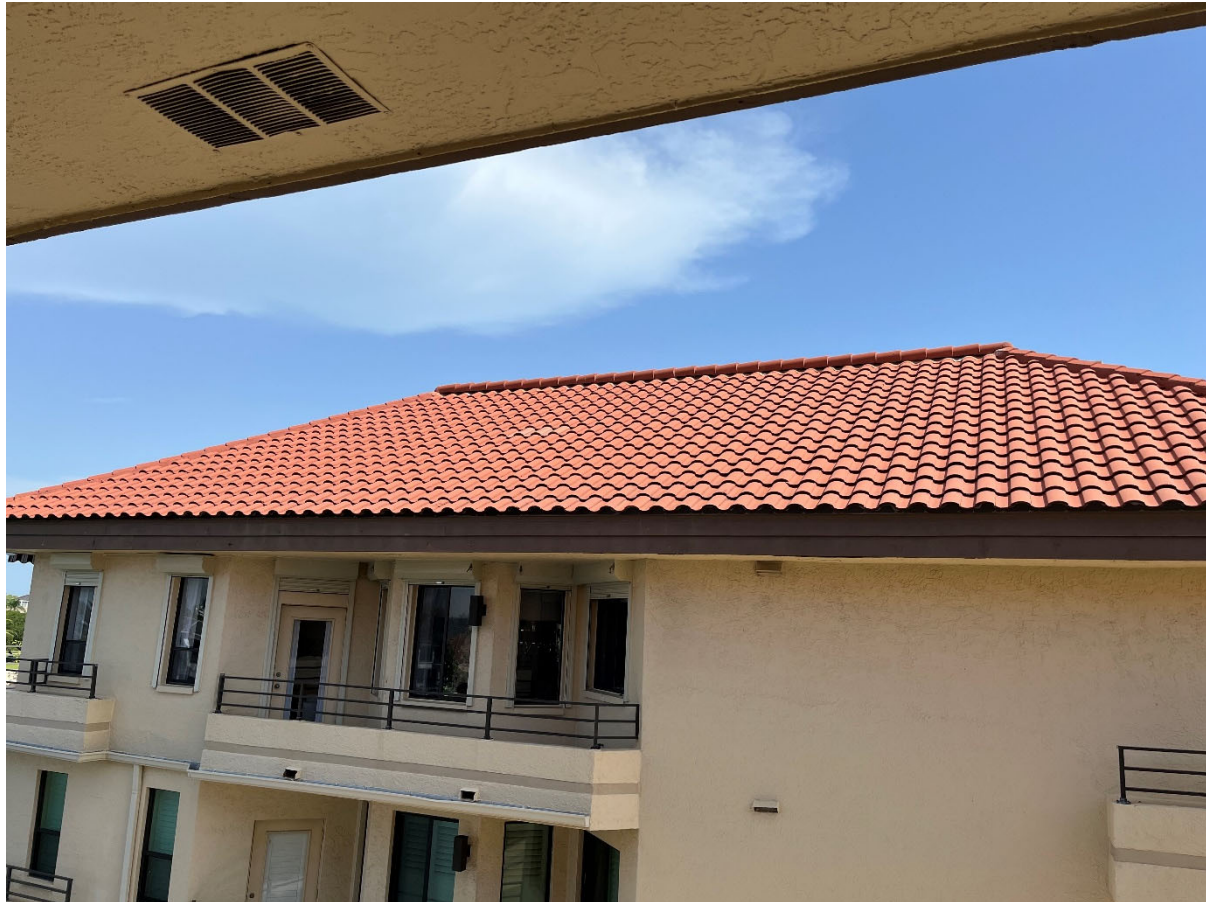
Typical Roof Surface

Roofing consists of terracotta clay tiles. Roofing was in good condition for an original roof of 36 years of age. This type of roof can last 40-50 years. On-site Manager said the roofs were scheduled for replacement in the near future. A few lighter colored replacement tiles were observed in various places. No residents reported any active water leaks. Though the underlying roof structure was not inspected, there was no evidence neither above nor below that the roof structure had any issues present. Representative photos follow:

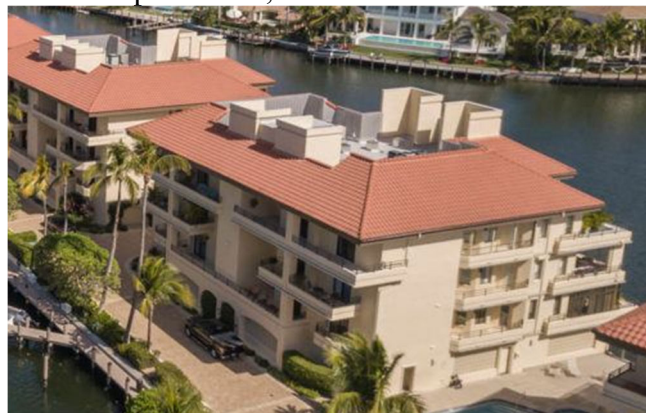
There is a small confined flat roof area in the center of the buildings that was not accessed. Since the roof is scheduled for replacement, this area should be evaluated or replaced a that time
