**TRC Worldwide Engineering
(Restoration & Inspection), LLC.**

Project Name: The Ardisonne – Exterior Building
Repairs & Related Work

Job Number: 24FTM628

Field Report #08

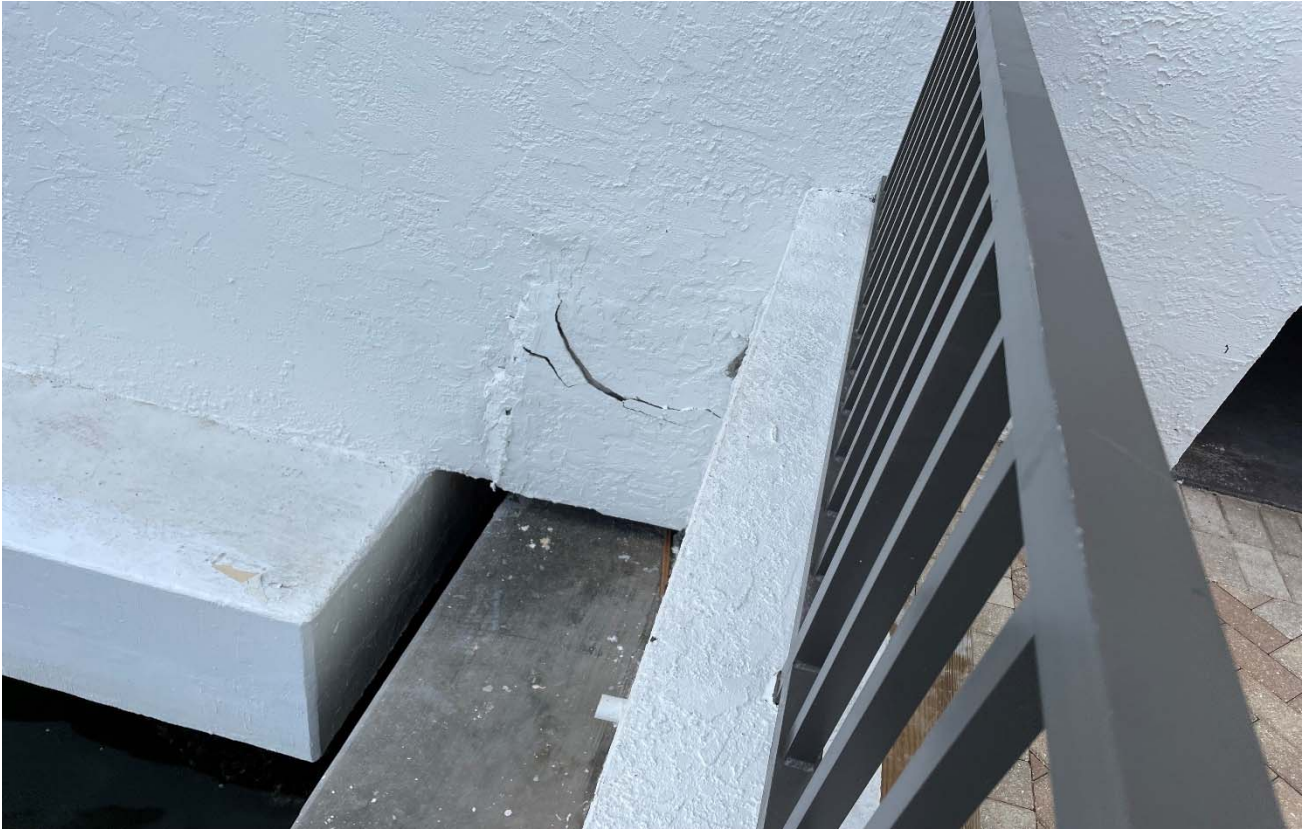
Photo #01

- Location No. 1:** Along the exterior perimeter property line wall located between Building No. 6 and Building No. 5. Areas of delaminated stucco finishes were removed by the contractor down to the bare concrete substrates for review. The structural surfaces were mechanically sounded and no apparent cracks, damages and deterioration were noted on the underlying structural wall components. **(Refer to Photos 1-3)**

- During evaluations the deteriorated stucco finishes mentioned above at their respected locations were mapped out in the field by TRC for contractor excavations, removals and replacements. The contractor shall excavate, remove and prepare the underlying structural surfaces and notify TRC upon completion for review prior to stucco material applications.

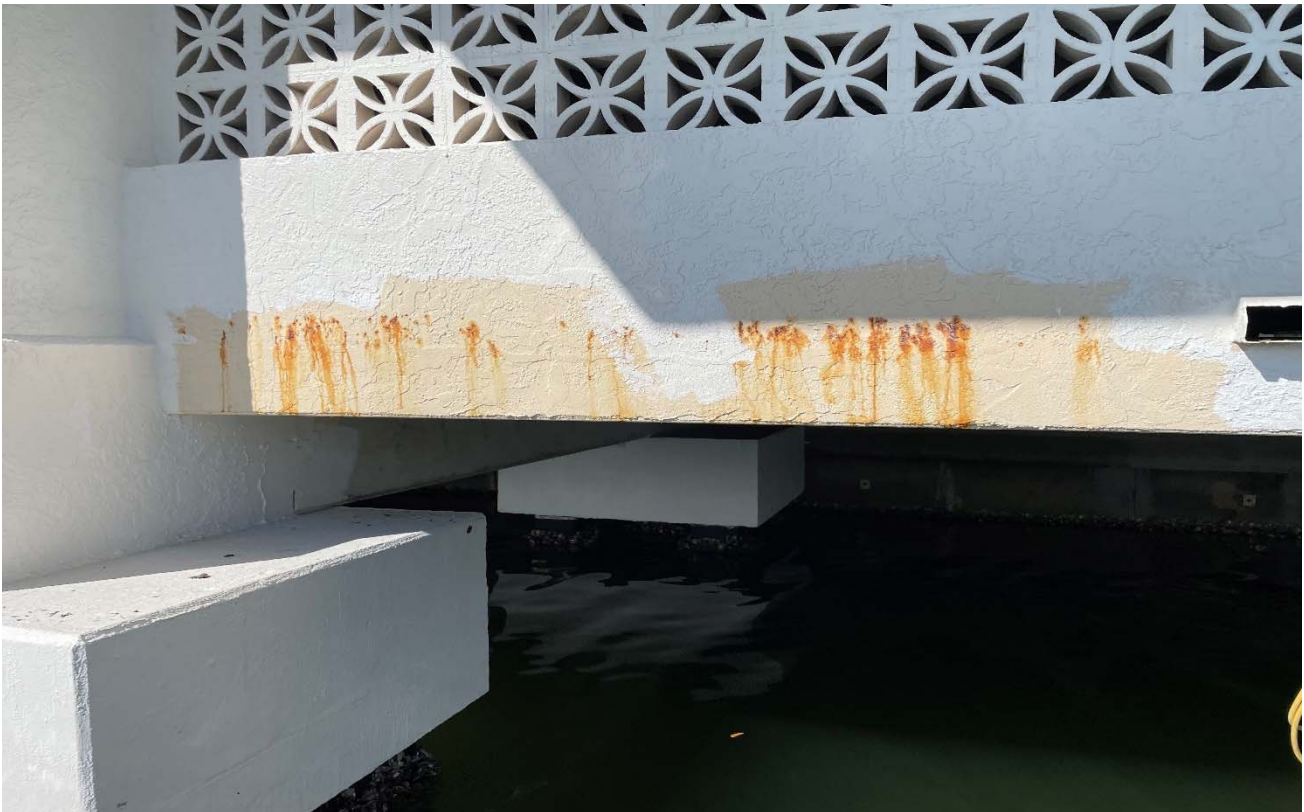
Photo #04

- Location No. 2:** Along the lower wall elevations over the water line on Building No. 5. Areas of rusted and deteriorated stucco finishes were removed by the contractor to review and mechanically sound the underlying structural elements at this location. No apparent damages, cracks or indications of deteriorated and spalling concrete were noted on the structural surfaces on Building No. 5. Rust stains and areas of corrosion visually noted on the exterior stucco finishes, were directly associated with deterioration of the metal lathing components utilized during original construction to attach the stucco finishes to the structure. **(Refer to Photos 4-6)**

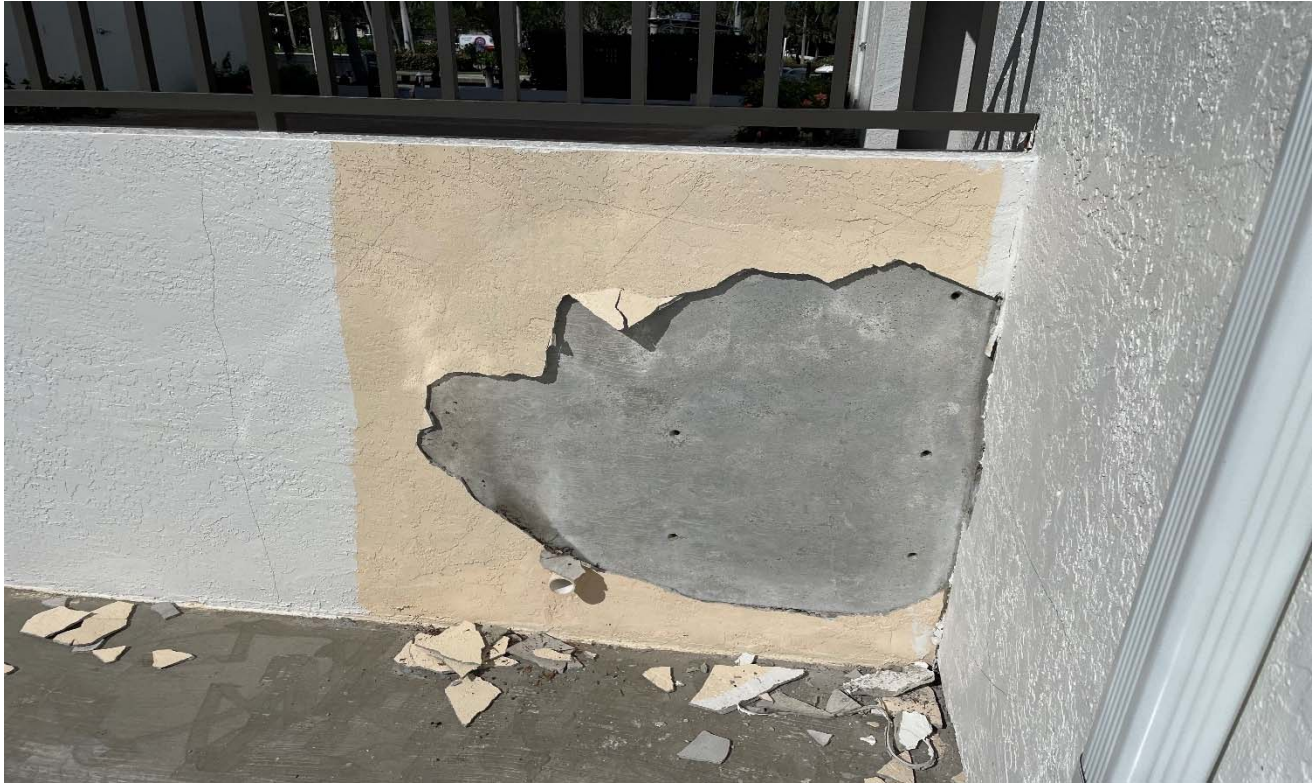
Photo #7

- Location No. 3:** Along the exterior perimeter property line wall located between Building No. 5 and Building No. 4. Areas of delaminated stucco finishes were removed by the contractor down to the bare concrete substrates for review. The structural surfaces were mechanically sounded and no apparent cracks, damages and deterioration were noted on the underlying structural wall components. **(Refer to Photos 7-10)**

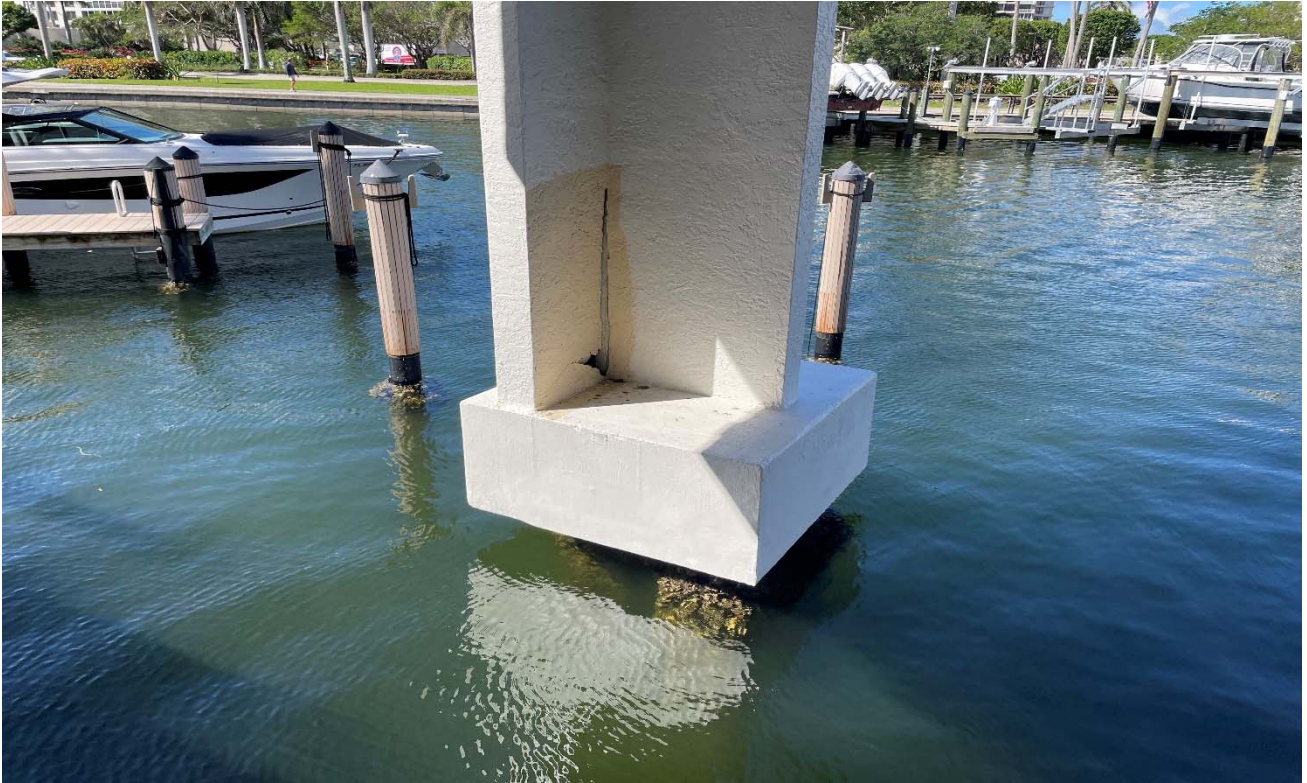
Photo #11

- Location No. 4:** On the North building elevation of Building No. 6 on the masonry column over the waterline pile cap. The exterior stucco finishes were built-out off the structural surface of the column with light gage metal framing, metal lath and stucco finishes. No. apparent deterioration was noted on the underlying structural surfaces. Damages were directed associated with the non-structural stucco finishes and metal framing components utilized during original construction on the building. **(Refer to Photos 11-12)**
