RE: Ardissone Condominium Association, Inc. Pile Cap Forensics Report Buildings 1 through 6

Pile Cap Photo Exhibit – The Ardissone Condominium Association

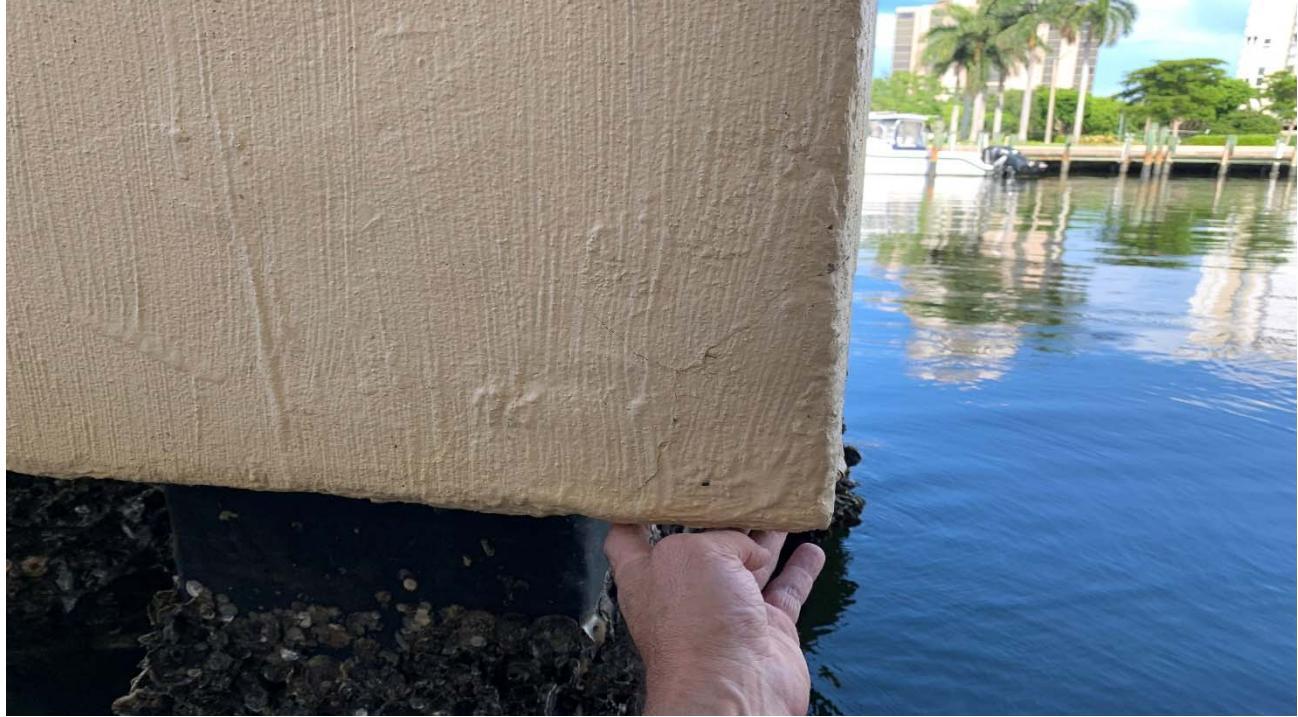
Photo #01

- 1. Damaged concrete areas were detected on the vertical surfaces of the pile caps, the sea wall caps and CMU surfaces below the sea wall at the base of the building. Hollow sounding concrete and apparent spalls on the sea wall and CMU surfaces were denoted on the plans by a "S/#" with the "#" representing the approximate surface area of the visible spall or surface area requiring excavation and repair. Please note that this does not represent the total cubic feet of repair volume that is presented in the probable opinion of construction cost sheet attached. TRC must estimate the repair depth in order to quantify the volume of concrete repairs which is then used by the contractors to bid the work. Additional field measured areas on the pile caps are also represented on the attached templates based on field measurements and past repair depths from excavations performed in 2019. (See Photos 1- 7)

We recommend that the deteriorated concrete sections should be excavated by power tools back to sound material to allow abrasive blast cleaning of the steel reinforcing bars free of rust and coated with an epoxy-cement bonding agent prior to forming and placing of new low permeability micro-concrete mix with integral corrosion inhibiting admixture. Based on the condition of the reinforcing steel in the concrete at the spalled areas previously repaired in the last restoration project and the unseen conditions that cannot be anticipated until excavation, it is our professional opinion that corrosion mitigation anodes continue to be used to ensure the mitigation of the corrosion to the reinforcing steel and provide sound repairs. It is also recommended that corrosion mitigation anodes be utilized at the concrete repair locations due to the age of the structure and the chlorides in the atmosphere from the surrounding environment that have permeated the concrete over time.

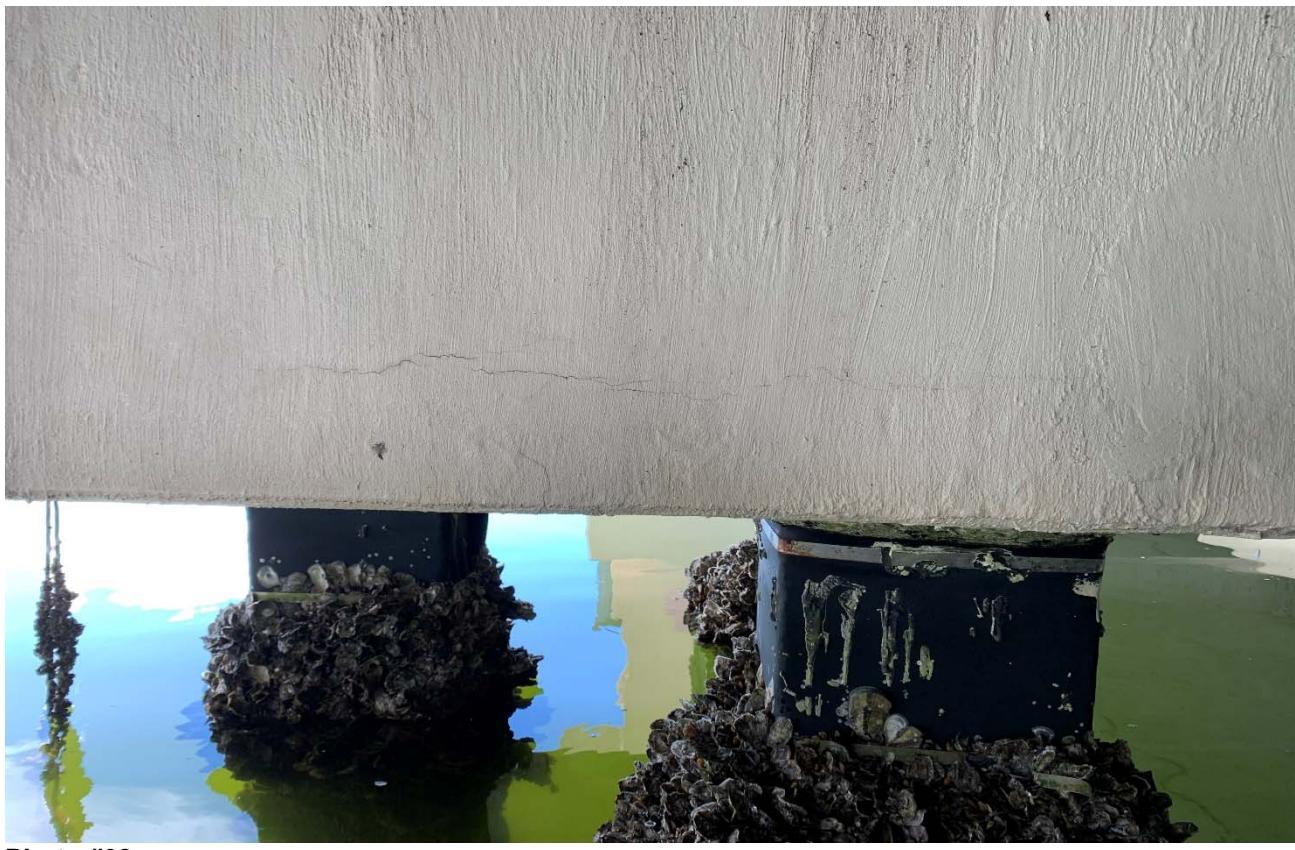
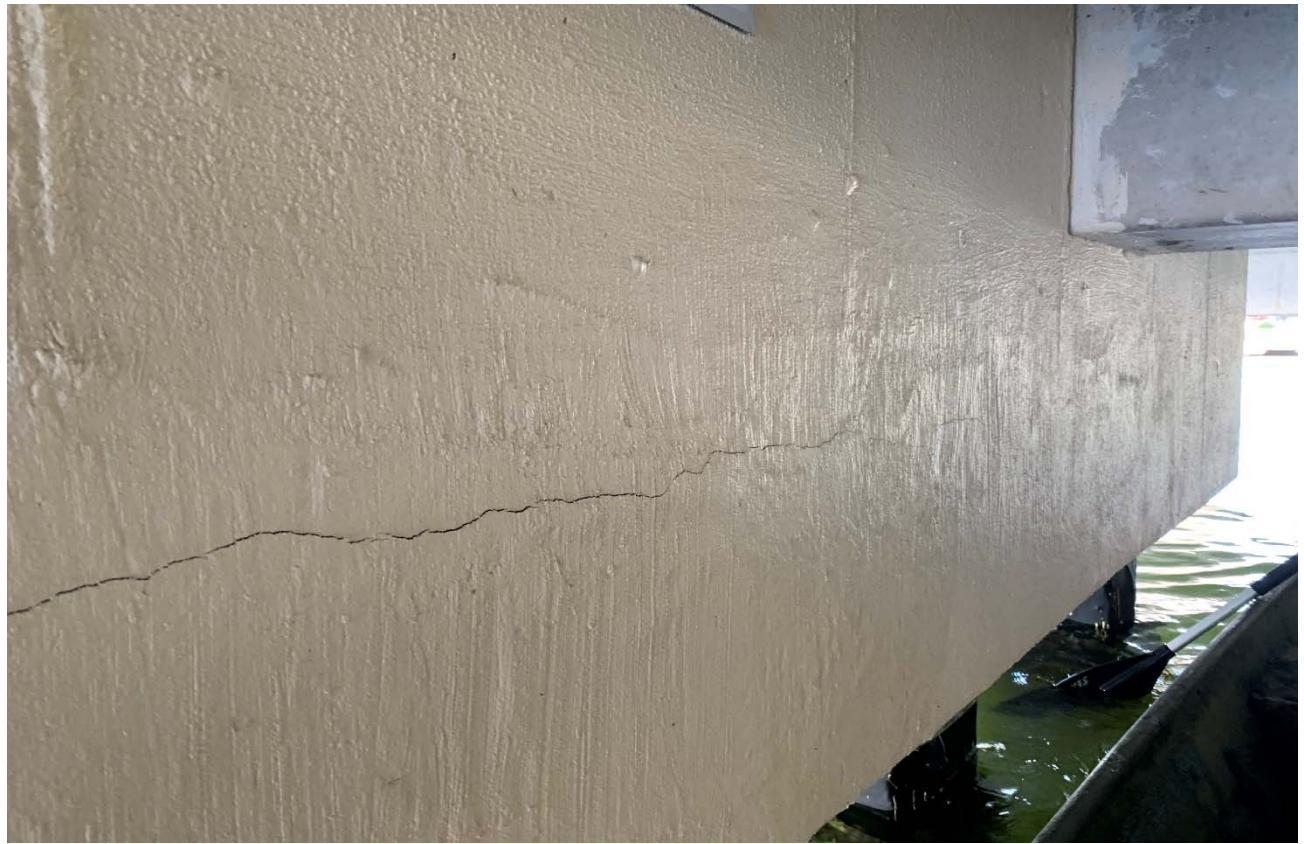
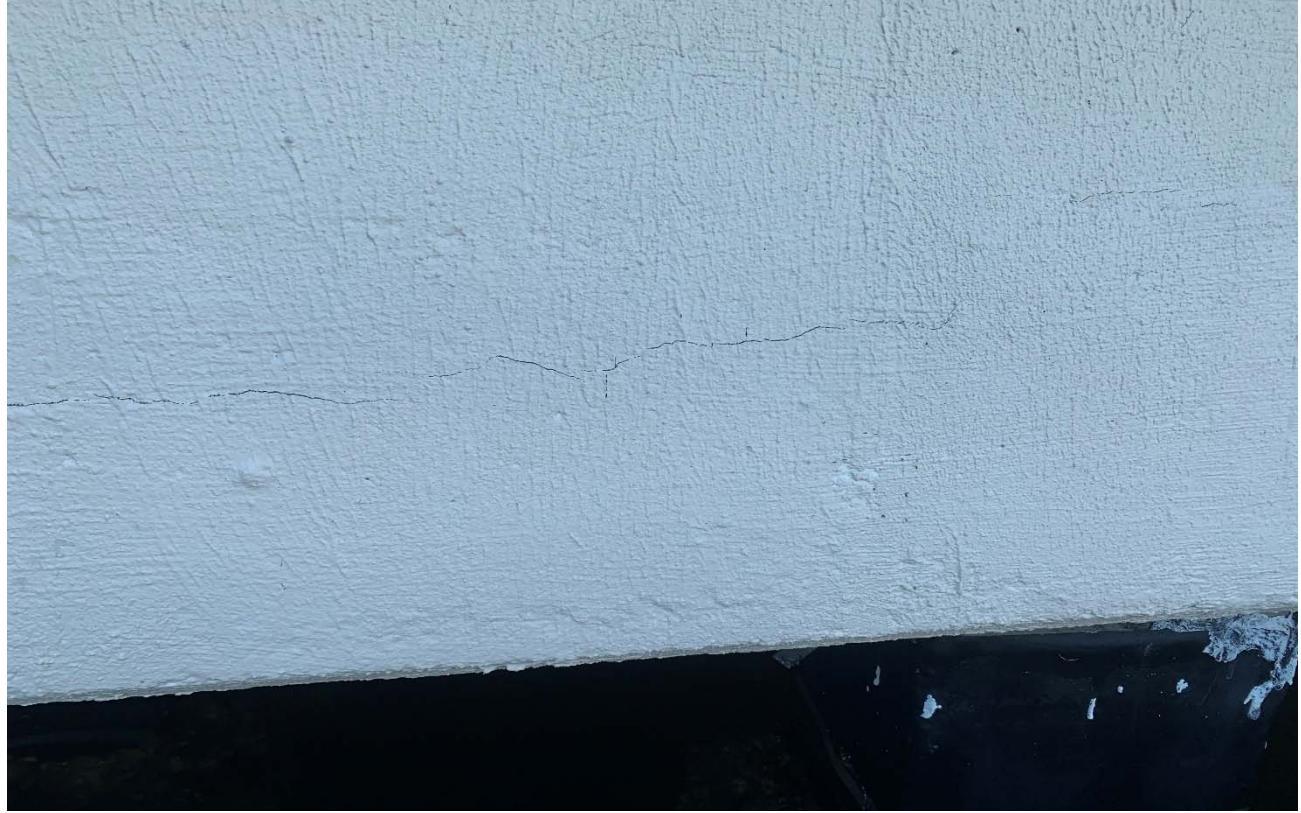
- 3. Additional horizontal cracks on the pile caps were visually observed on the bottom vertical face of the caps. Each of the pile caps located on the building were sounded and lacked the hollow echo of a typical spall and the majority of the deteriorated concrete areas were based on visually observations. (See Photos 8-14)

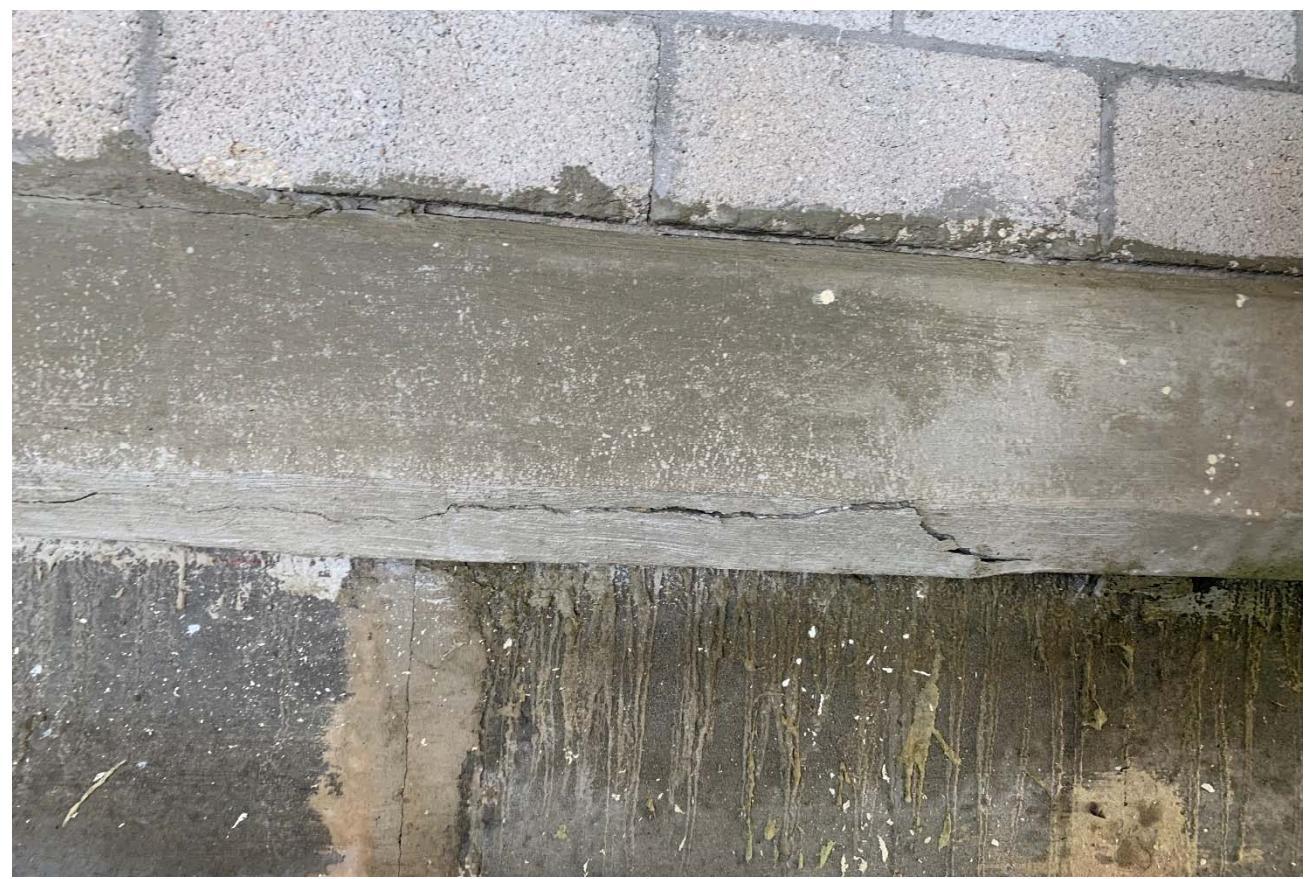
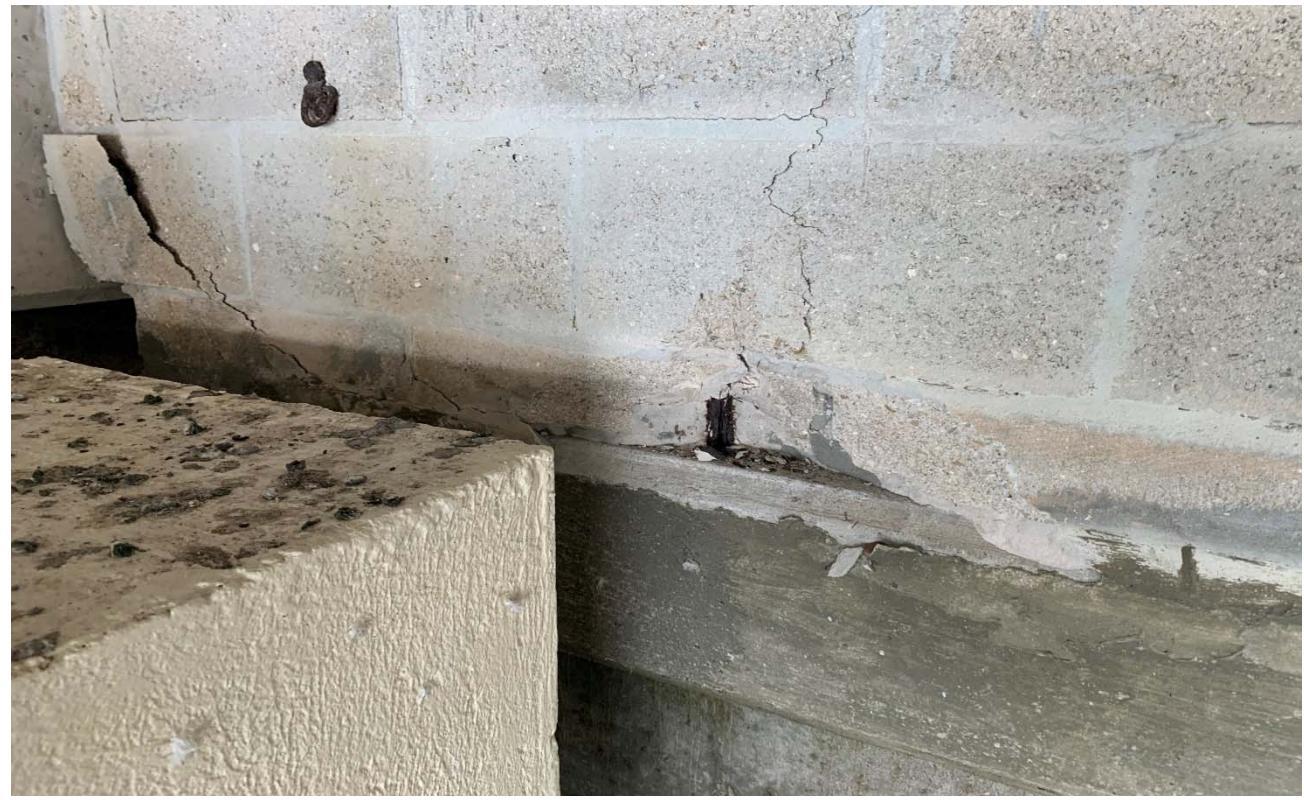
- 4. Several areas of spalling deteriorated concrete were also visually observed on the sea wall caps and CMU surfaces below the base of the building structure. These areas were noted primarily on buildings No. 2 and No. 3. Large cracks, heaved sections of the concrete surface and visually exposed reinforcement bars were observed at these locations. A hollow reverberance was also detected when sounded during our observations, refer to the attached templates for locations. (Refer to Photos 15-18)

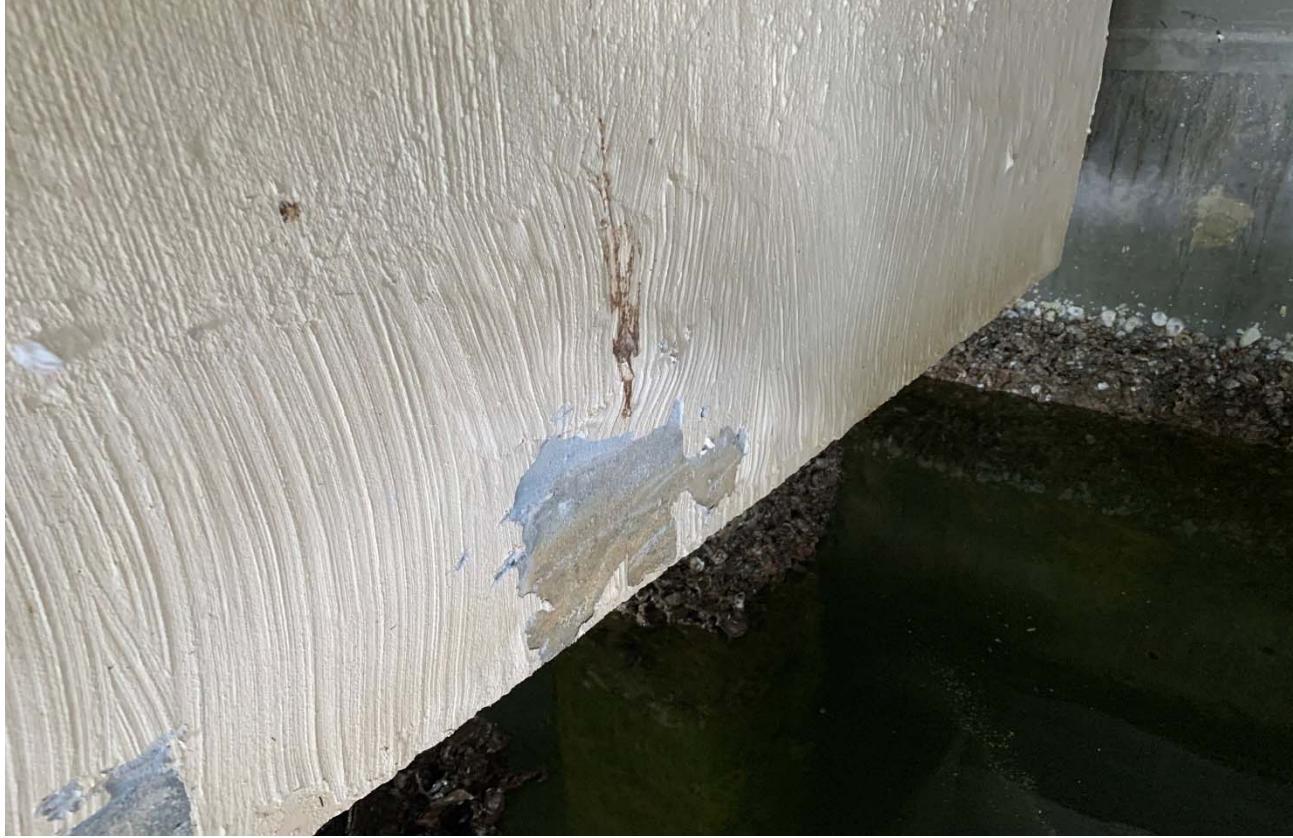
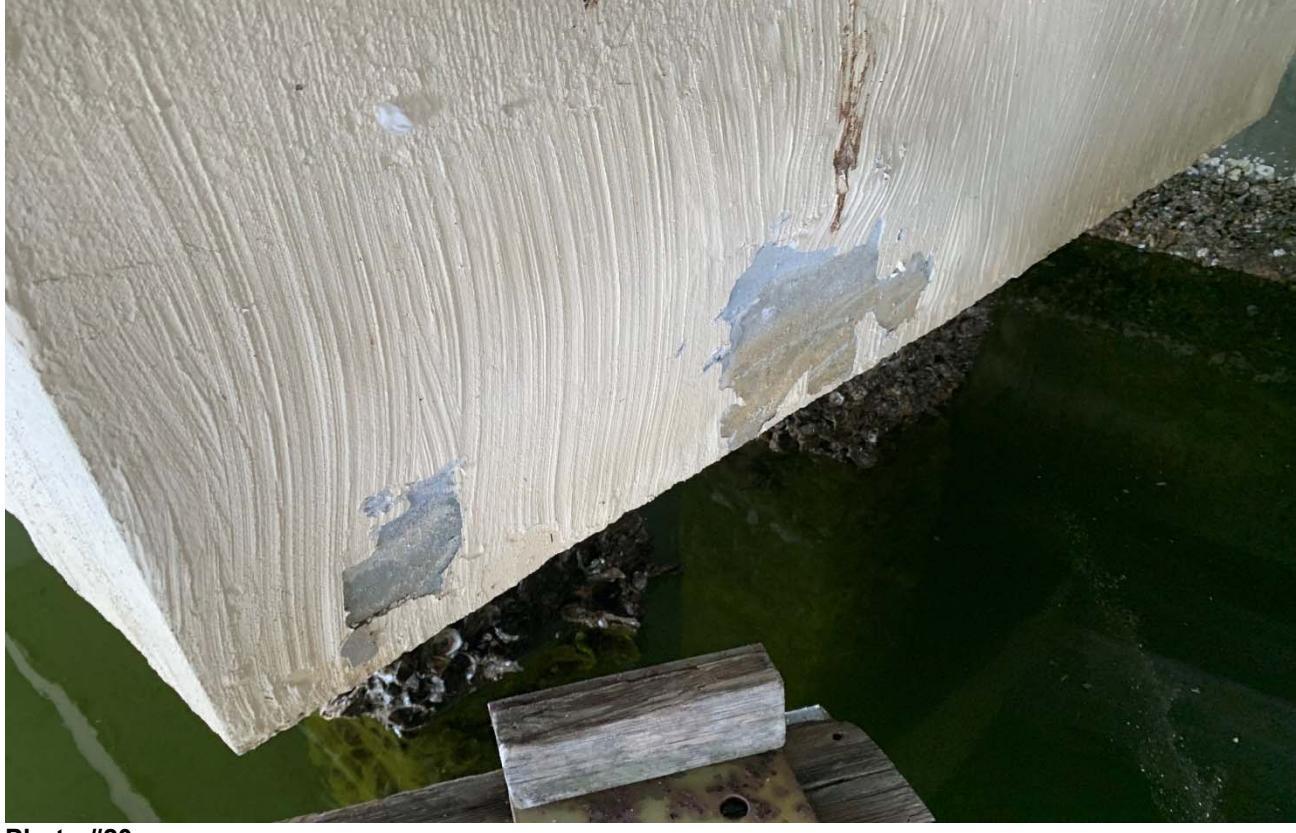
- 5. All the pile cap surfaces were previously coated with a cementitious waterproofing membrane and painted to match the existing finishes on the building. The existing cementitious coatings were also inclusive in the past concrete restoration repairs to the caps and conducted at all excavated repair locations and areas where delamination or failures occurred. One minor area of delaminated cementitious waterproof coatings was observed throughout all of the buildings. A minor location of coating failure was identified on the vertical face of pile cap No. 30 located on building 3. (See Photos 19-20)

Following the concrete repairs on the pile cap surfaces the existing cementitious waterproofing membrane coatings shall be re-applied to the repair areas for future protection of the concrete surfaces of the pile caps from moisture. We feel that proceeding with waterproof coating as such would consolidate mobilization costs, promote future protection of the concrete, and ensure a uniform finish with the existing finishes. In conjunction with the cementitious

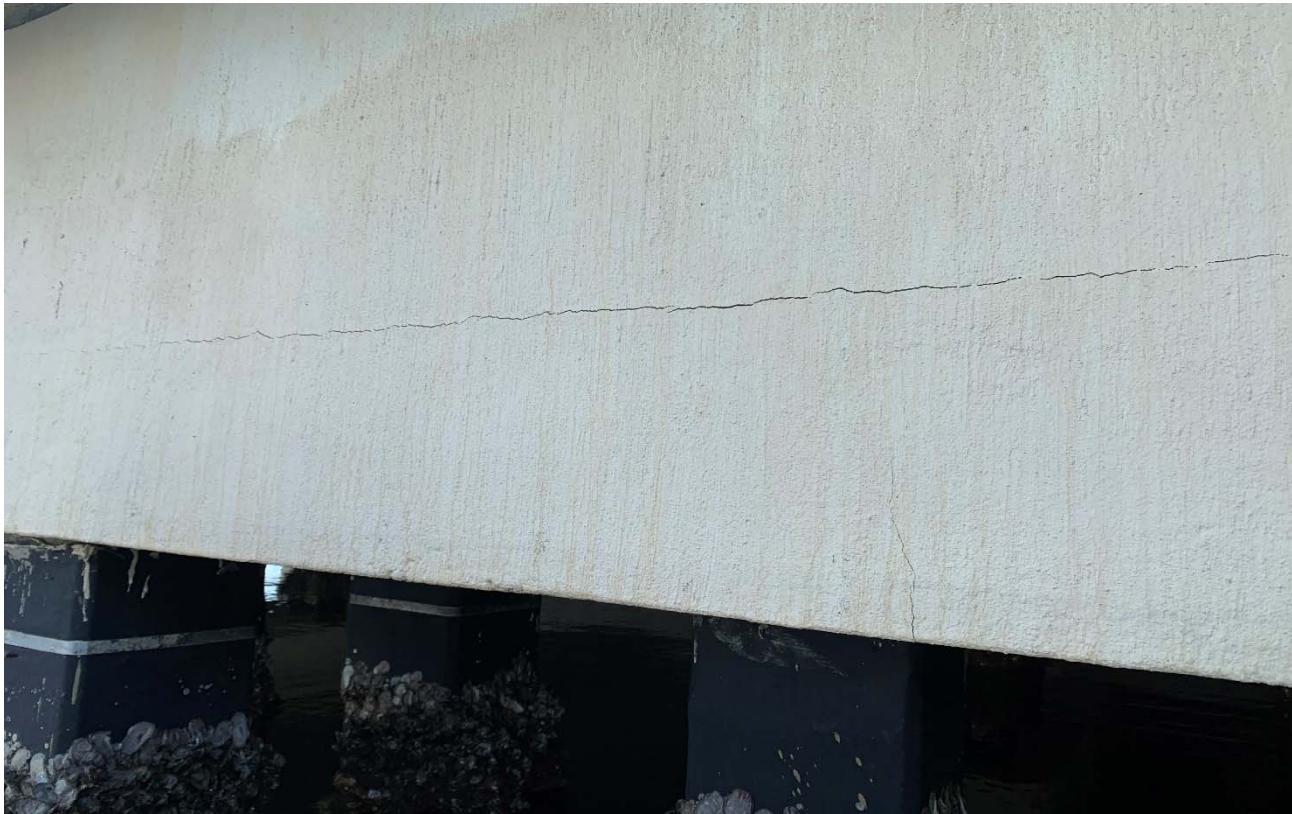
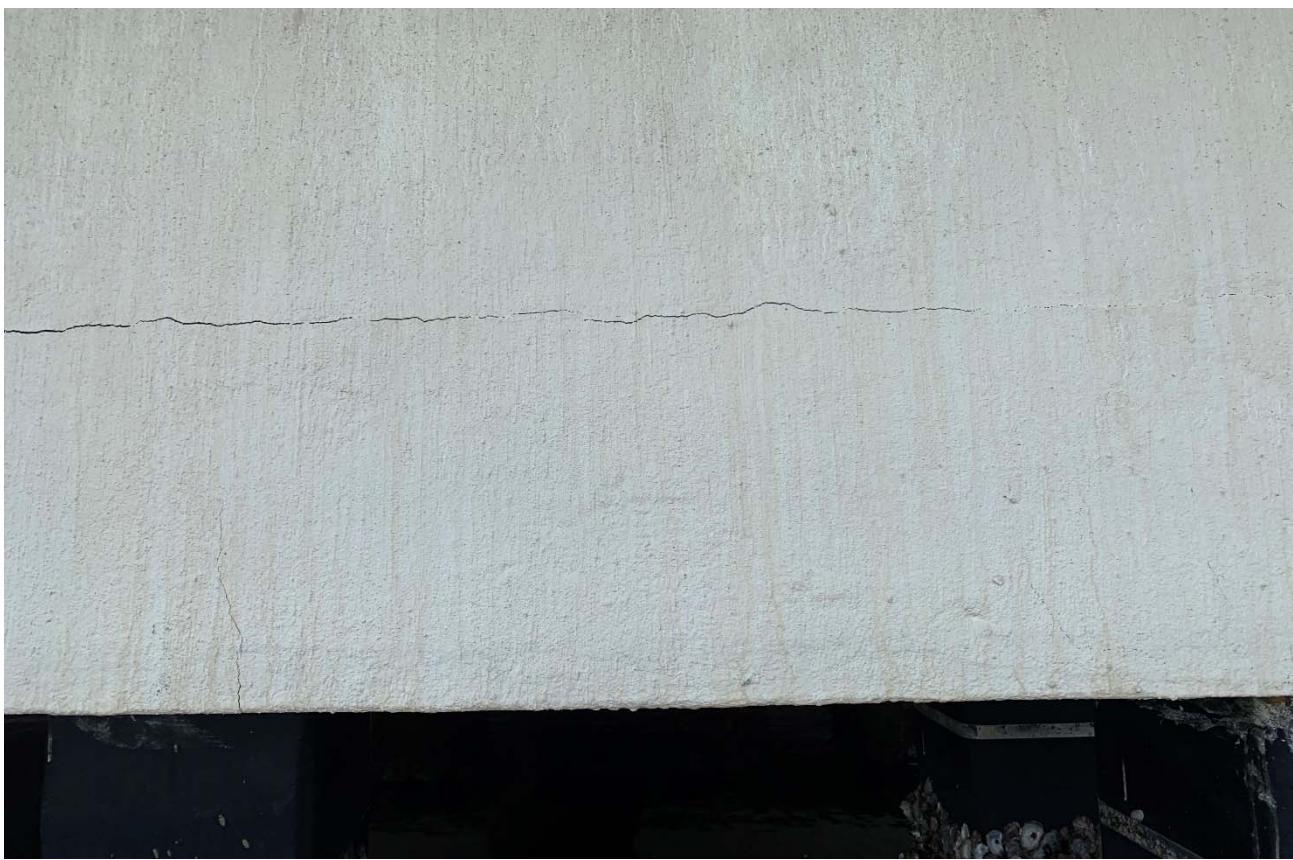
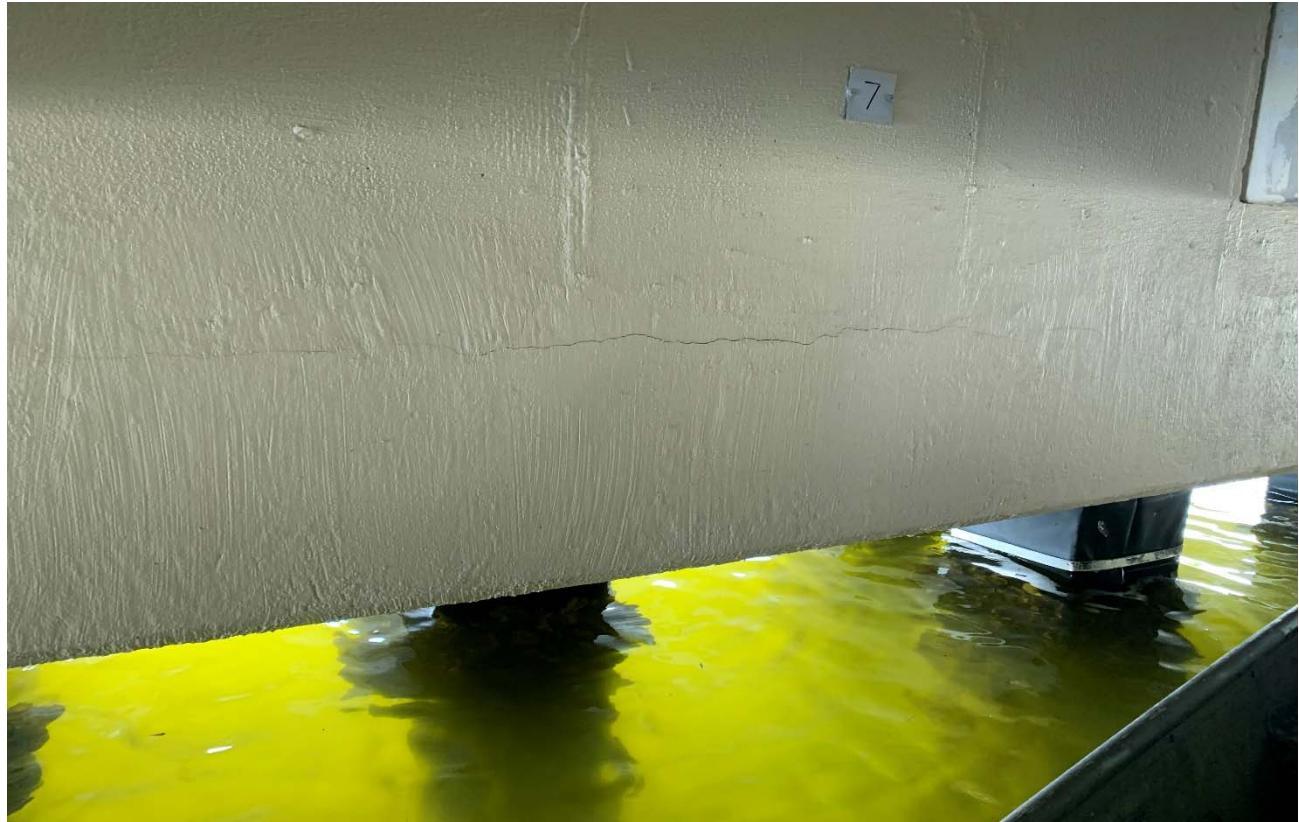
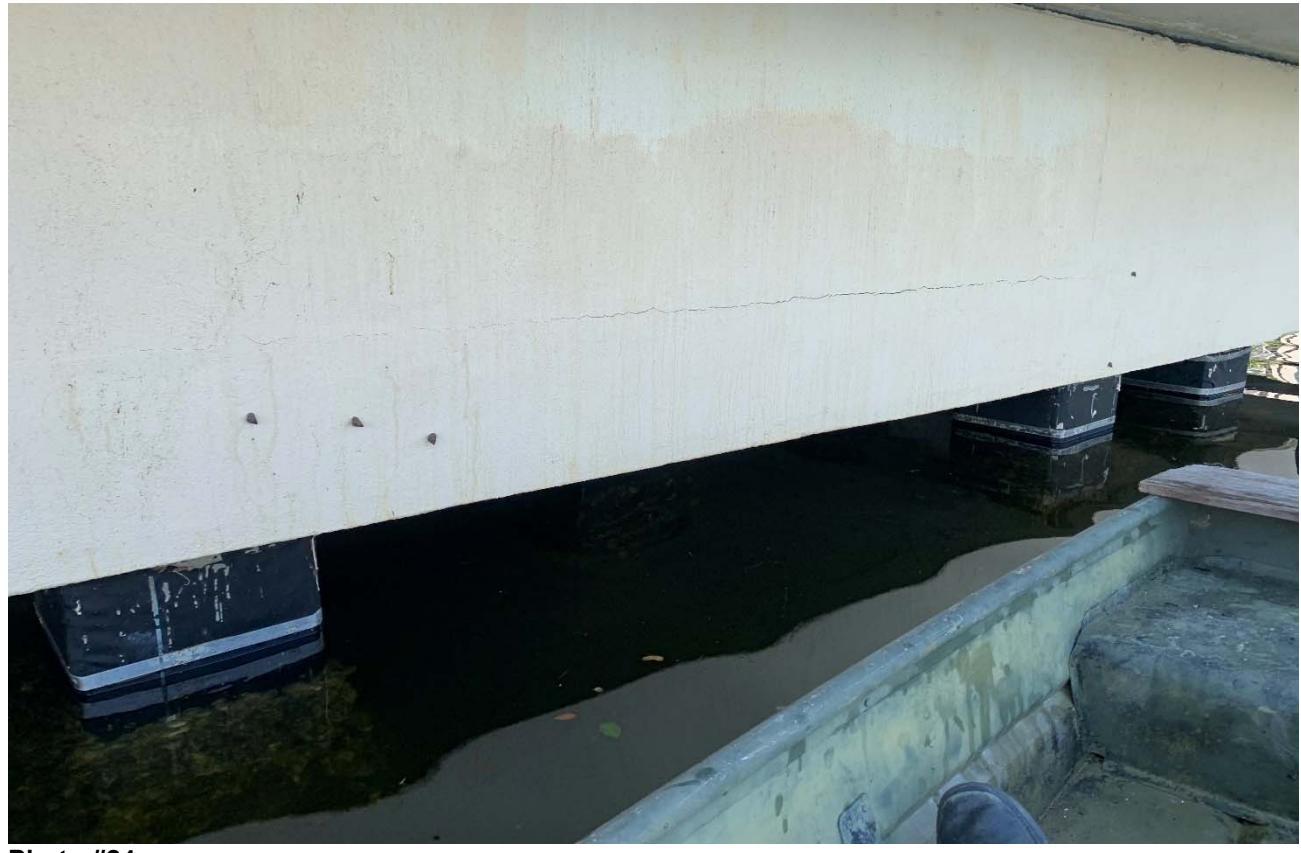
- 7. Several hairline cracks were also observed on the vertical face of the pile caps during observations at previously repaired locations. The cracks identified at these locations were straight and uniform, following the linear outline of the saw cuts performed during the excavational process on the caps, indicative to a cold joint. A cold joint is typically formed from an interruption or delay in concrete operations. This occurs when concrete begins to set before the following batch is placed or at repair locations where the new concrete repair mortar joins the existing. (See Photos 21-24)

waterproof coating replenishments at the new repair areas, the existing repairs with cold joint delineations on the vertical face of the caps be routed out, sealant applied and recoated with the specified cementitious coatings.

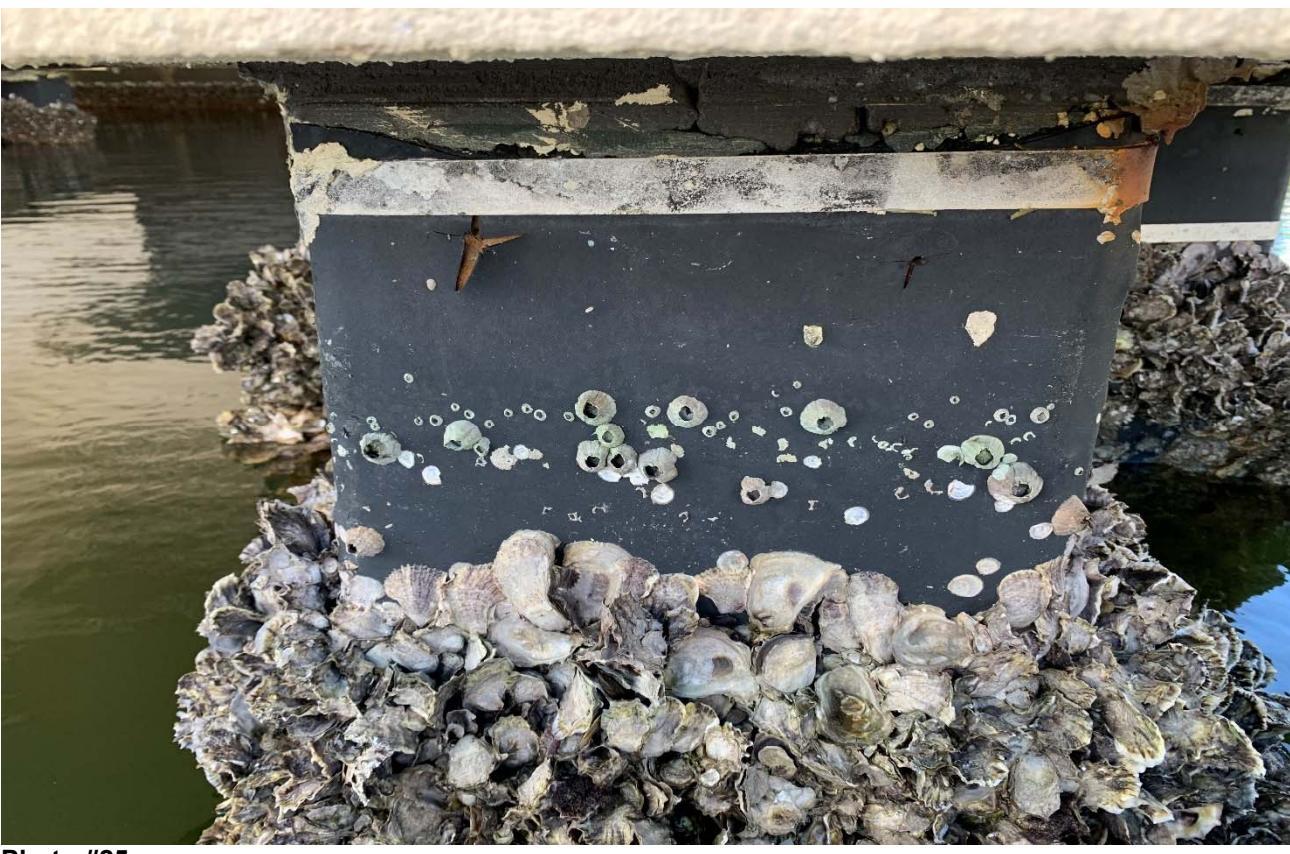
- 8. During the pile cap evaluations, the existing piling wraps were visually observed below the caps. All of the pilings were protected with what appears to be a standard HDPE material wrapped around the pilings and secured with galvanized metal straps on the upper portion of the pilings just below the cap. All of the existing HDPE wrap materials appear to be intact. One piling wrap on building No. 6 under pile cap No. 63 was visually damaged. (See Photo 25)

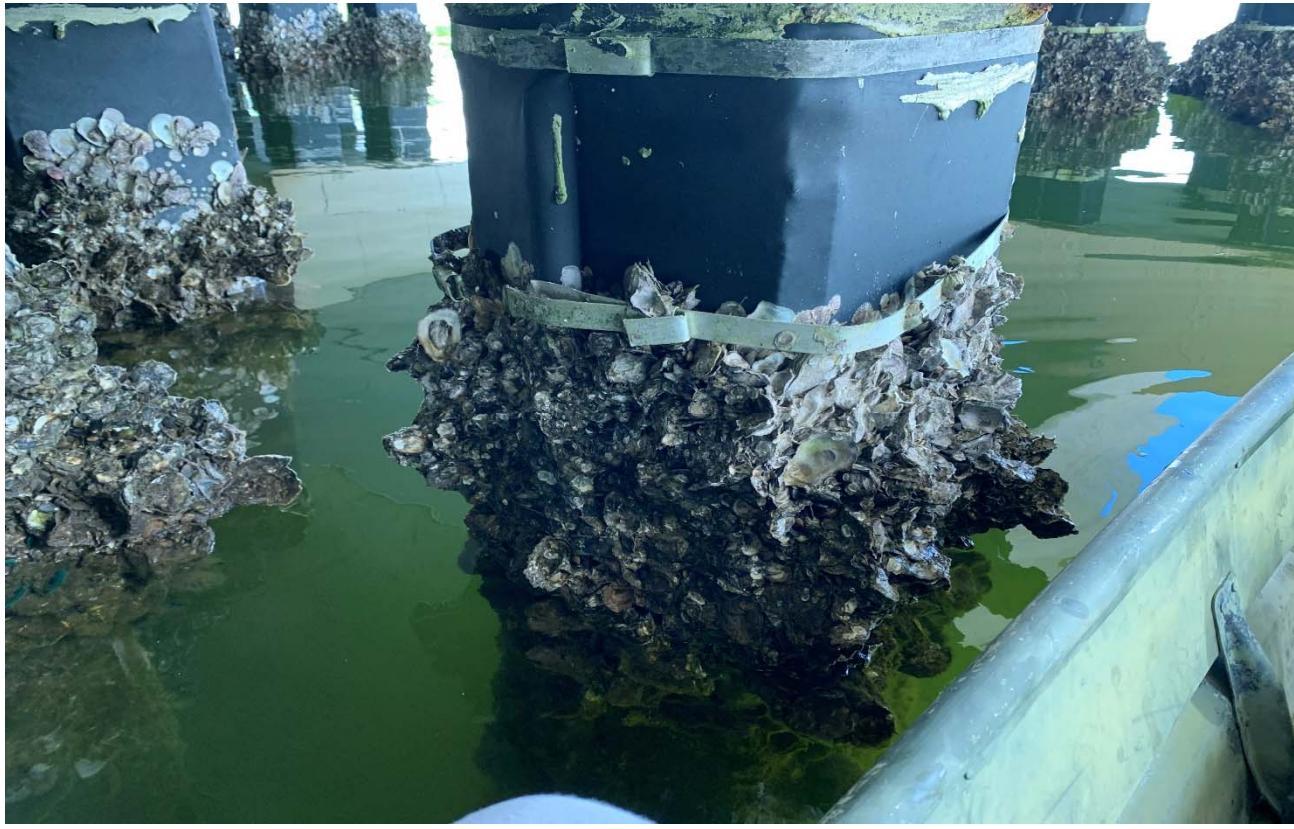
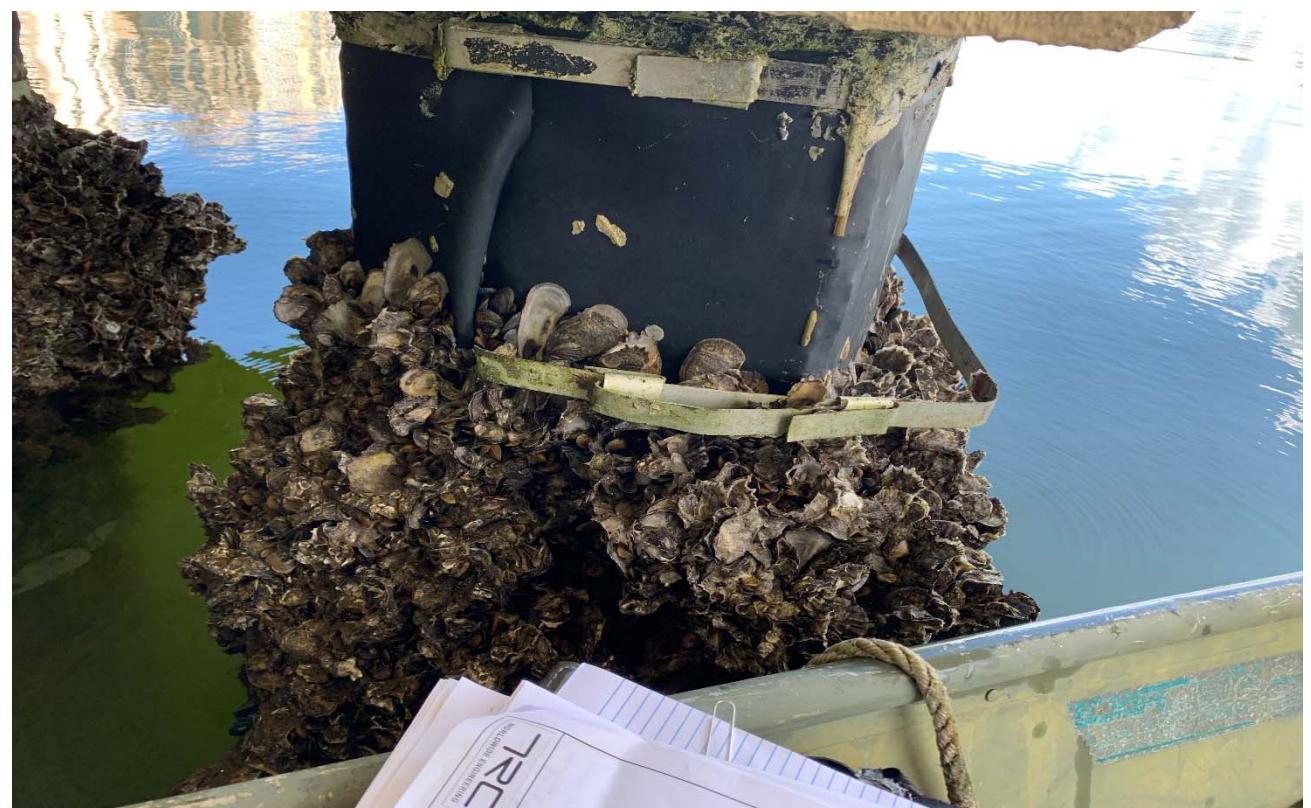
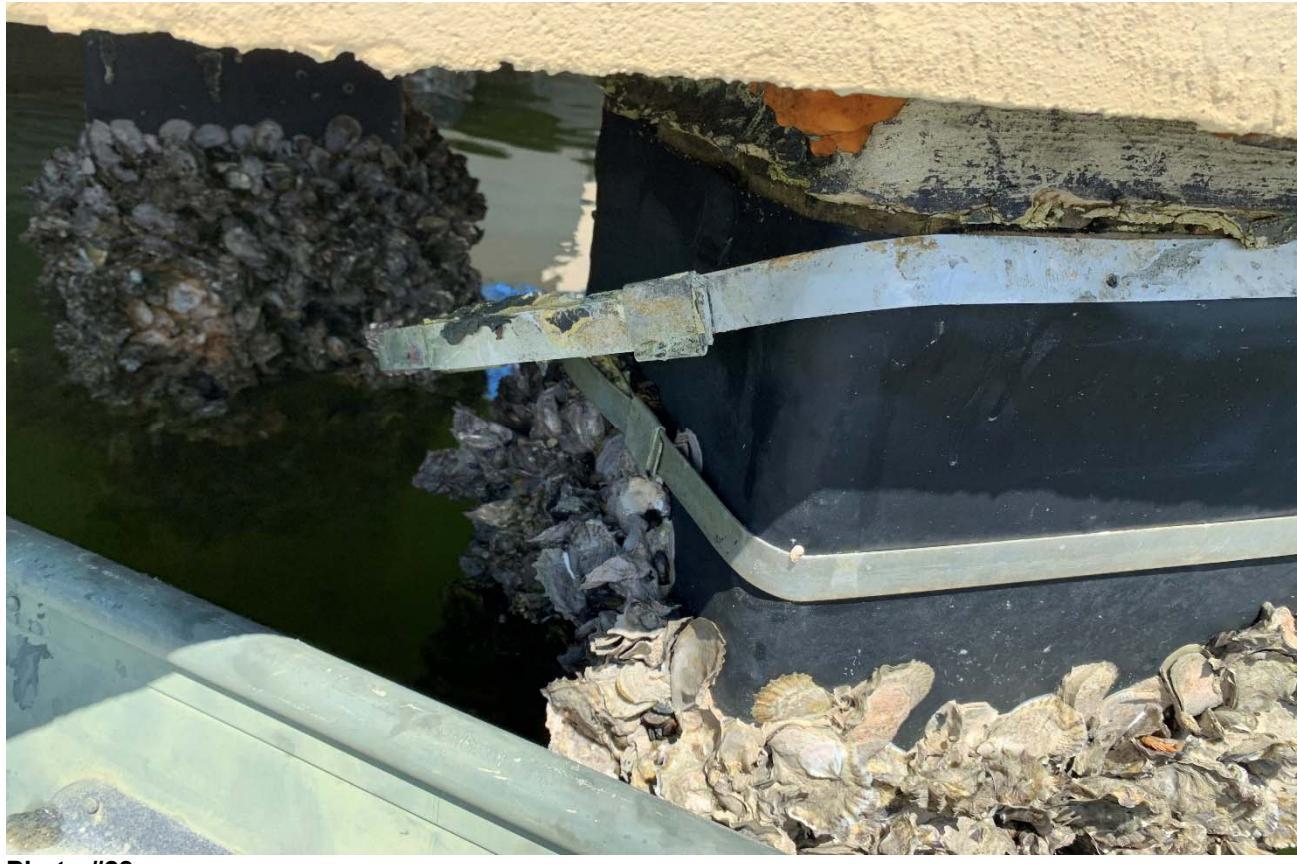
- 9. A handful of the straps observed on the upper surfaces of the pilings were also damaged, loose or not secured at the upper portion of the pilings. This was noted at seven locations under the follow pile cap locations: No. 24, No. 37, No. 48, No. 67, No. 68, No. 63 and No. 62. (See Photos 26-28)
