TRC Worldwide Engineering – Restoration & Inspection, LLC

# RE: Ardissone Condominium Association, Inc. Exterior Building Forensics Report Buildings 1 through 6

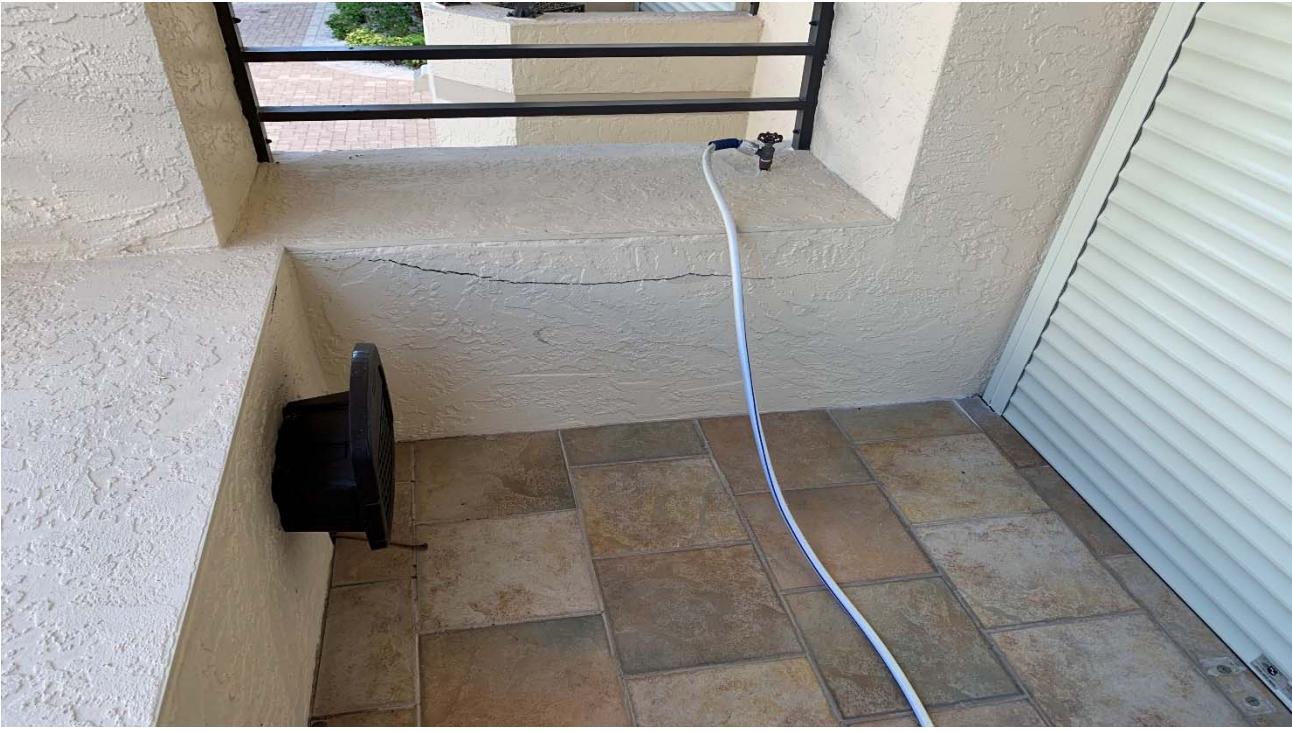
Photo #01

- 1. Several concrete spalls were identified on the balcony surfaces located on Unit 201.
  - a. (2) concrete spalls were identified on the interior and exterior planter walls located on the North end of the balcony along the upper portion of the planter walls. (Refer to Photos 1-2)
  - b. (3) concrete spalls were identified on the interior planter walls along the upper portions of the wall along the East end of the balcony deck. (Refer to Photos 3-4)

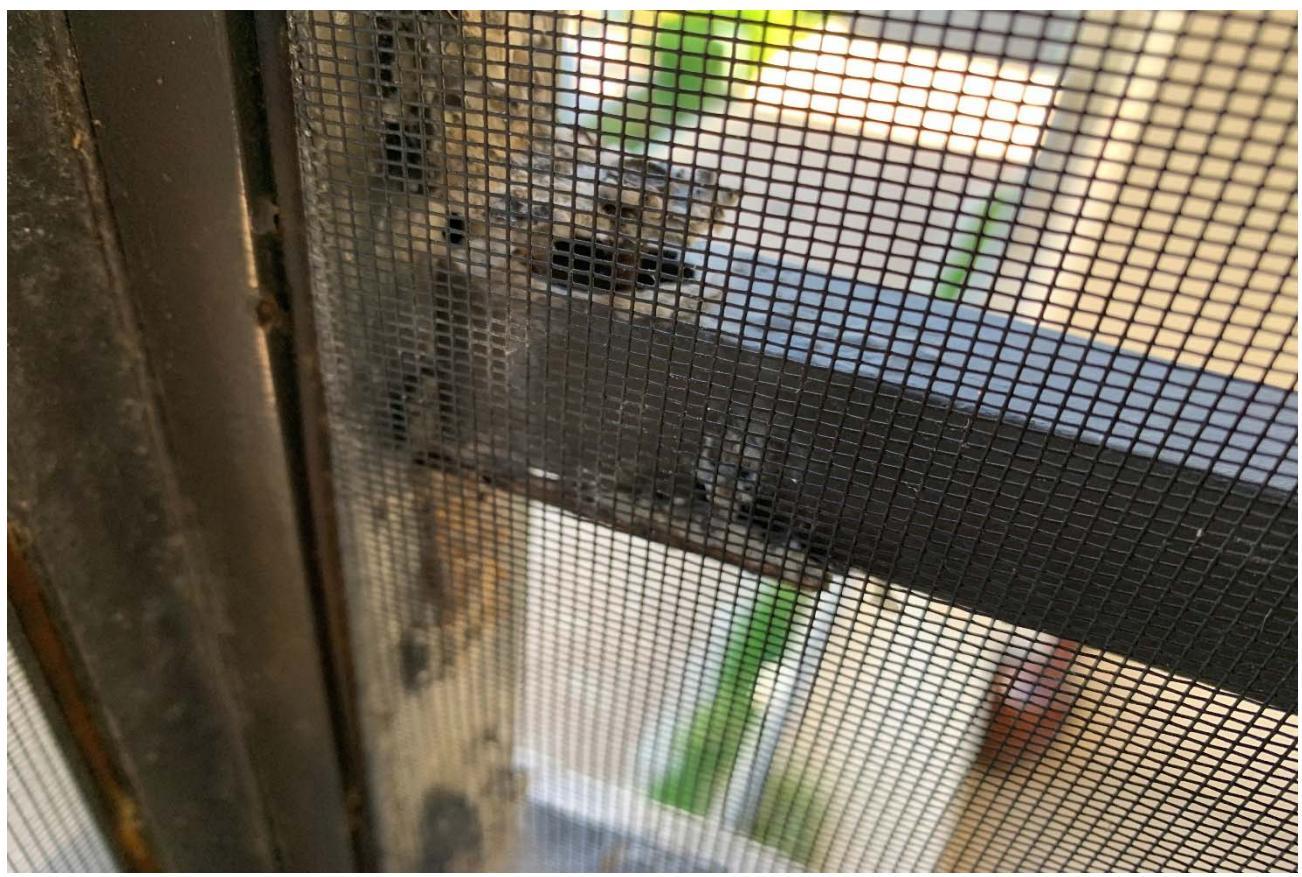
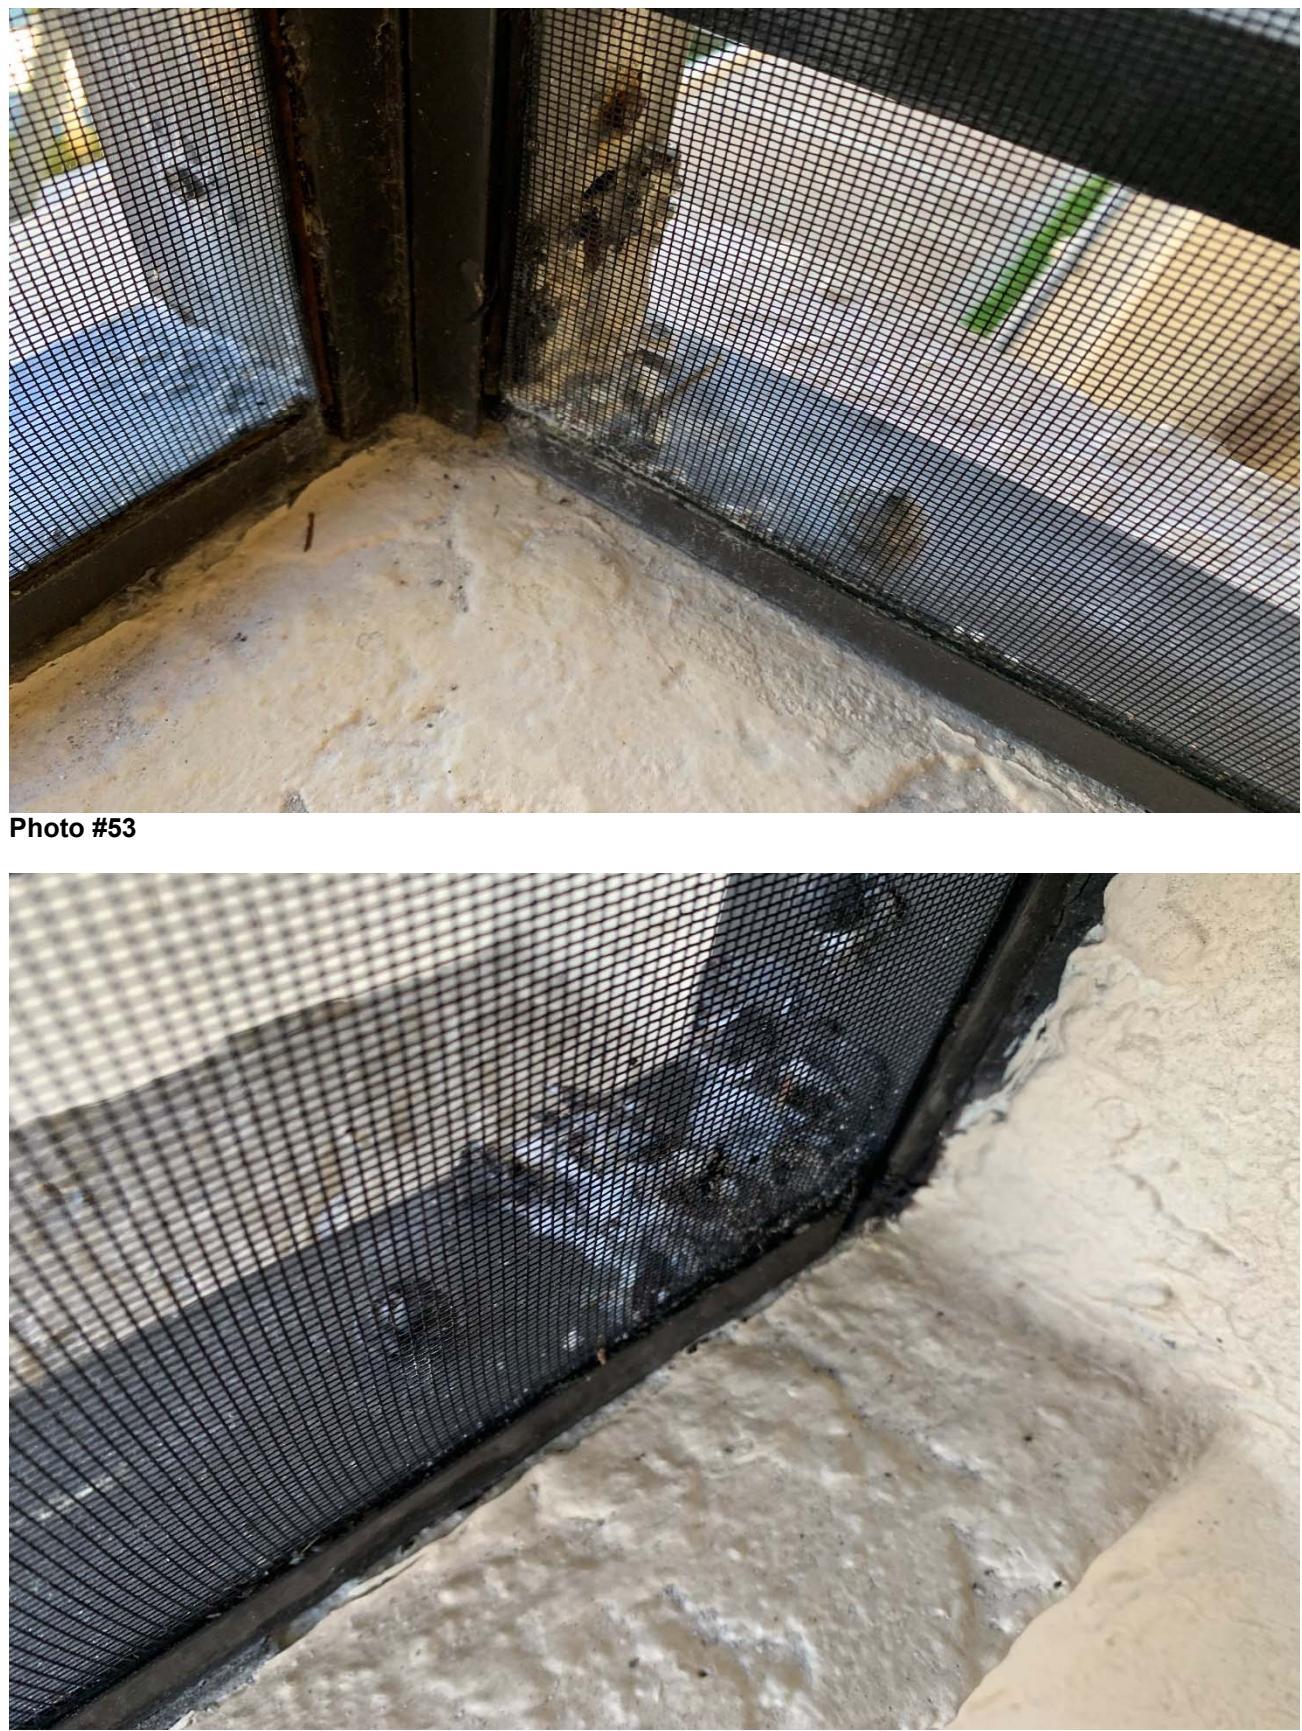
Photo #52

- c. Coating failures and delamination's were also noted on the protective finishes implemented on the rails on Unit 201. (Refer to Photos 50-51)
  - d. The handrails located along the balcony of Unit 204 have been integrated with a screen enclosure framing. Extreme corrosion and section loss on the aluminum components was visually observed throughout the perimeter guardrails. (Refer to Photos 52-56)

During the conditional survey of the balconies, it was noted that the railings are showing signs of the finish wearing, oxidation and corrosion to the aluminum components occurring. Including severe corrosion and section loss of the components noted above at the balcony locations observed. This corrosion would result in reduction in strength of connections that would not be readily apparent. The weakened connections may not be capable of resisting code required railing loads which would be required for the safety barrier. Hence, it is critical that the railings, finishes and connections be maintained. Based on the observations at the locations mentioned within this report. TRC would recommend the railings to be replaced in conjunction with the repair work and coating replenishments on the exterior of building in 2022.

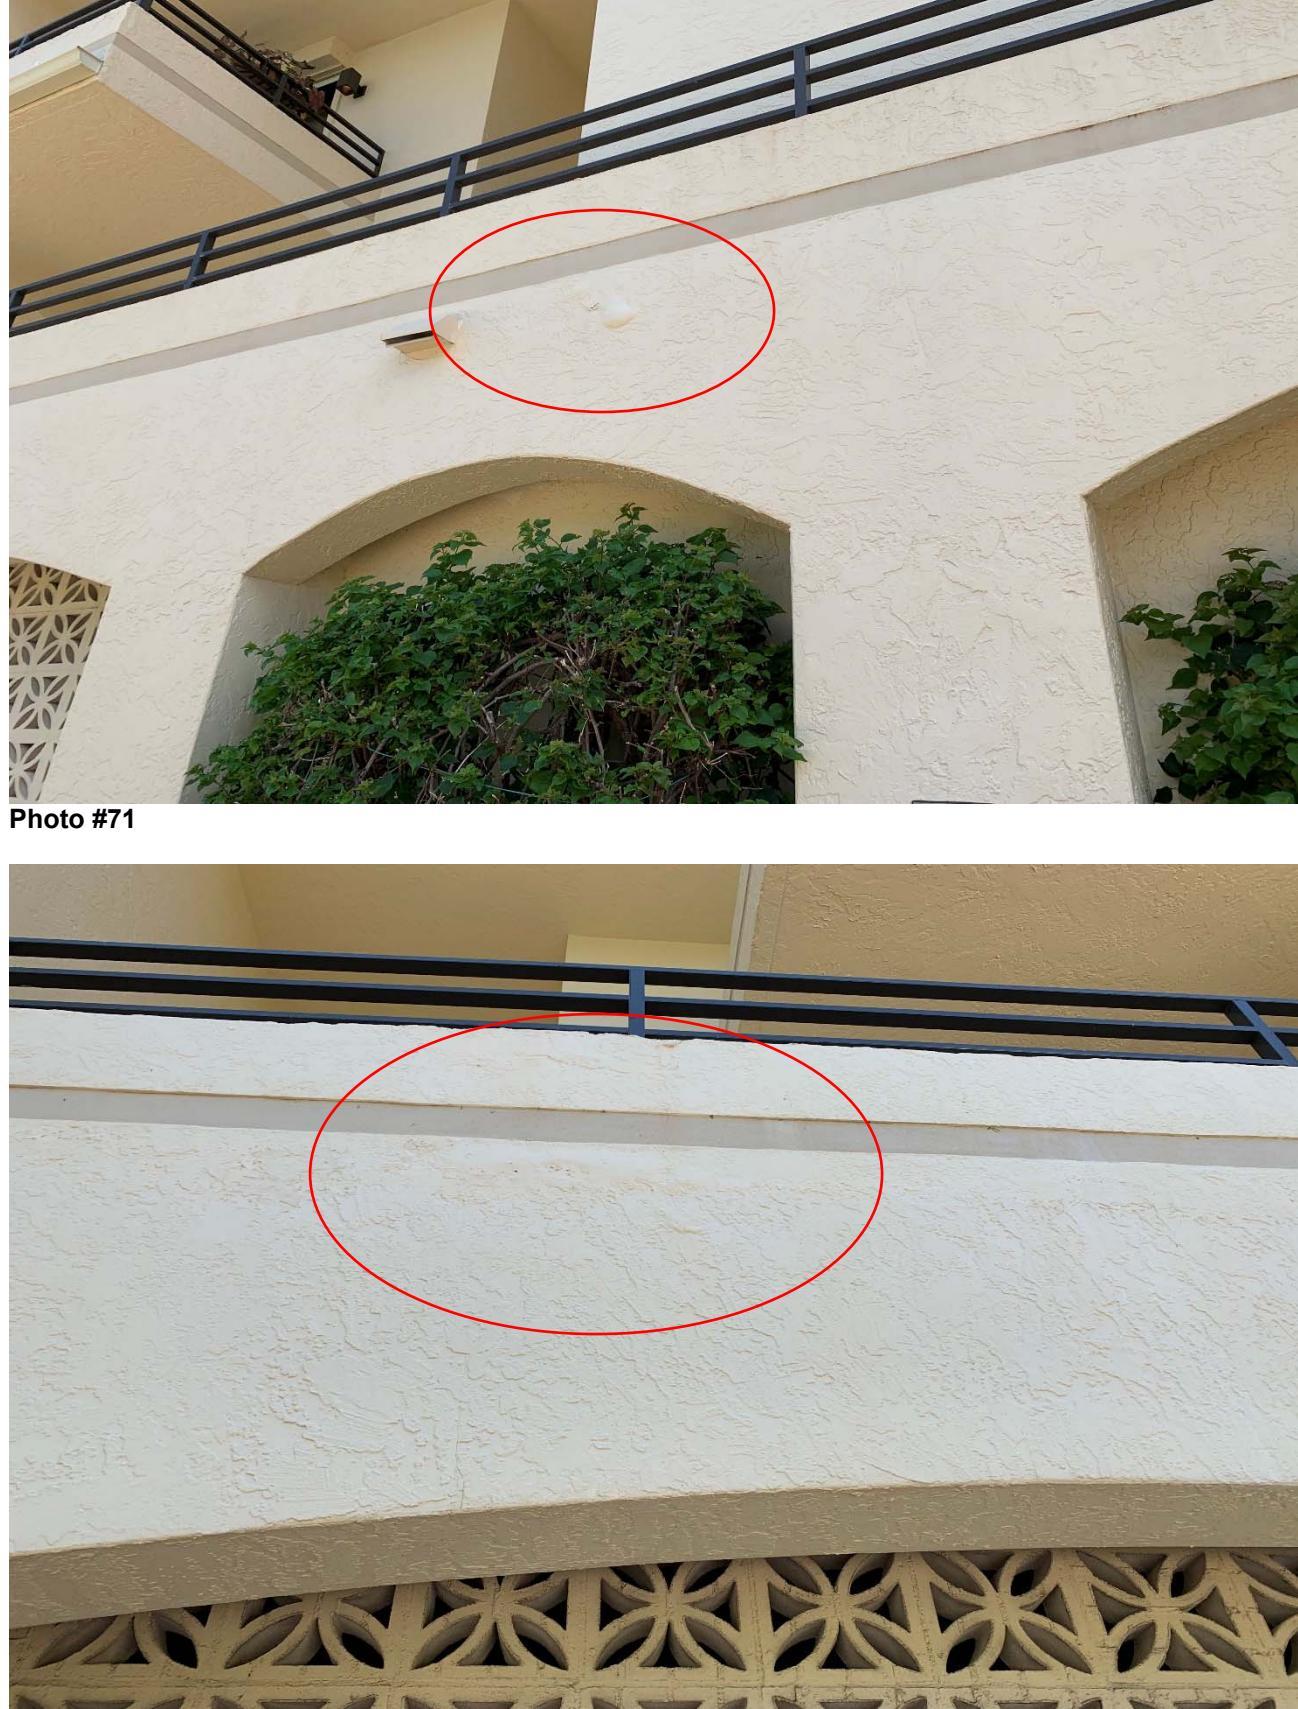
Photo #72

- c. Visually observations within the scupper revealed a lack of waterproof membrane system within the planter locations. (Refer to Photos 69-70)
- d. Additional visually observations as previously mentioned on the exterior of the building revealed several areas of delaminated coatings just below the balcony slab transitions of the planters, indicating moisture intrusion within the structure. (Refer to Photo 71-72)

Due to the current conditions associated with the planters on the Unit balcony decks concerning moisture and water intrusion and the lack of a waterproof membrane. TRC would recommend the removals of the interior planter walls at all balcony locations and the

implementation of a waterproof membrane on the structural slab surfaces to be flashed up the perimeter wall and within the perimeter wall scupper locations.
