# TURRELL, HALL & ASSOCIATES, INC. Marine & Environmental Consulting

#### **RE:** Seawall Assessment for Ardissone Condominiums

Seawall Assessment Ardissone Condominiums February 2019

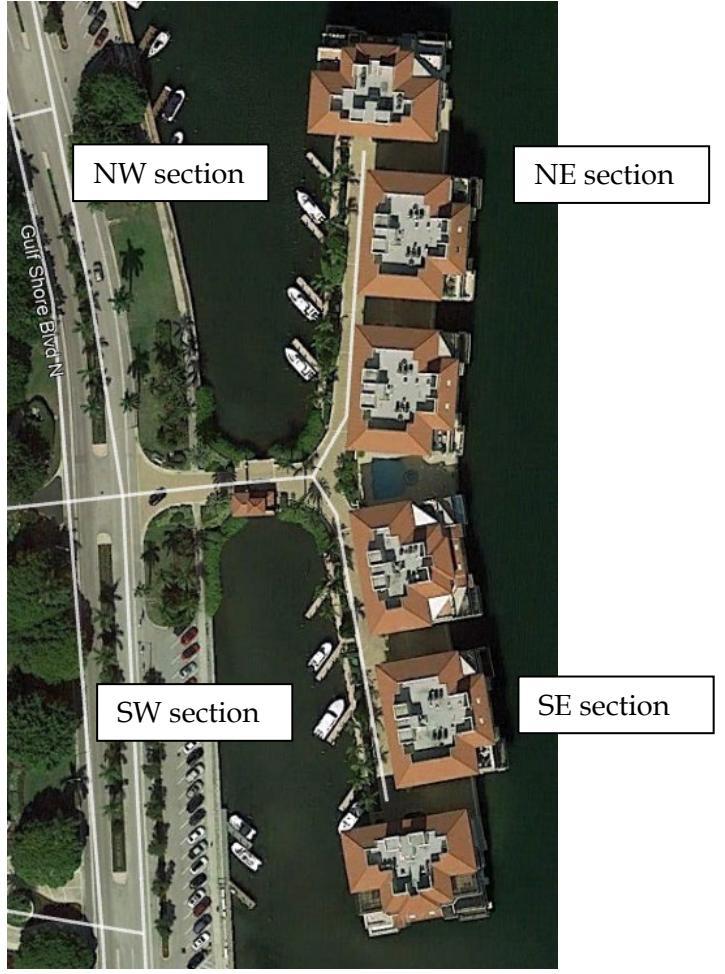
Figure 1. Aerial view of the property.

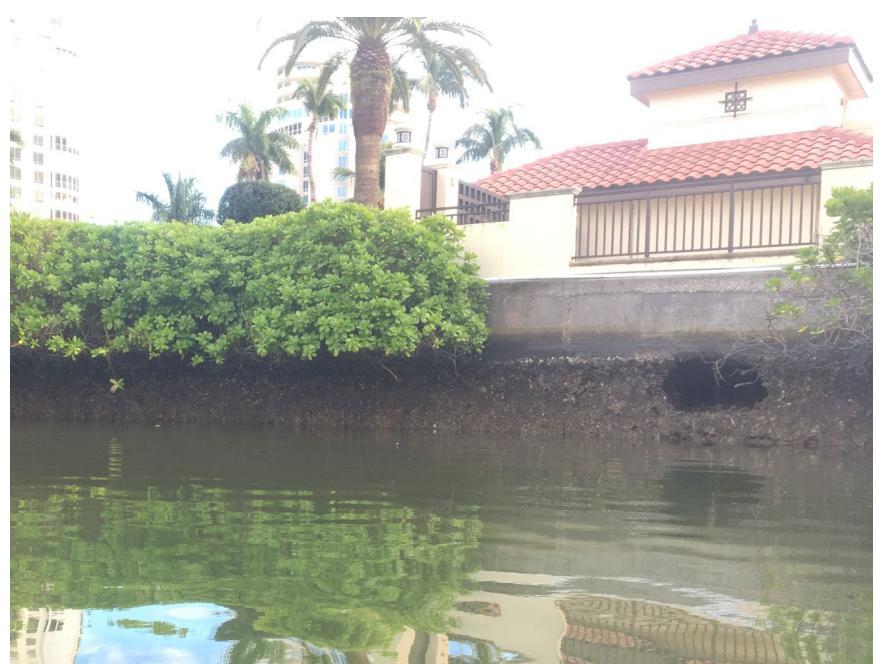
Figure 3. Overview of the seawall (access road seawall, north side)

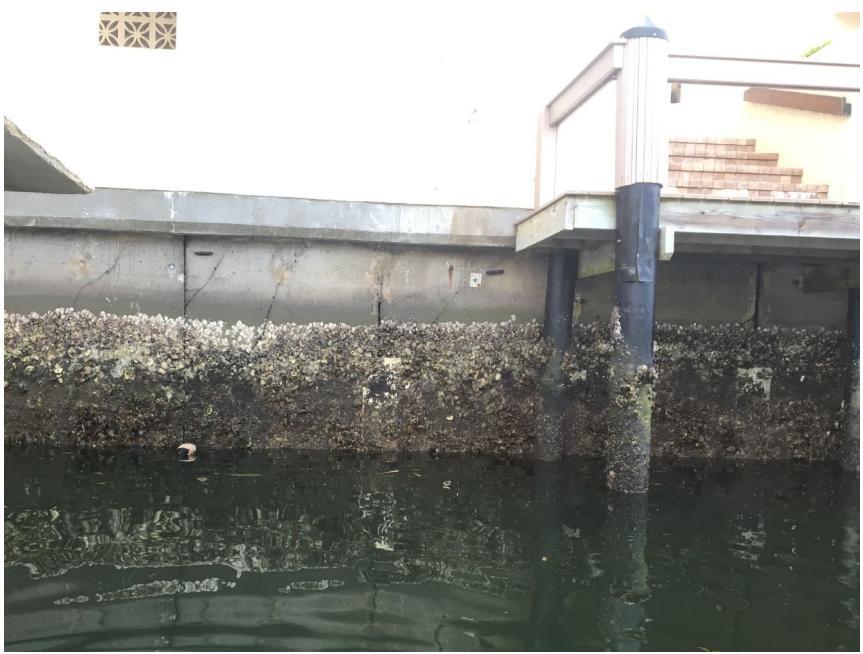
Figure 4. Overview of the seawall (west side, at the docks)

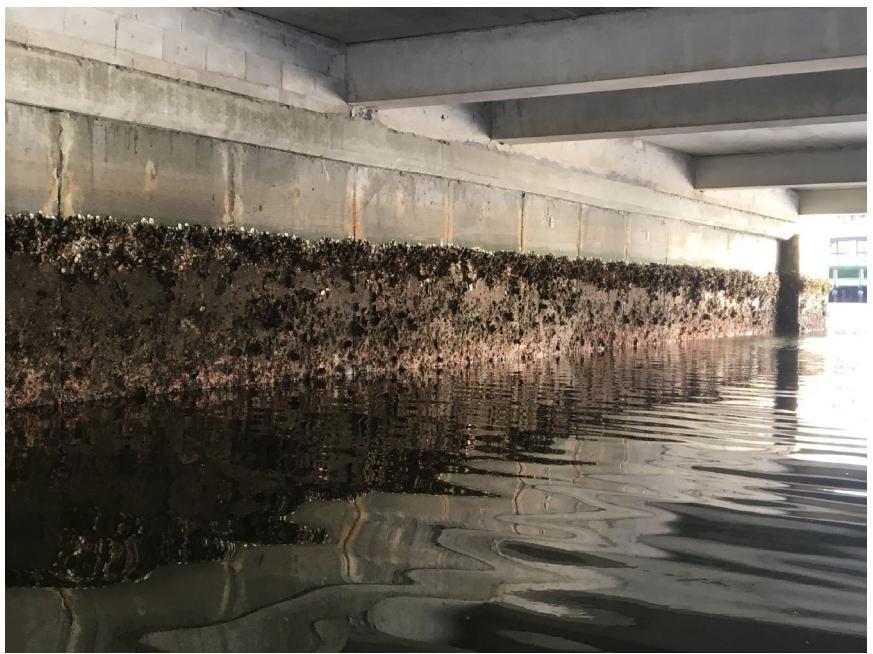
Figure 5. Overview of the seawall (north side, under the buildings).

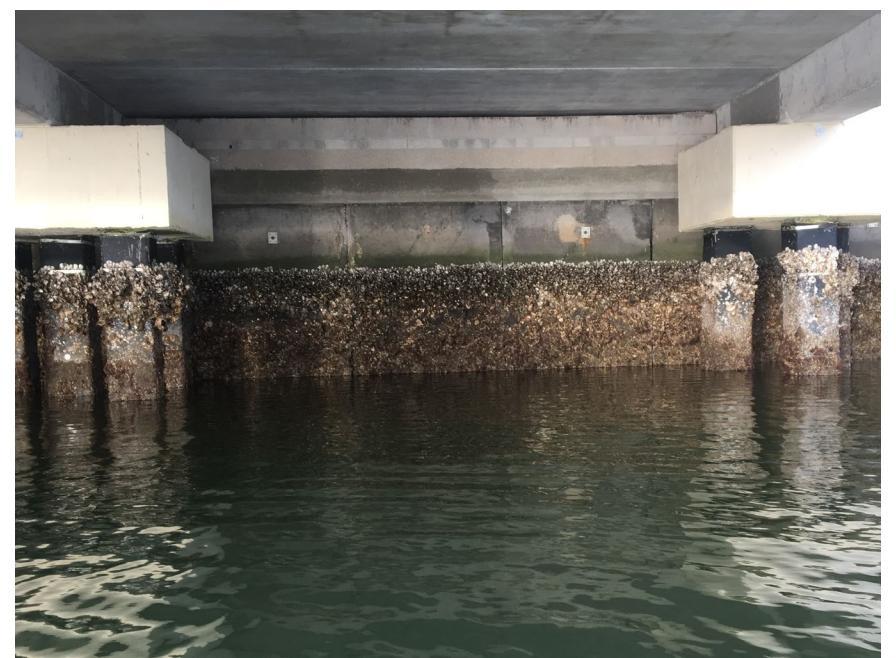
Figure 6. Overview of the seawall (east side, under the buildings)

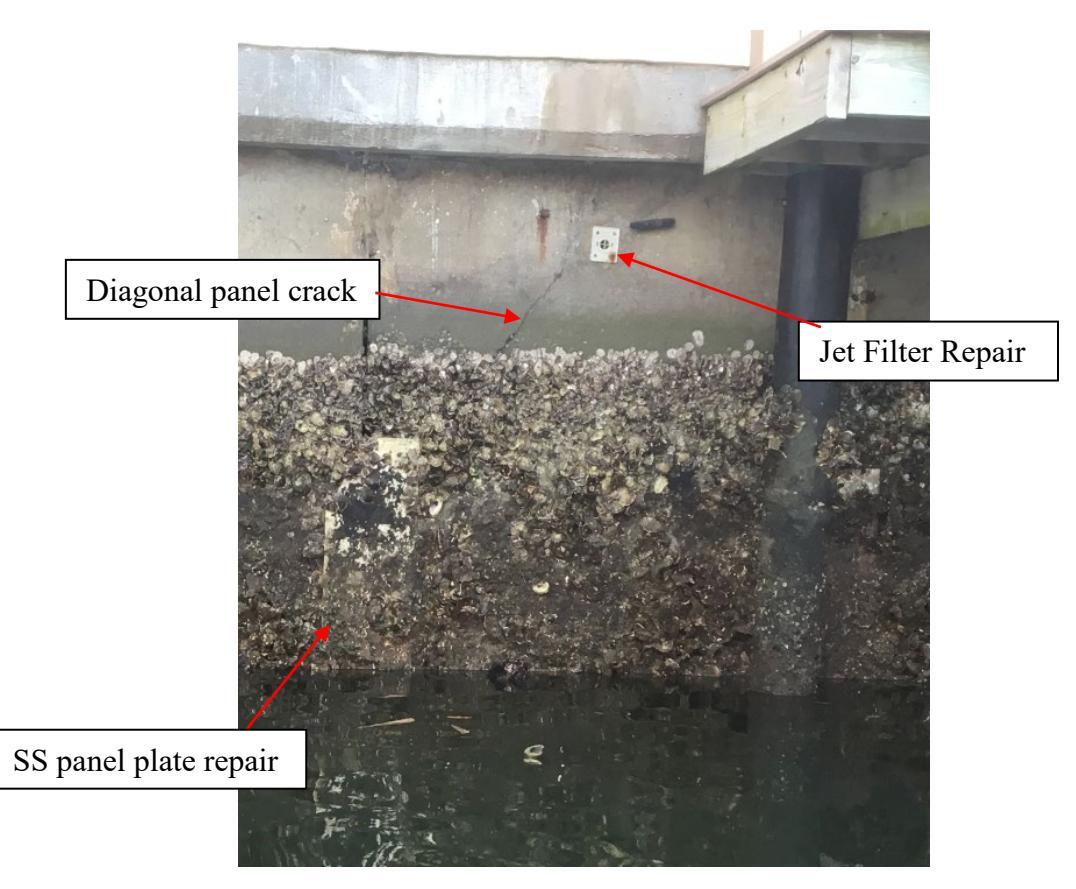
Figure 7. Seawall panel defects and repairs.

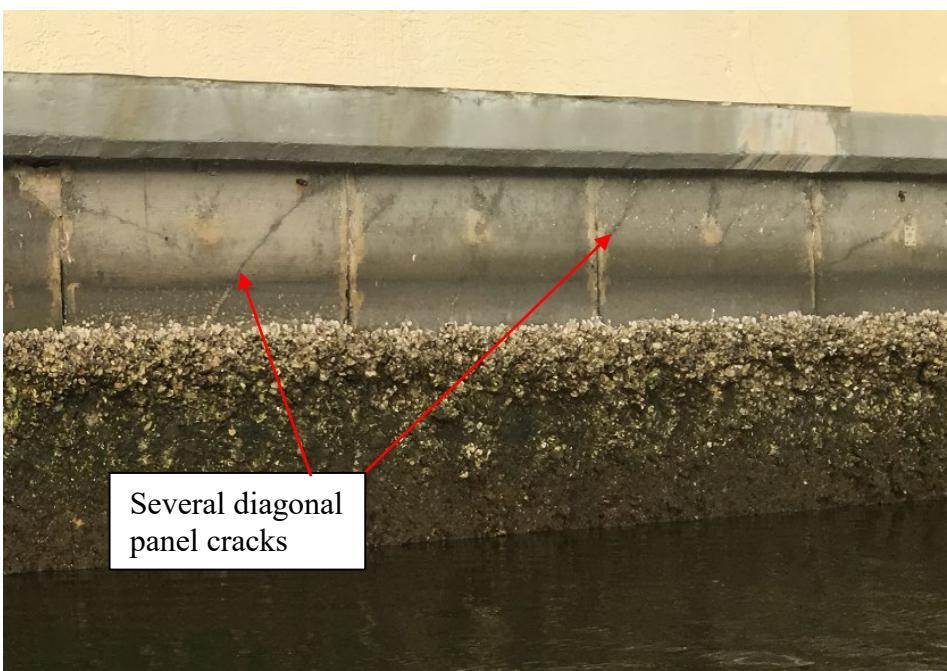
Figure 8. Seawall panel defects and repairs.
