BONDURANT
ARCHITECTURE

ARDISSONE CONDOMINIUM ASSOCIATION, INC

Report Date:
July 13, 2023

1.0 INTRODUCTION

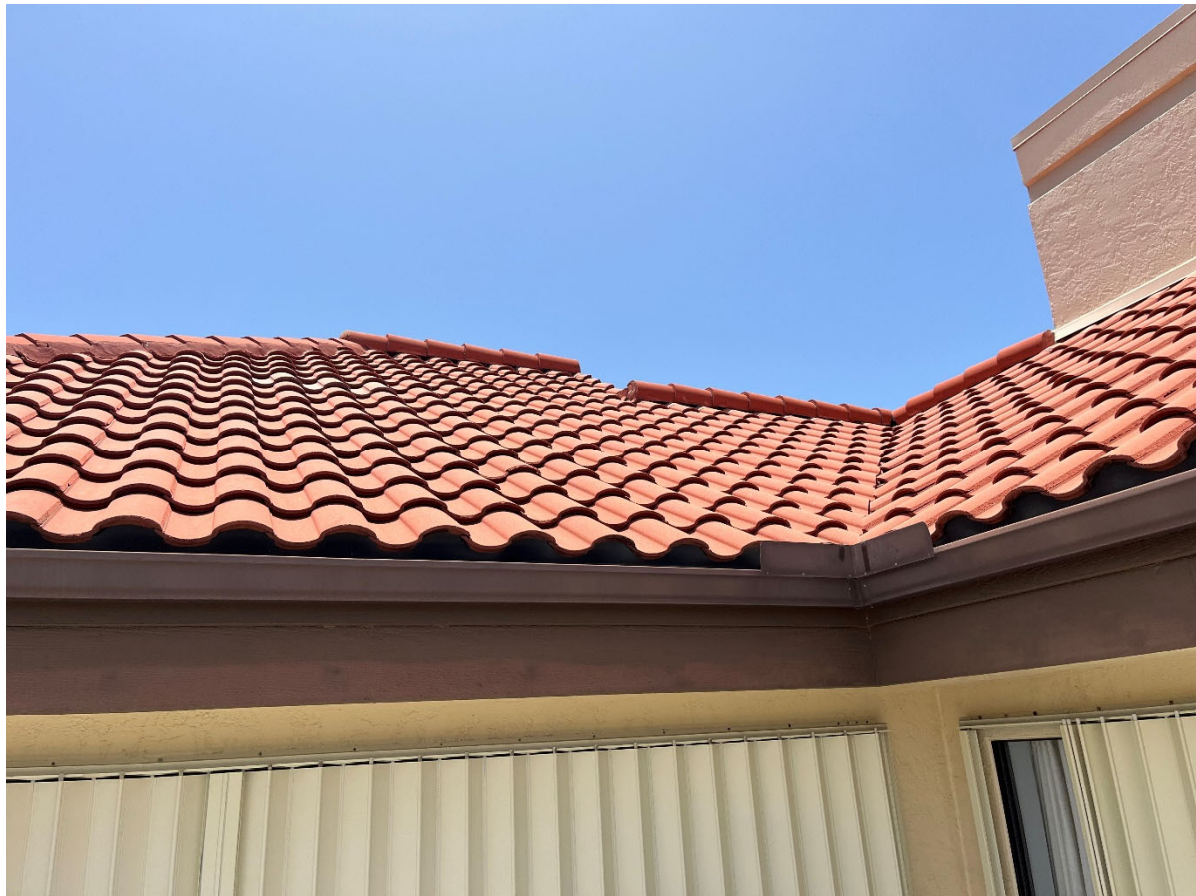
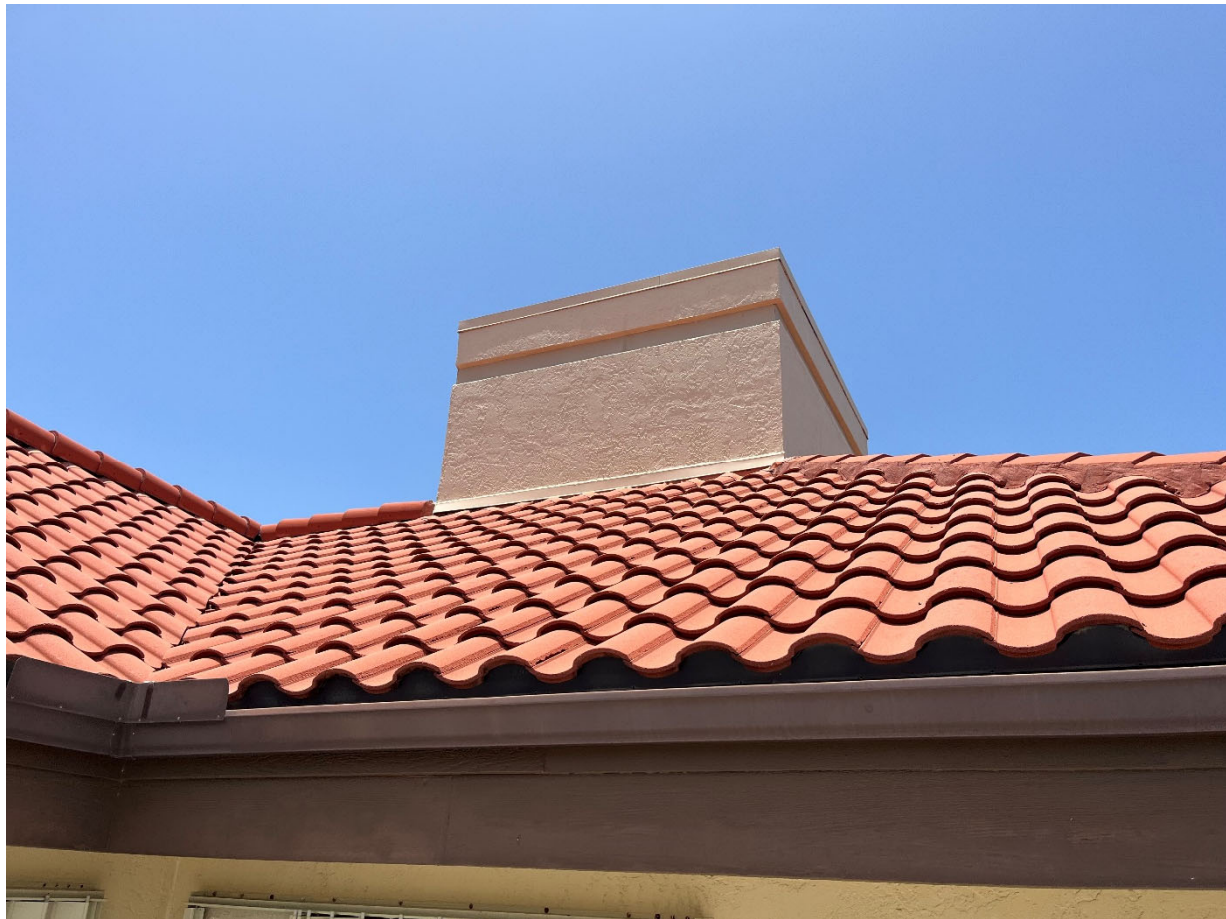
There is a small confined flat roof area in the center of the buildings that was not accessed. Since the roof is scheduled for replacement, this area should be evaluated or replaced a that time
