RE: Ardissone Condominium Association, Inc. Pile Cap Forensics Report Buildings 1 through 6

Pile Cap Photo Exhibit – The Ardissone Condominium Association

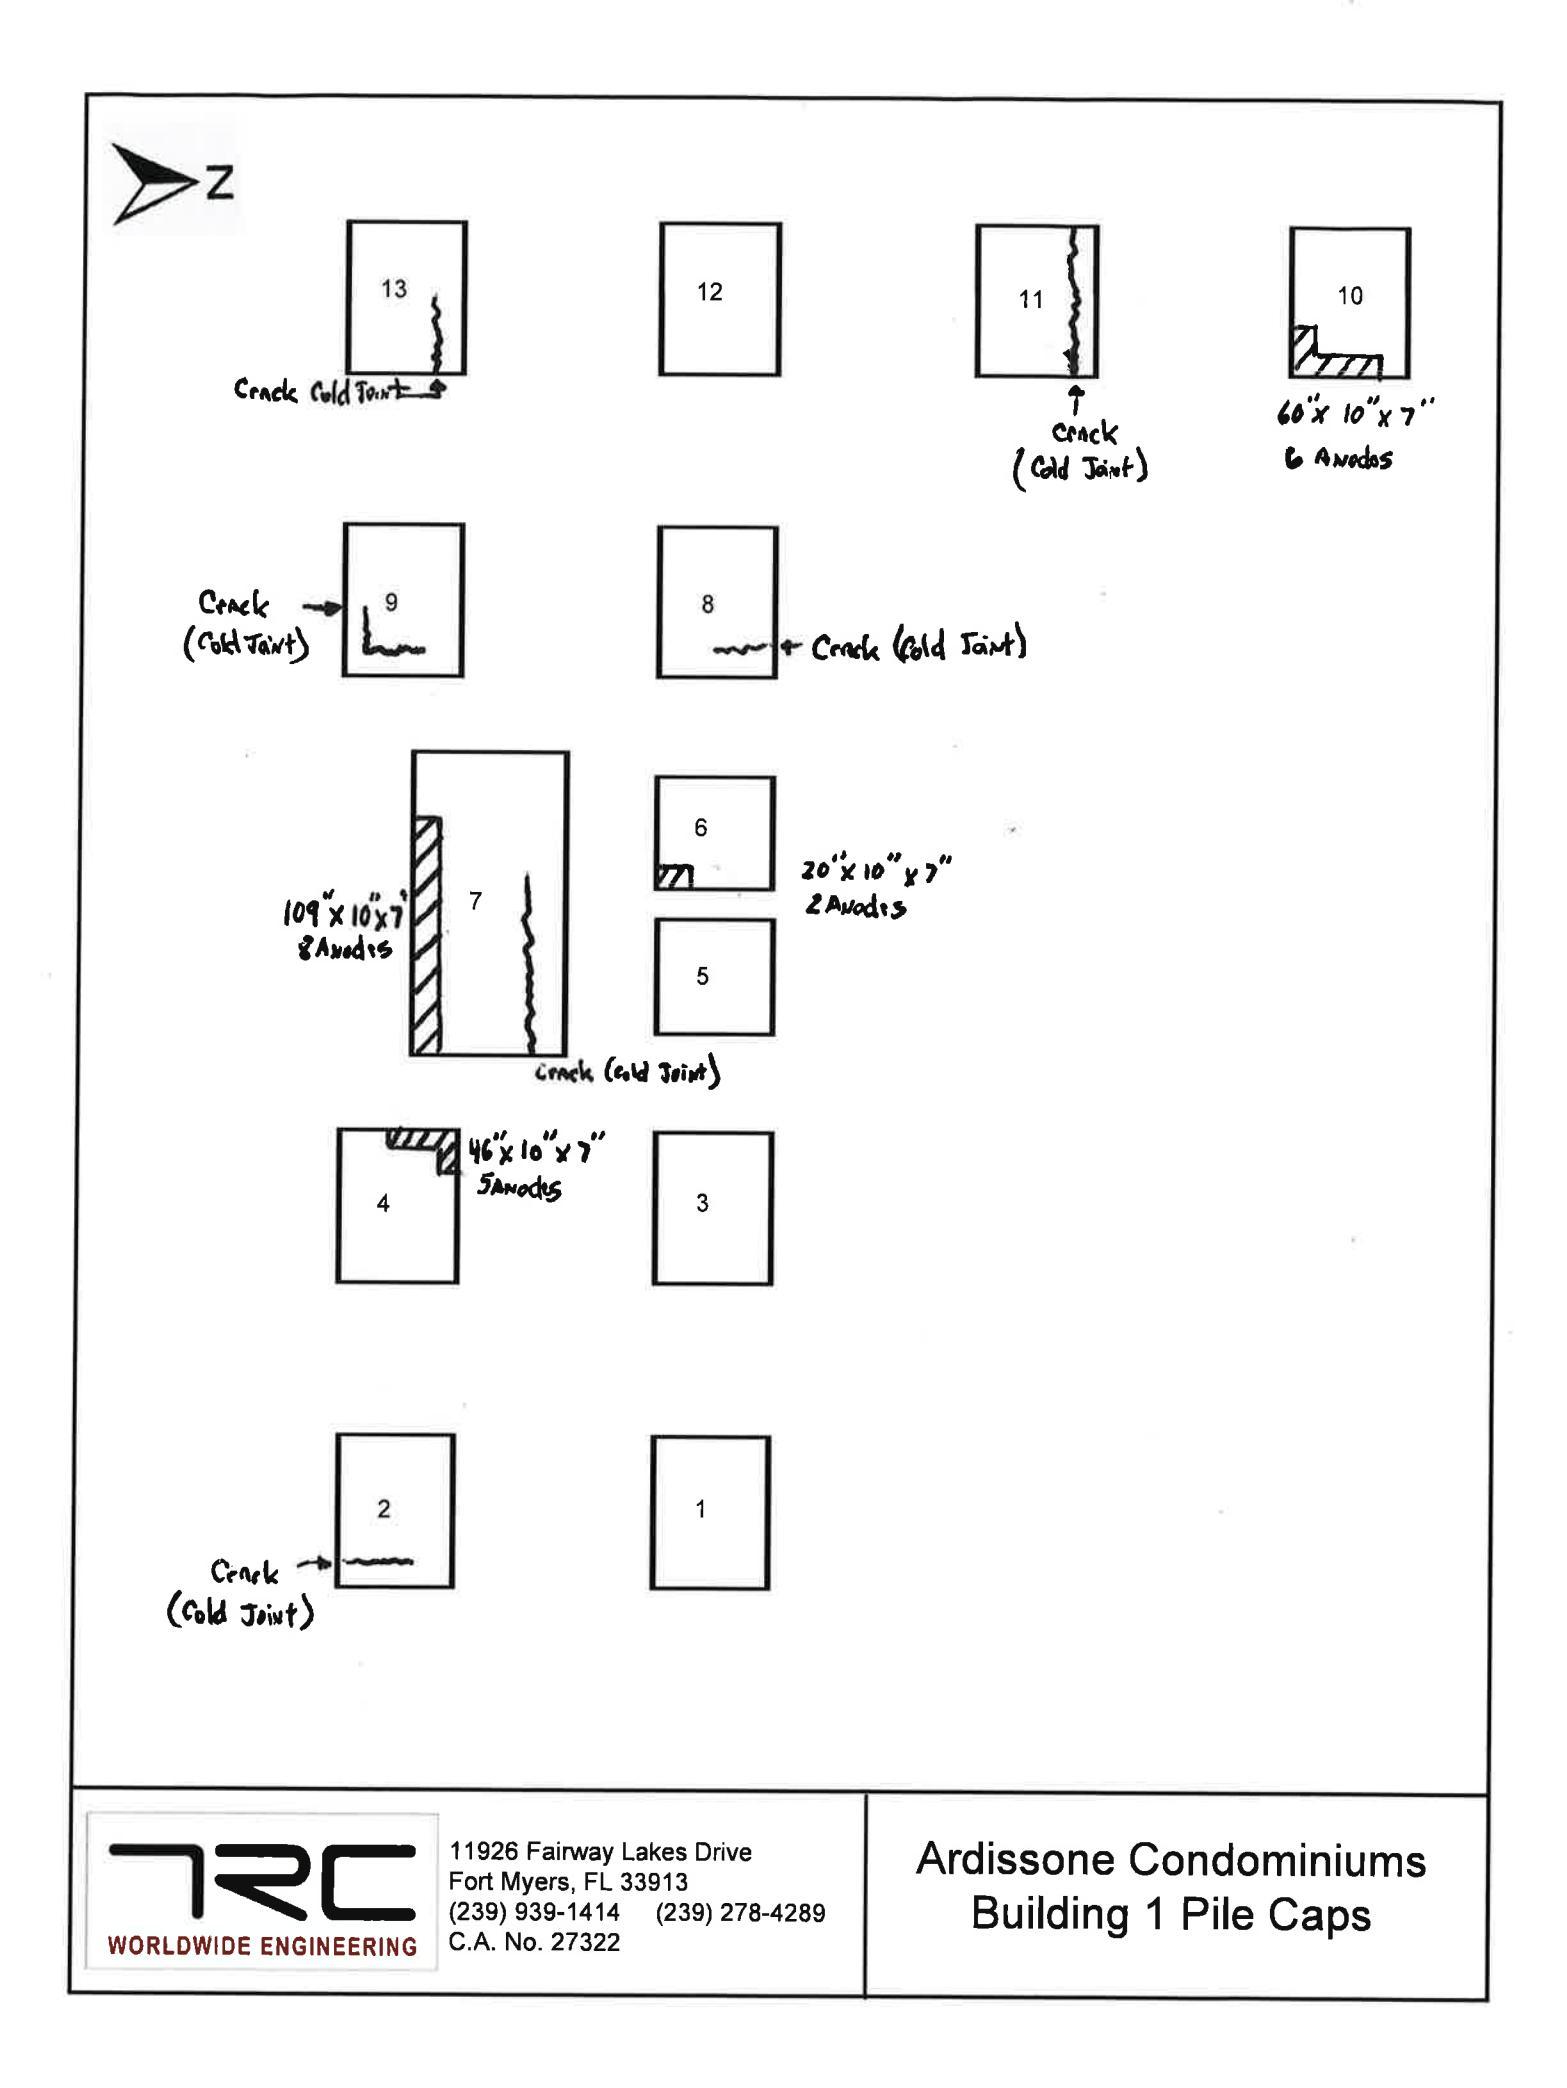
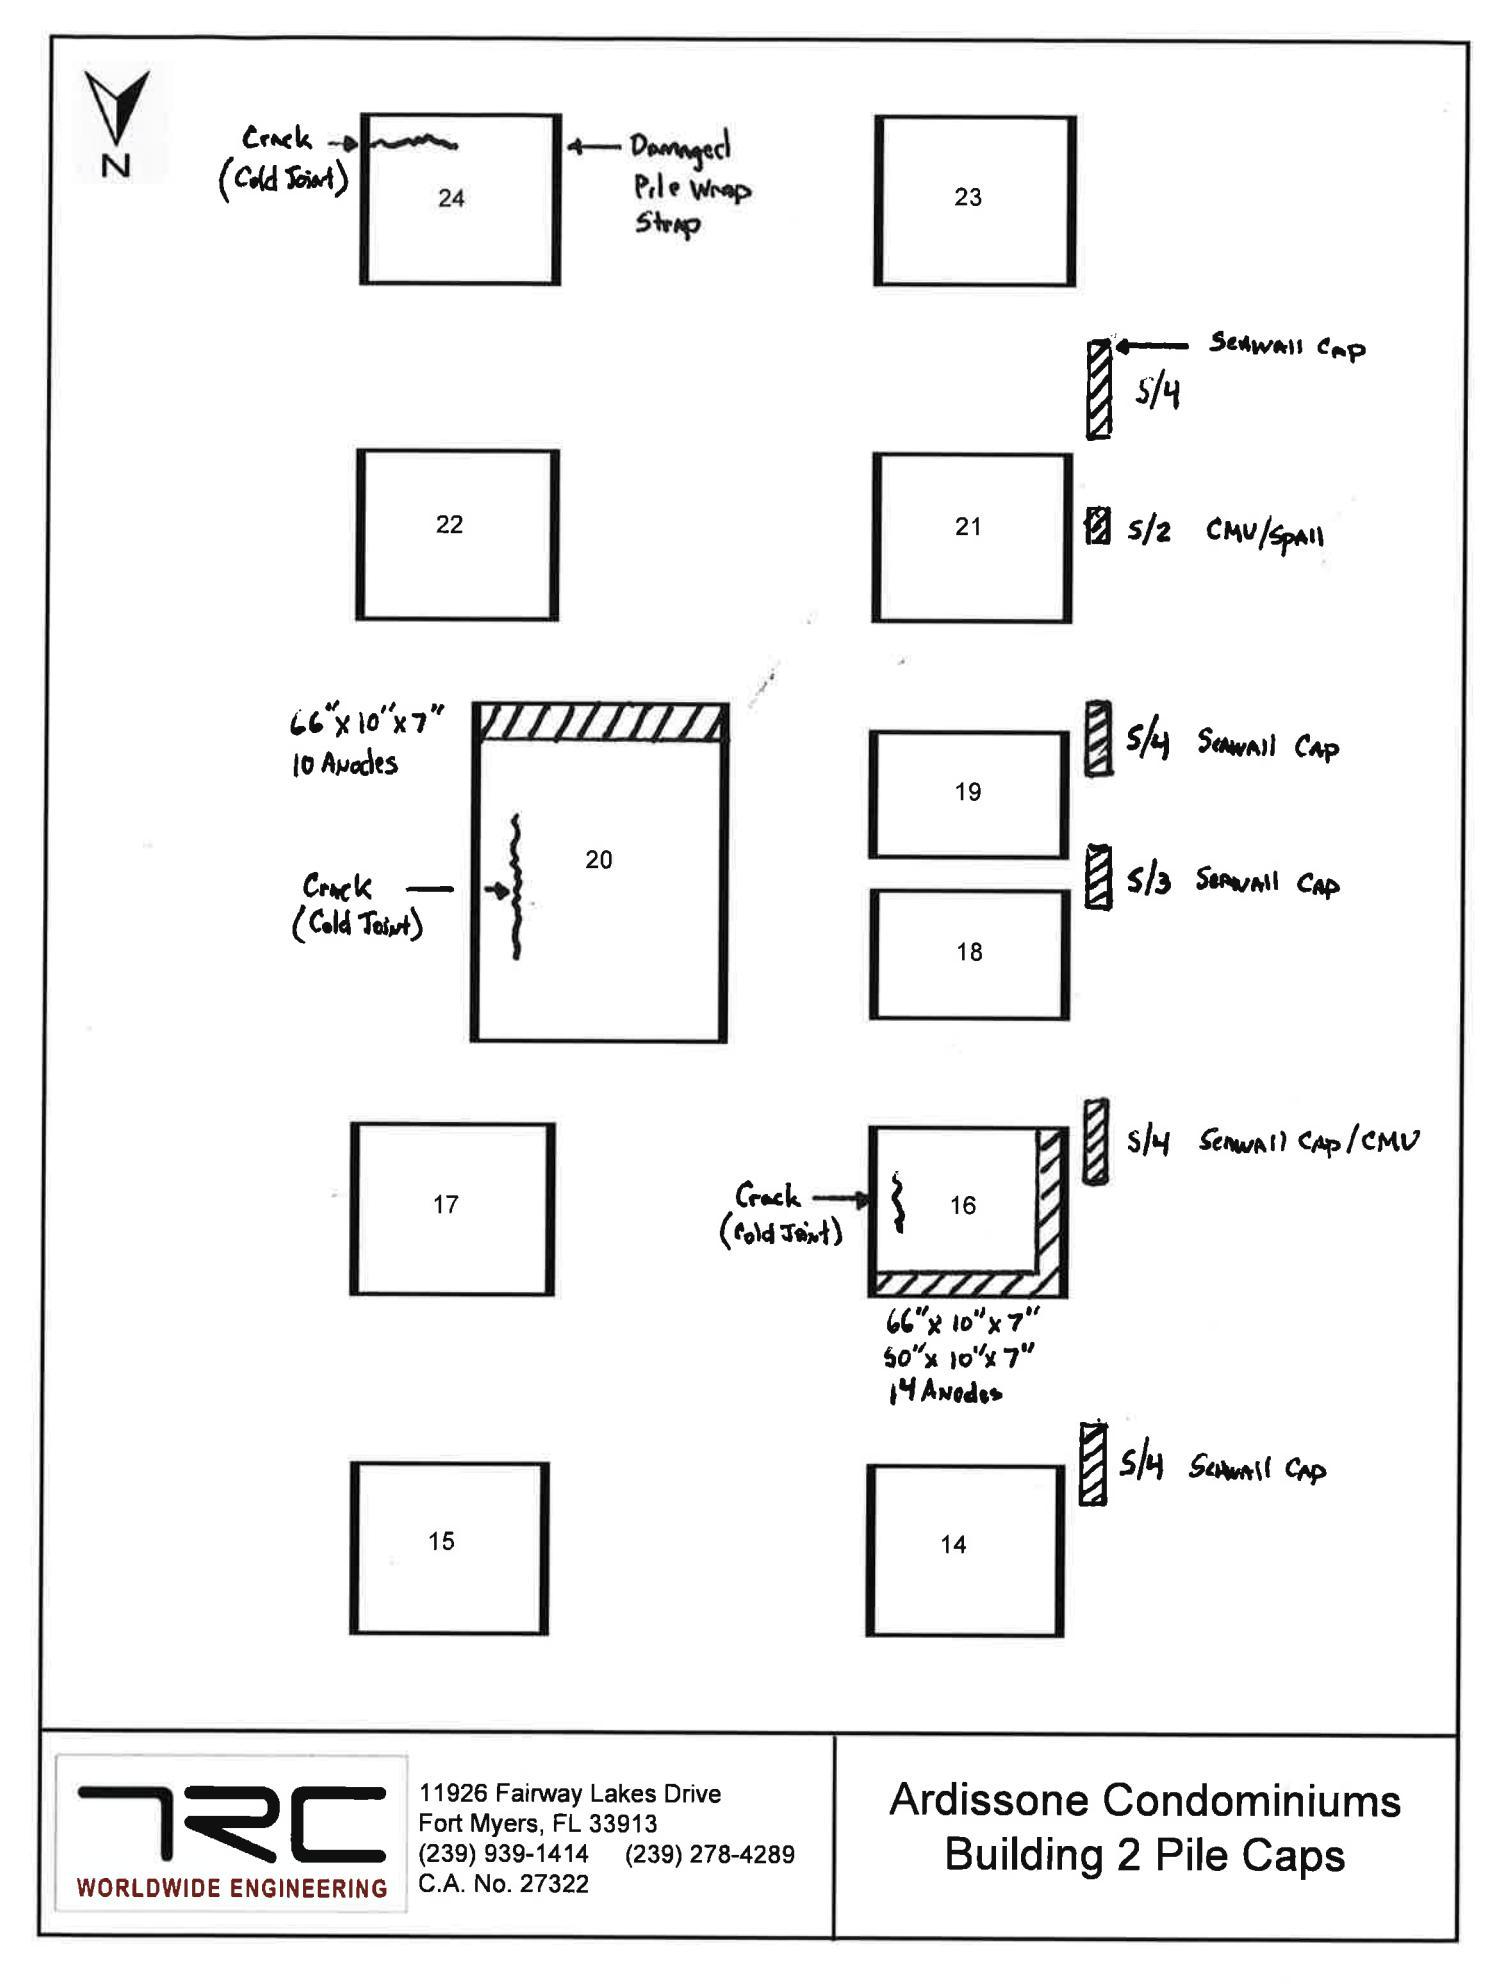
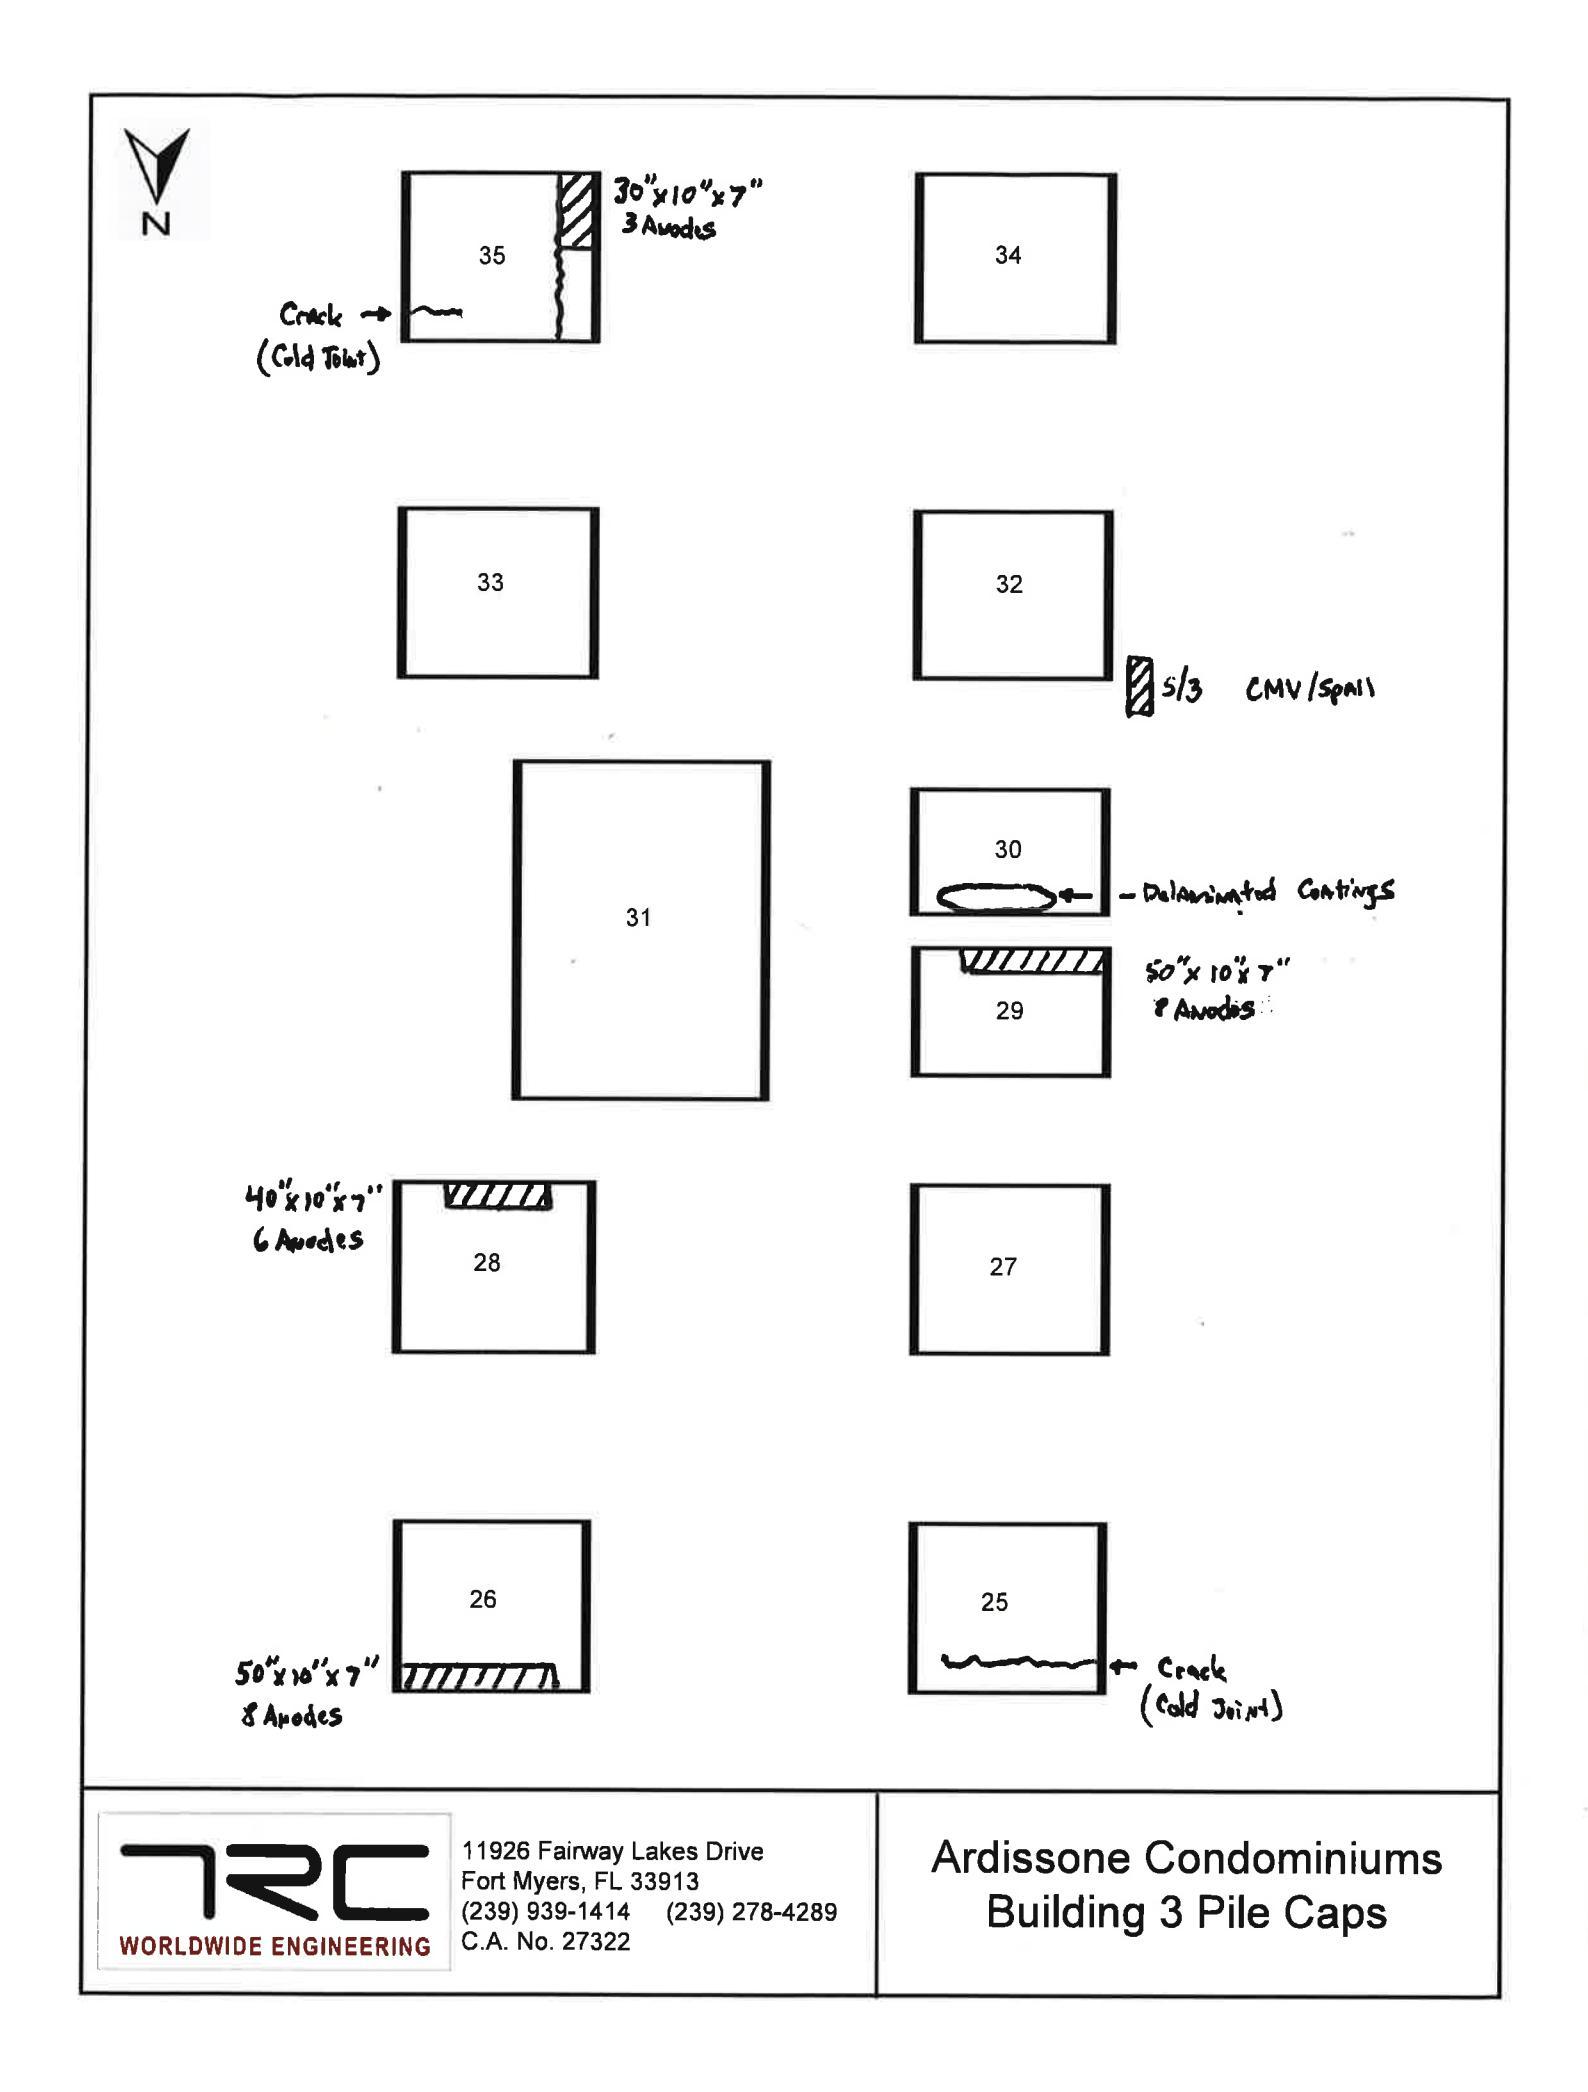
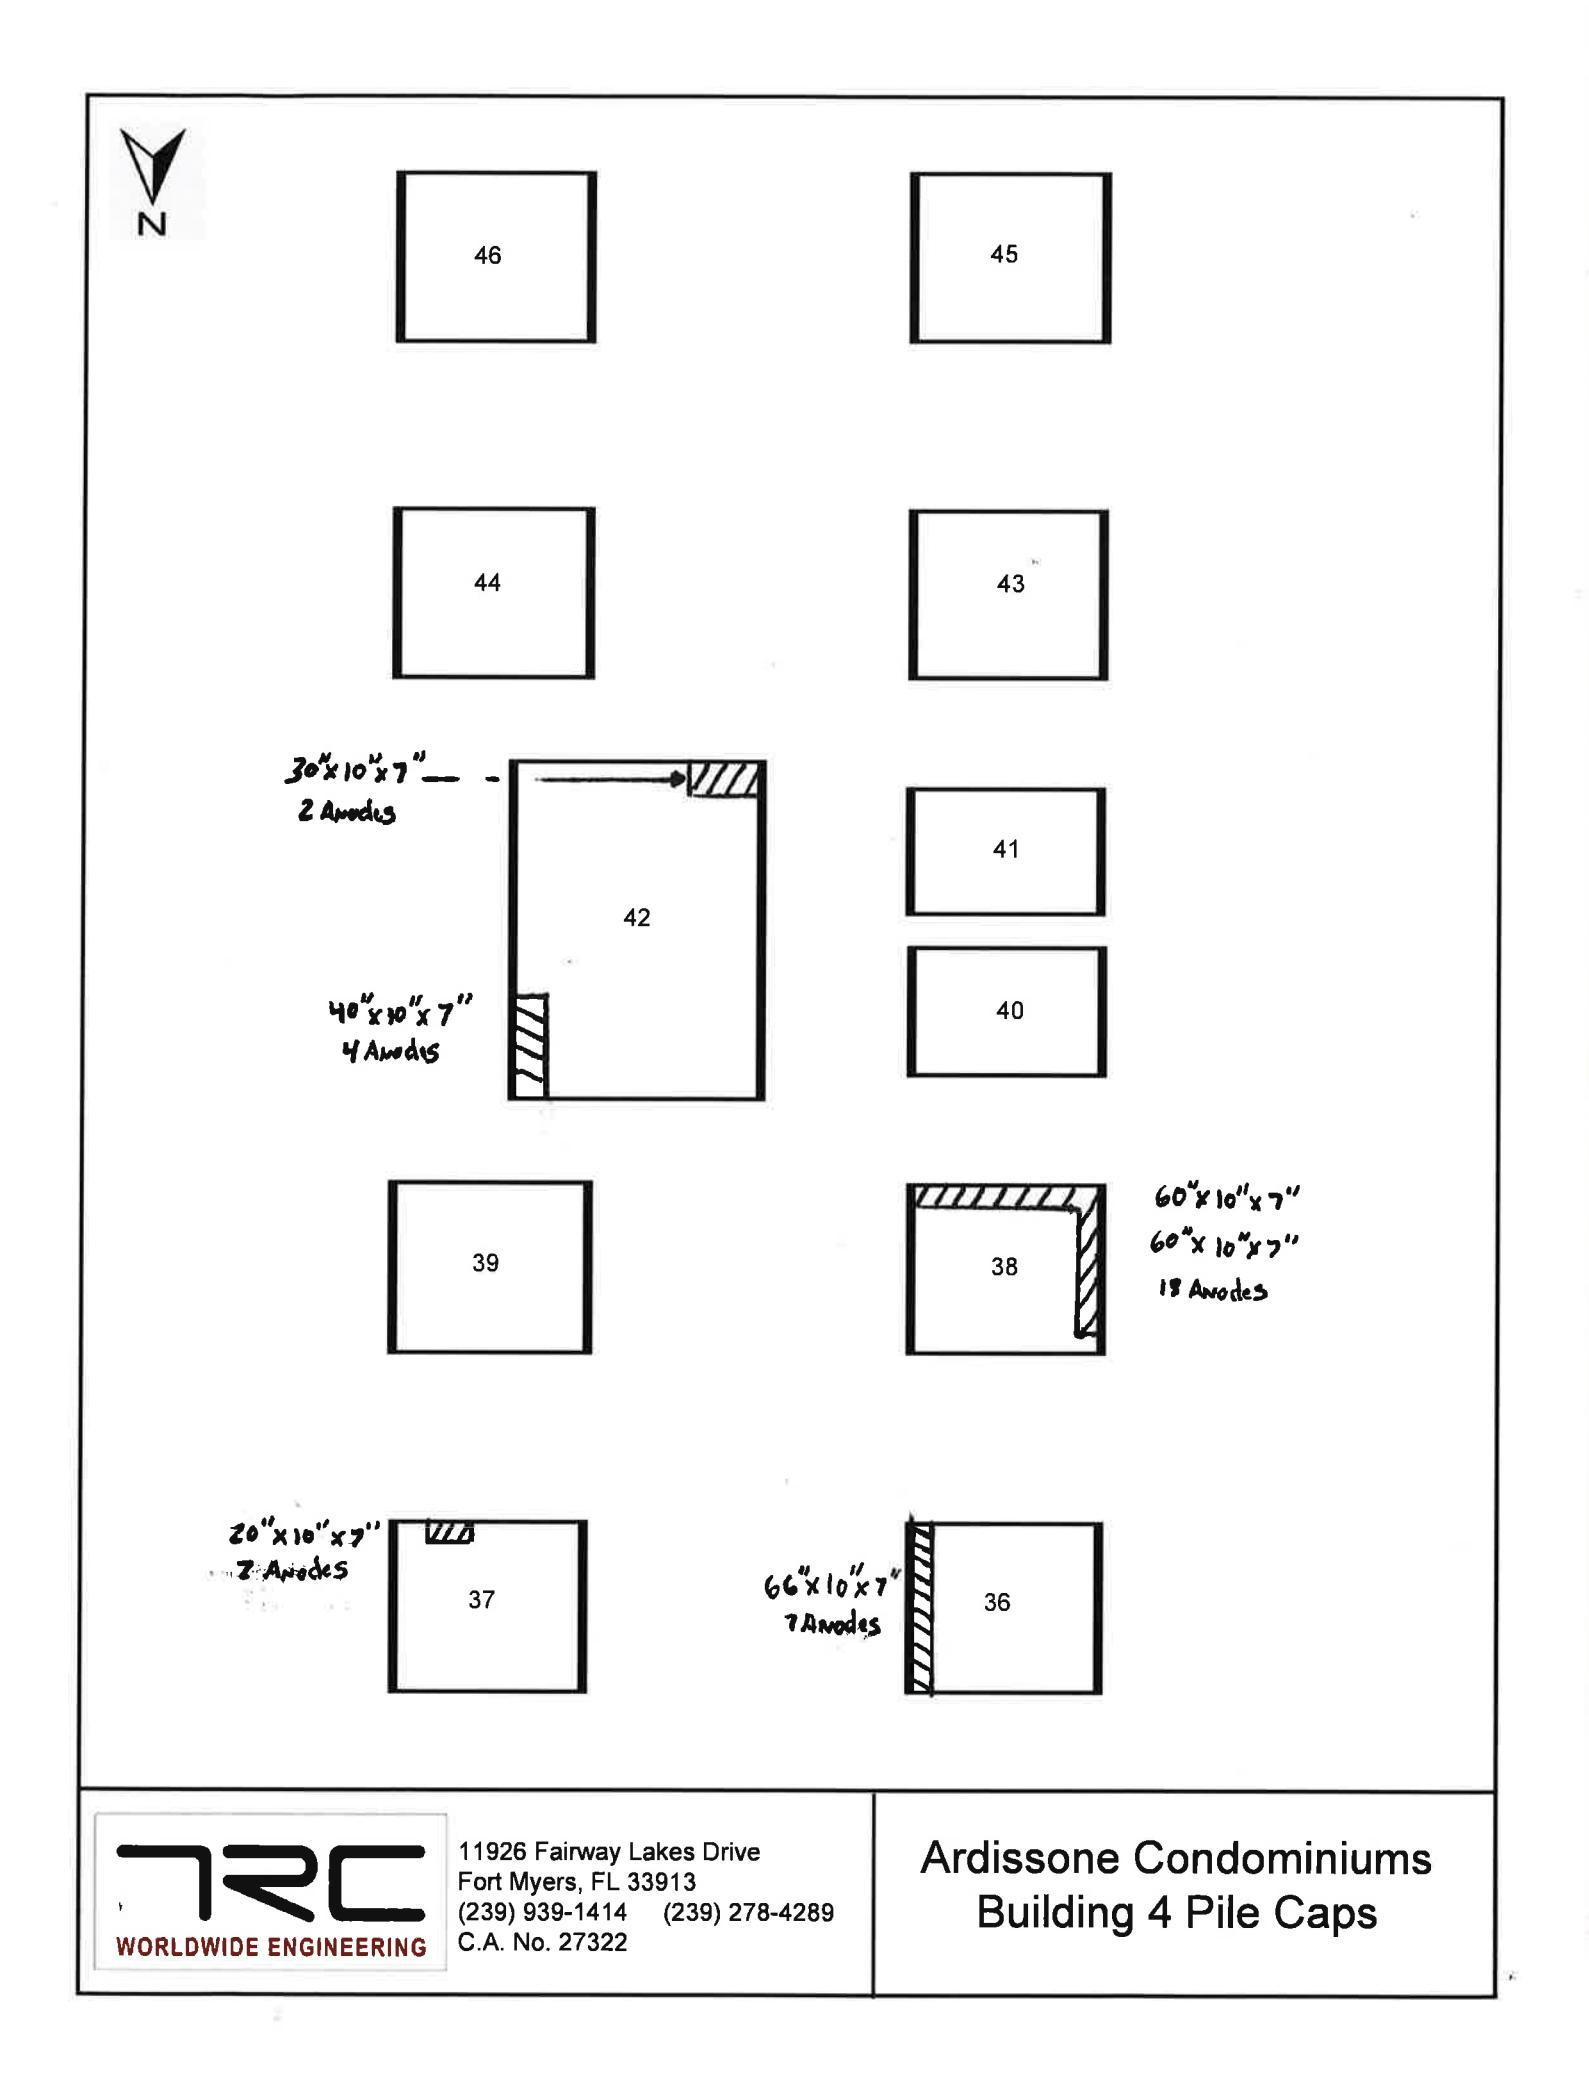
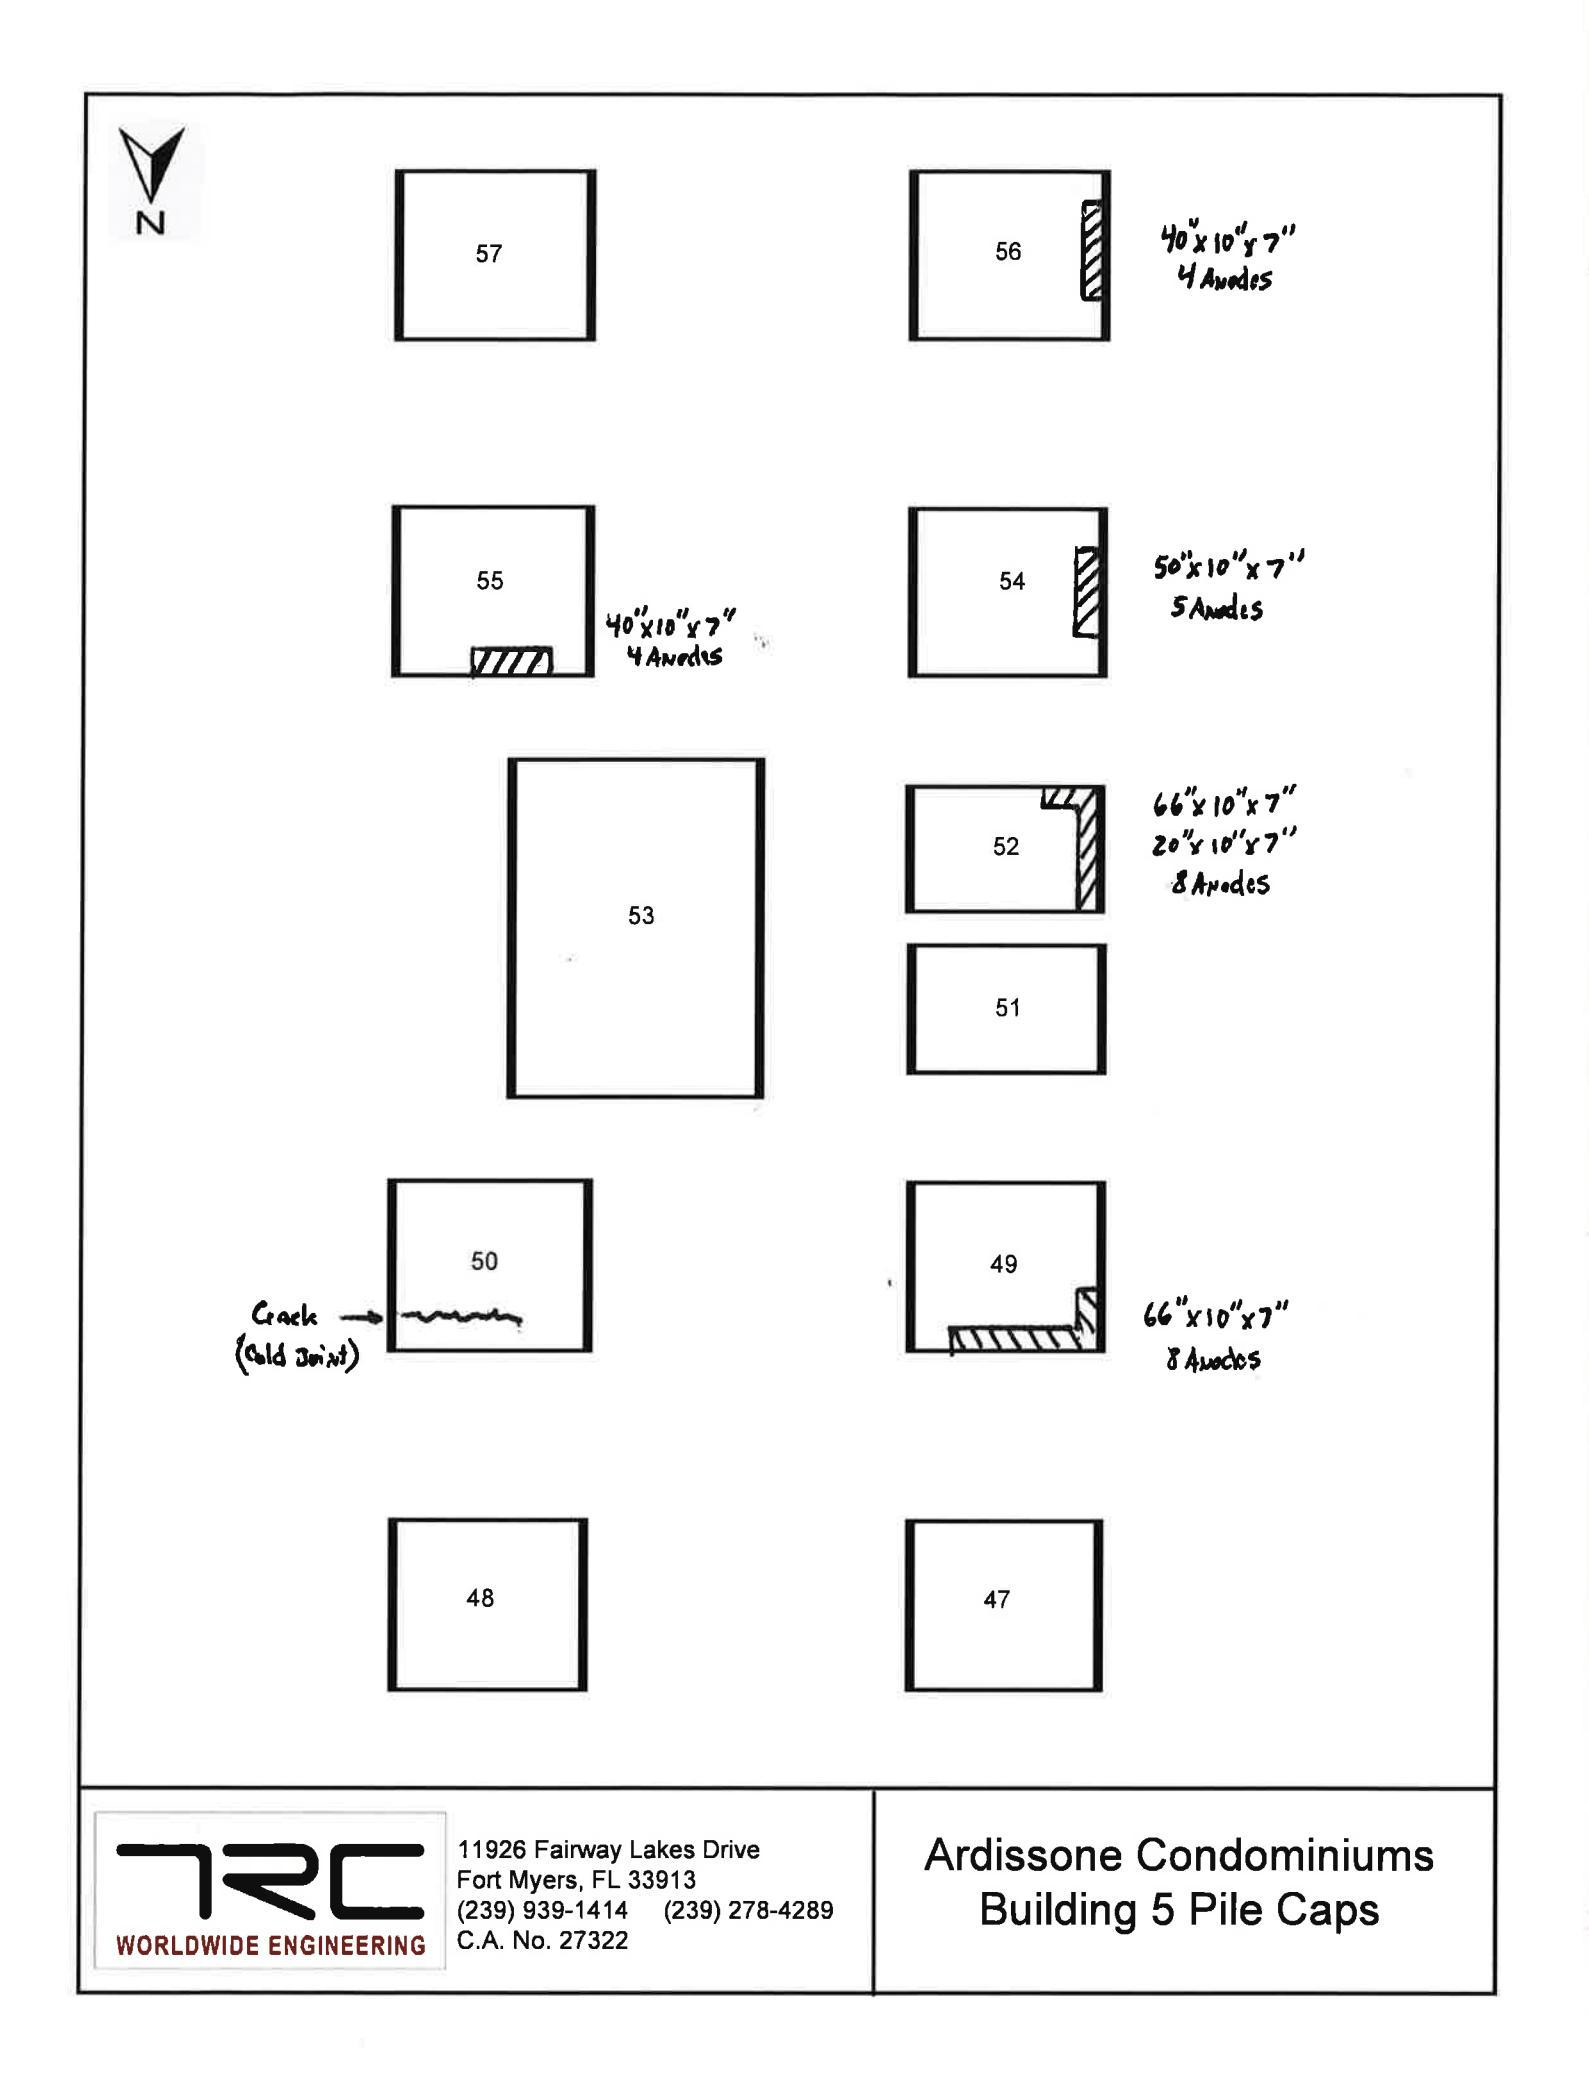
- 1. Damaged concrete areas were detected on the vertical surfaces of the pile caps, the sea wall caps and CMU surfaces below the sea wall at the base of the building. Hollow sounding concrete and apparent spalls on the sea wall and CMU surfaces were denoted on the plans by a "S/#" with the "#" representing the approximate surface area of the visible spall or surface area requiring excavation and repair. Please note that this does not represent the total cubic feet of repair volume that is presented in the probable opinion of construction cost sheet attached. TRC must estimate the repair depth in order to quantify the volume of concrete repairs which is then used by the contractors to bid the work. Additional field measured areas on the pile caps are also represented on the attached templates based on field measurements and past repair depths from excavations performed in 2019. (See Photos 1- 7)

We recommend that the deteriorated concrete sections should be excavated by power tools back to sound material to allow abrasive blast cleaning of the steel reinforcing bars free of rust and coated with an epoxy-cement bonding agent prior to forming and placing of new low permeability micro-concrete mix with integral corrosion inhibiting admixture. Based on the condition of the reinforcing steel in the concrete at the spalled areas previously repaired in the last restoration project and the unseen conditions that cannot be anticipated until excavation, it is our professional opinion that corrosion mitigation anodes continue to be used to ensure the mitigation of the corrosion to the reinforcing steel and provide sound repairs. It is also recommended that corrosion mitigation anodes be utilized at the concrete repair locations due to the age of the structure and the chlorides in the atmosphere from the surrounding environment that have permeated the concrete over time.
